kunanyi / Mount Wellington Mountain Bike Tracks 1a, 1b, 12 and Upper Luge Historic Heritage Assessment

Final Report for the City of Hobart

20 November 2020

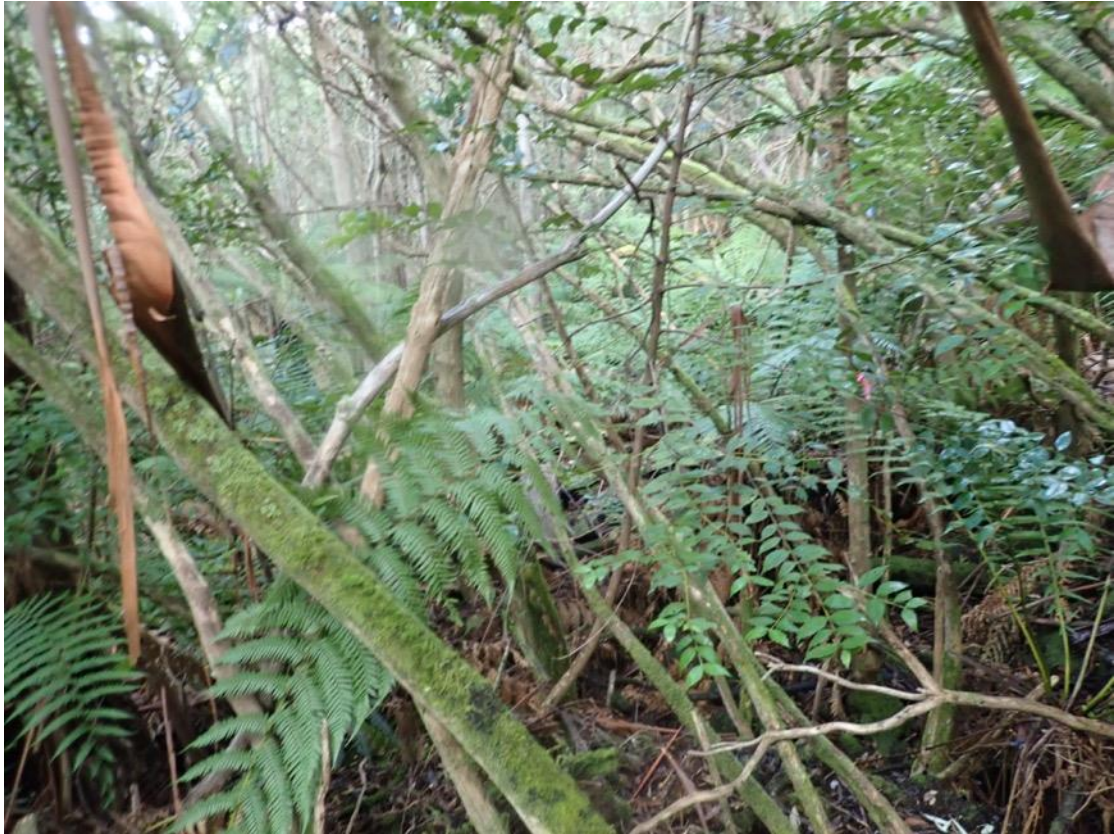
Figure 5.1.1 Typical vegetation and ground surface visibility within Survey Area One; visible in the photograph is pink flagging tape marking the location of proposed Track 1a.

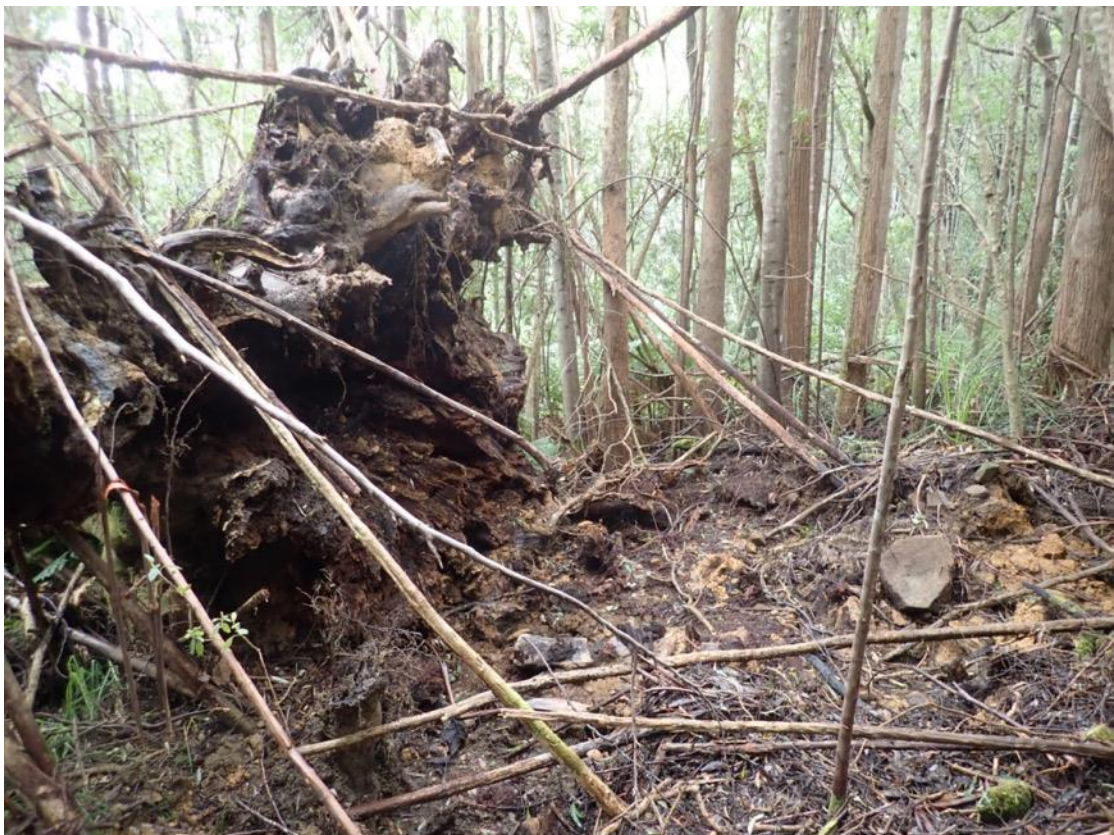
Figure 5.1.2 Looking to the east and showing the dolerite and orange clay soil exposed by the fallen tree.

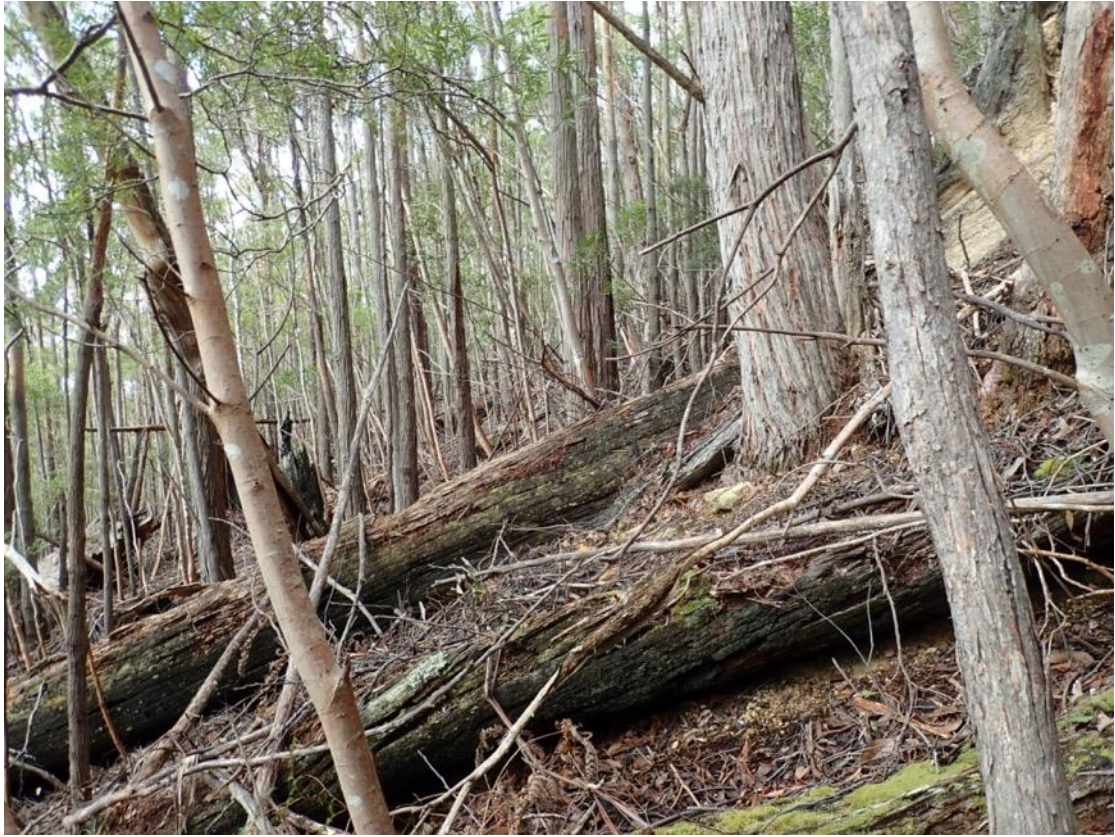
Figure 5.1.3 Looking east and showing an open area within Survey Area Two with the typical form of deadfall and leaf litter obscuring ground surface visibility.

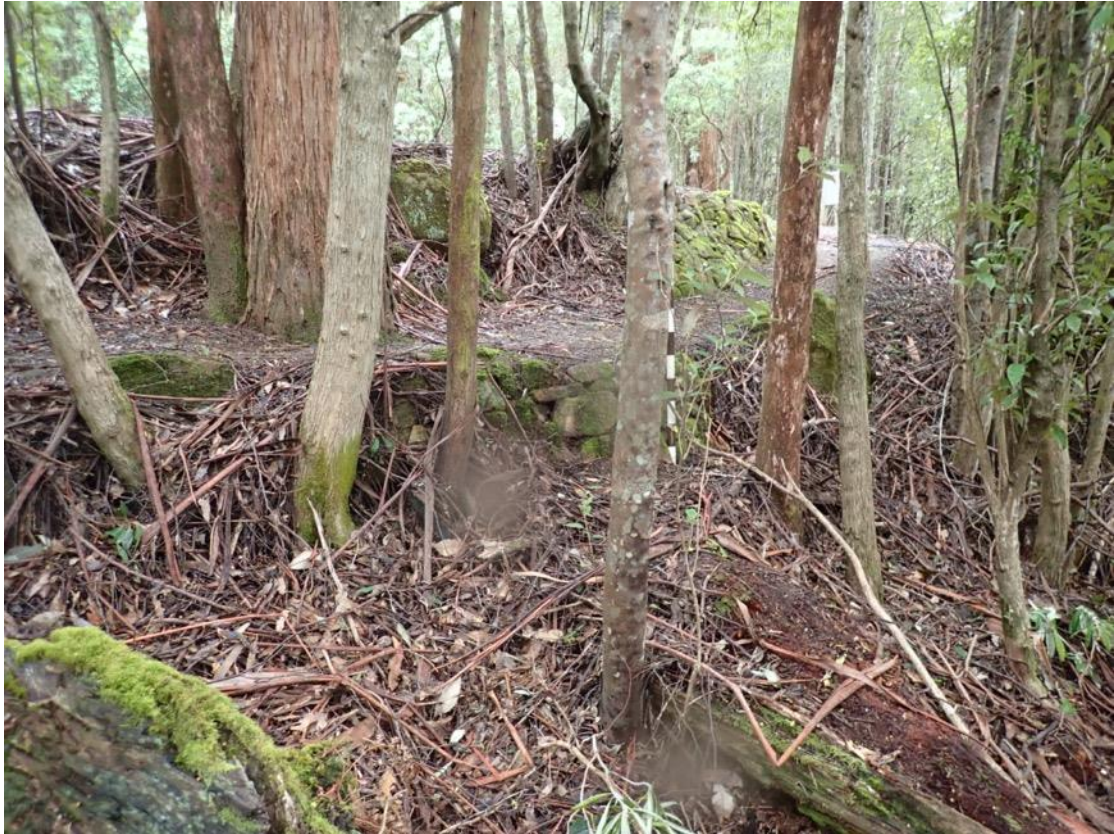
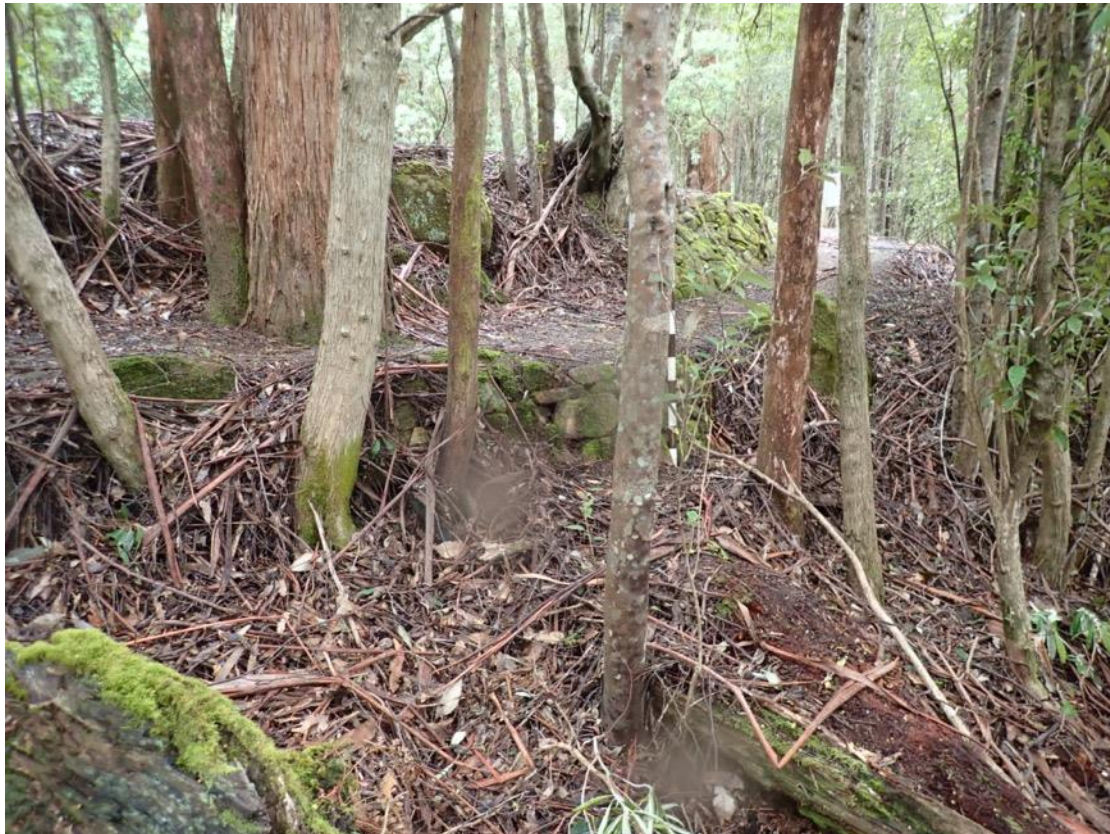
Parts of the Circle Track and vehicle track were observed within this survey area. The proposed Tracks 1a and 1b both intersect with the Circle Track and Track 1b is within the vehicle access track. The intersection of the proposed Track 1a occurs with Circle Track both close to Pinnacle Road and at some distance to the east whereas Track 1b is likely to cross the Circle Track only close to Pinnacle Road. At this location Circle Track is an approximately 1m wide clay pad with either a rough stone rubble border or where raised above the slope slightly, supported by random coursed rubble.

Figure 5.2.1 View west showing the entrance to the Circle Track adjacent to Pinnacle Road. Shown in the centre of the photograph is the random coursed rubble supporting structure below the track. The scale has 100mm marks.

Figure B.1.1 View west showing the entrance to the Circle Track adjacent to Pinnacle Road. Shown in the centre of the photograph is the random coursed rubble supporting structure below the track. The scale has 100mm marks.

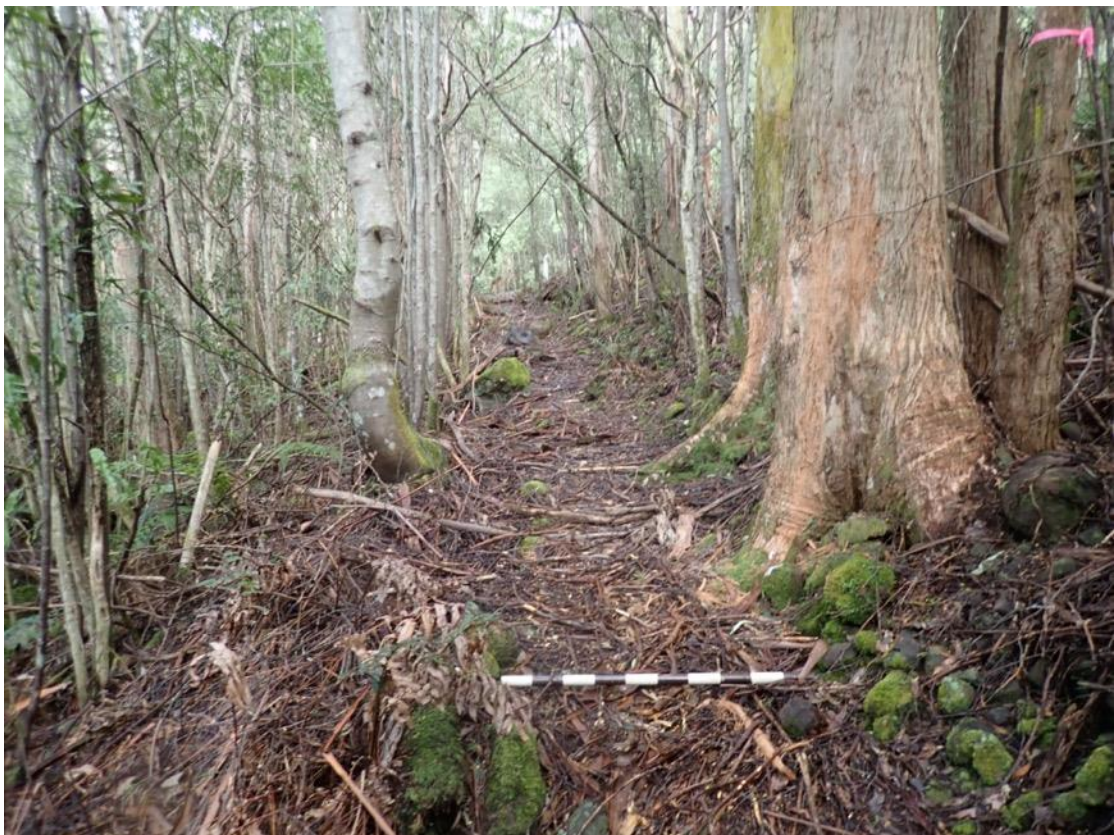
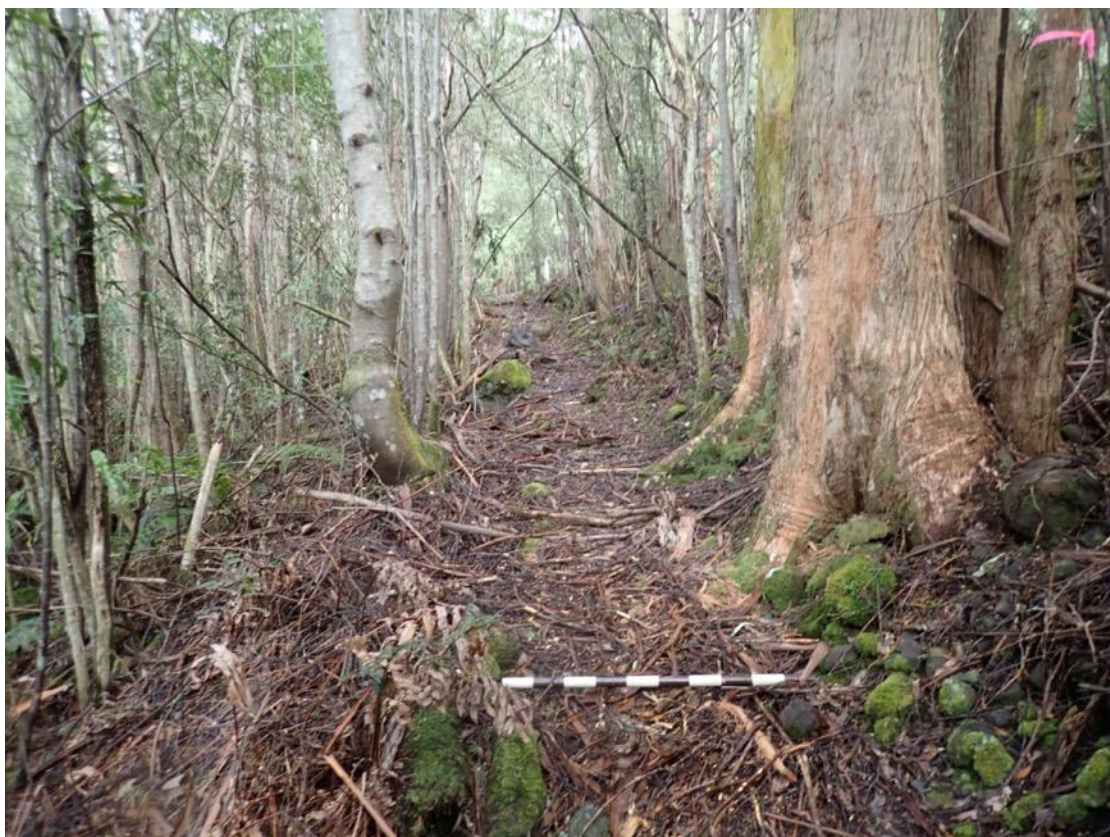
Figure 5.2.2 View to the west over the centre of the Circle Track showing the pink flagging tape marking the line of the proposed Track 1a visible in the right of the photograph.

Figure B.1.2 View to the west over the centre of the Circle Track showing the pink flagging tape marking the line of the proposed Track 1a visible in the right of the photograph.

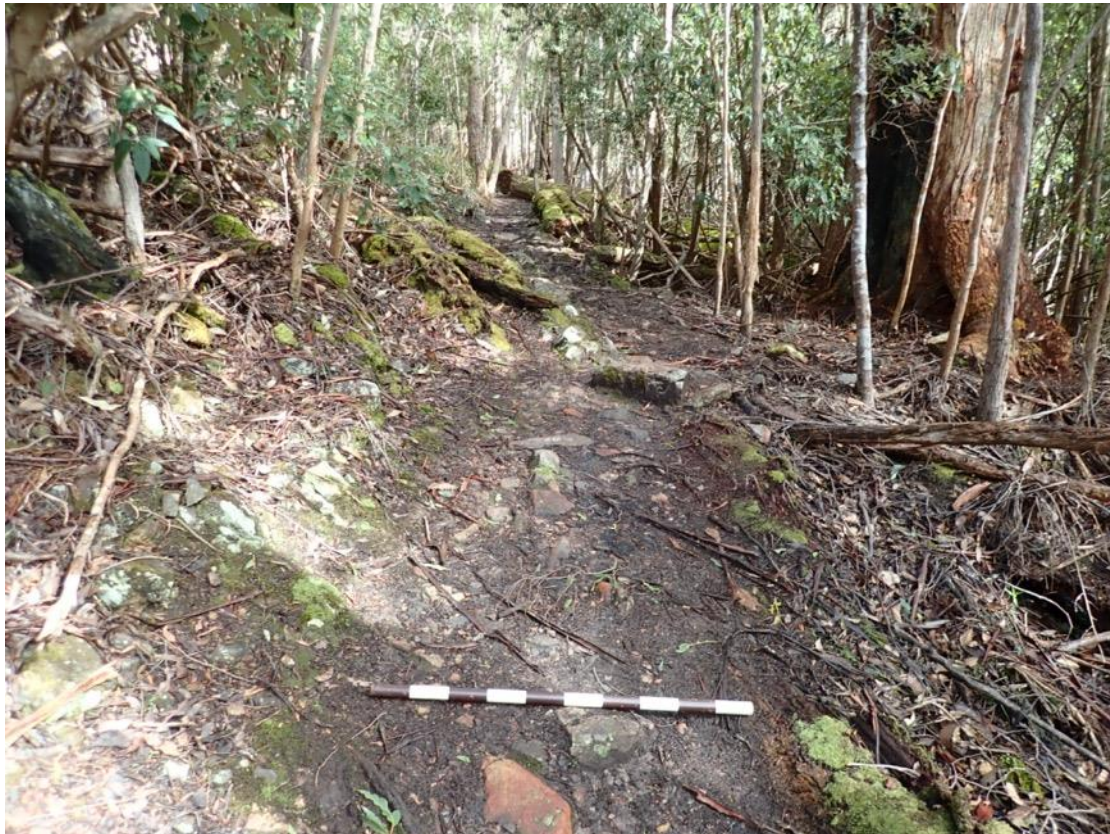
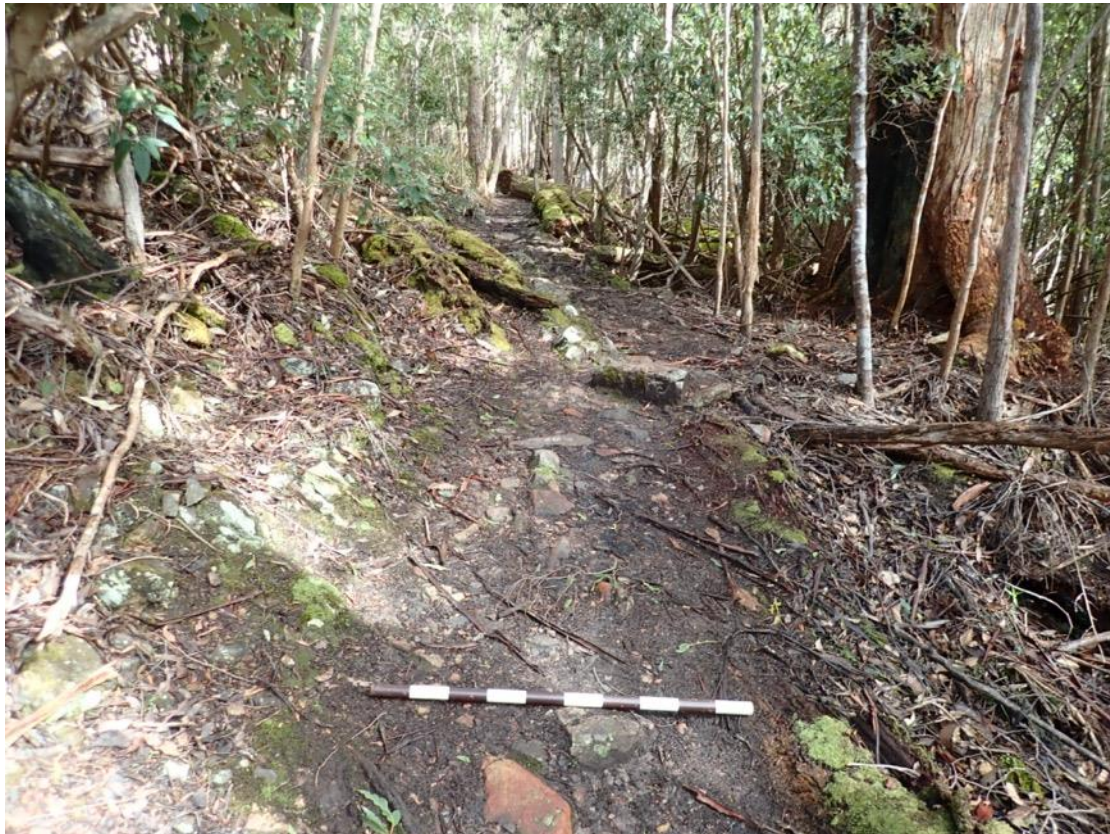
Figure 5.2.3 Looking north along Woods Track from the point where Track 1a is proposed to intersect with it. The scale has 100mm marks.

Figure B.1.3 Looking north along Woods Track from the point where Track 1a is proposed to intersect with it. The scale has 100mm marks.

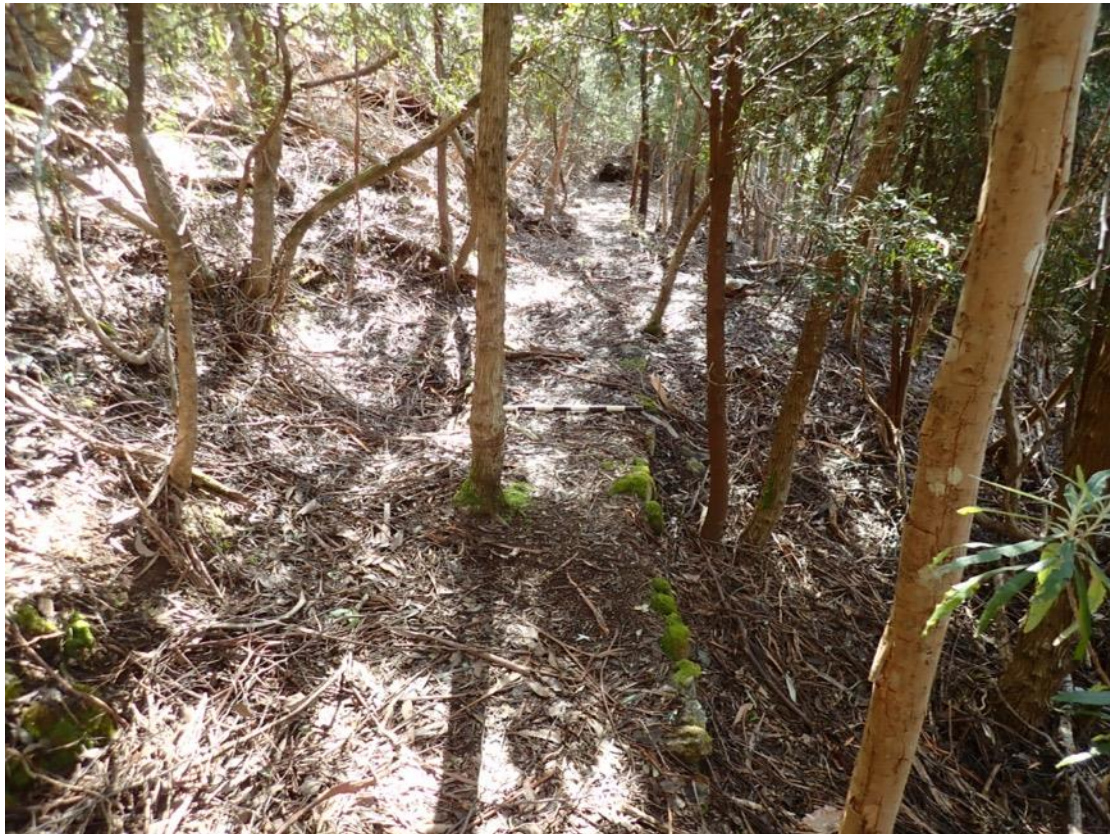
This other track, referred to here as the remnant track, extends north to south across the study area following the slope of the hill with a slight curve to the west as it goes north. This track is formed of a combination of benching, uncoursed random rubble facing beneath and a clay surface. However, this track is in varying states of repair with 5-10m stretches no longer being visible on the surface and possibly entirely removed. This track is most distinct at its junction with the former section of the Fingerpost Track. Track 1a crosses this remnant track only once at an oblique angle after its final descending switchback, however the putative location of Track 1b appears to closely align with this feature and may also cross twice along the southern border of the survey area.

Figure 5.2.5 Looking north along the unnamed remnant track. The scale has 100mm marks.

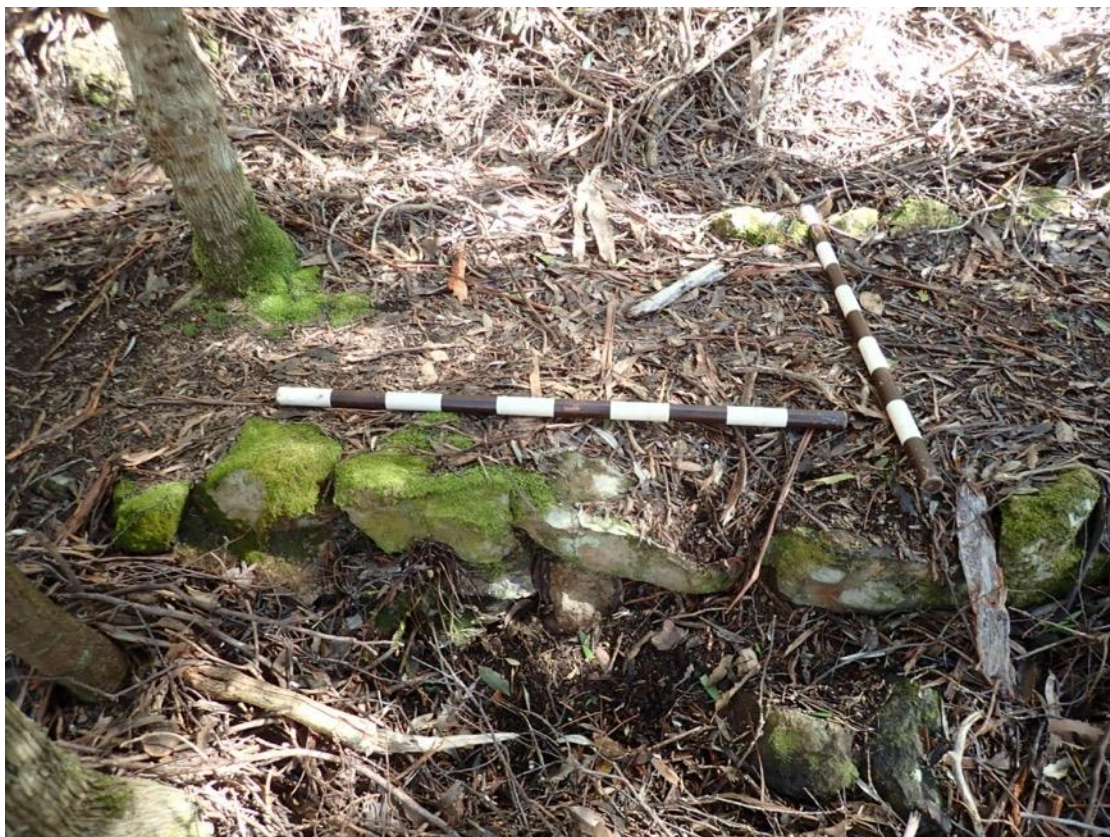
Figure 5.2.6 Detail view of the uncoursed stone rubble forming the base of the track. The scale has 100mm marks.

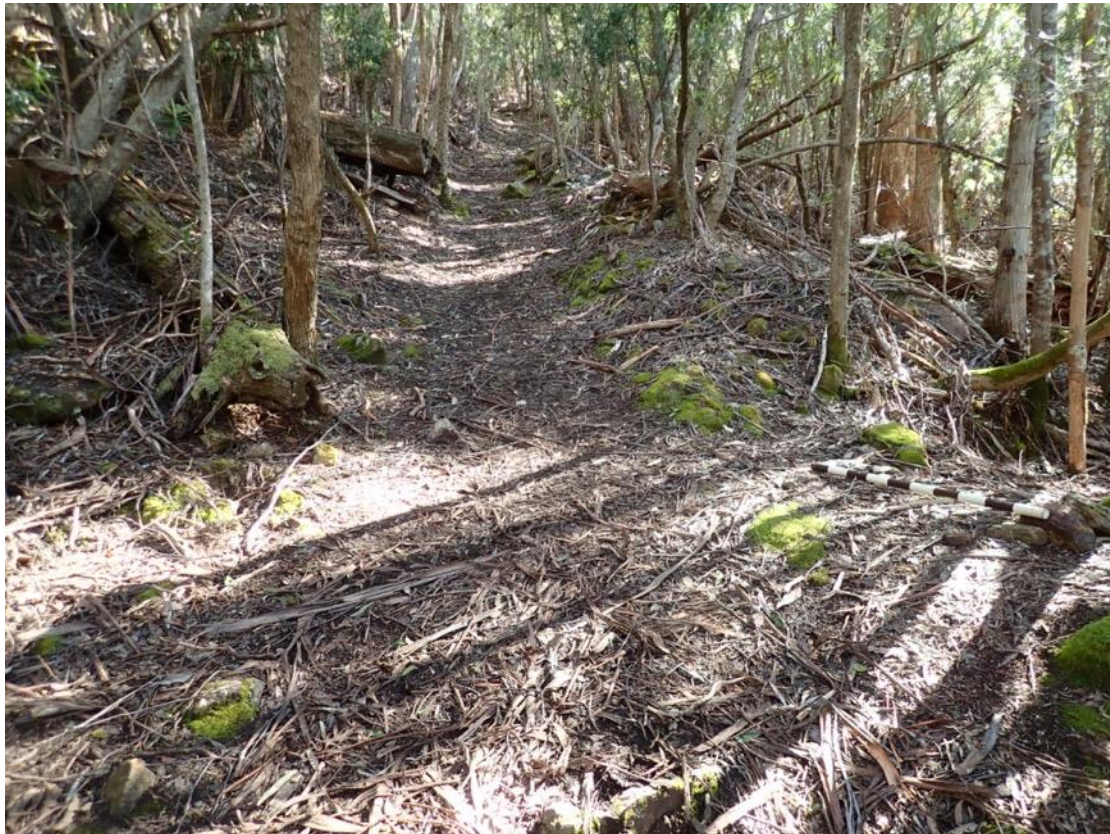
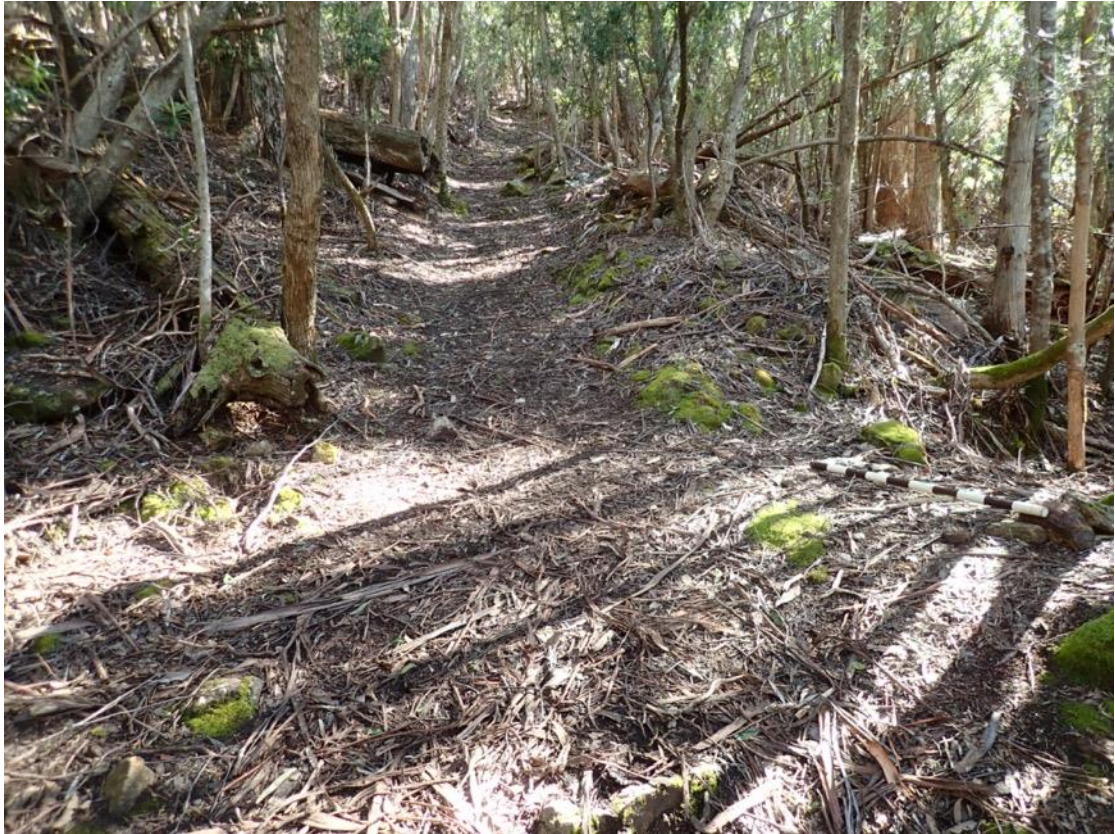
Track 1a avoids a small track, formerly part of Fingerpost Track, leading from O'Grady's Falls Fire Track to Pinnacle Road however it appears that Track 1b enters into this track several times at the acute angles of its switchbacks. This unnamed track is 1-1.4m wide and is formed on a rocky clay surface, which likely represents the wearing down of this track into the natural strata of this area. This track intersects with another track, unused but more formally constructed about half way up its length.

Figure 5.2.7 Looking south along a former part of the Fingerpost Track, the scale in the right of the photograph indicates its intersection with the unnamed remnant track. The scale has 100mm marks.

Figure B.1.7 Looking south along a former part of the Fingerpost Track, the scale in the right of the photograph indicates its intersection with the unnamed remnant track. The scale has 100mm marks.

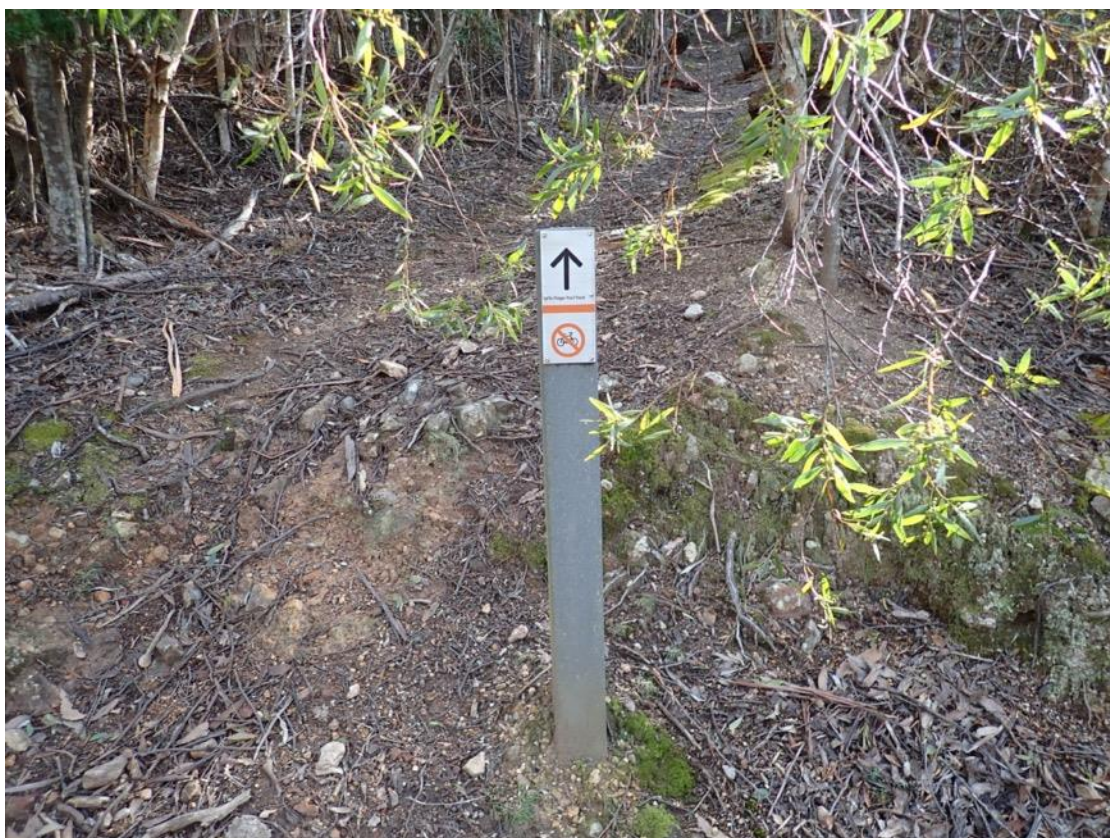
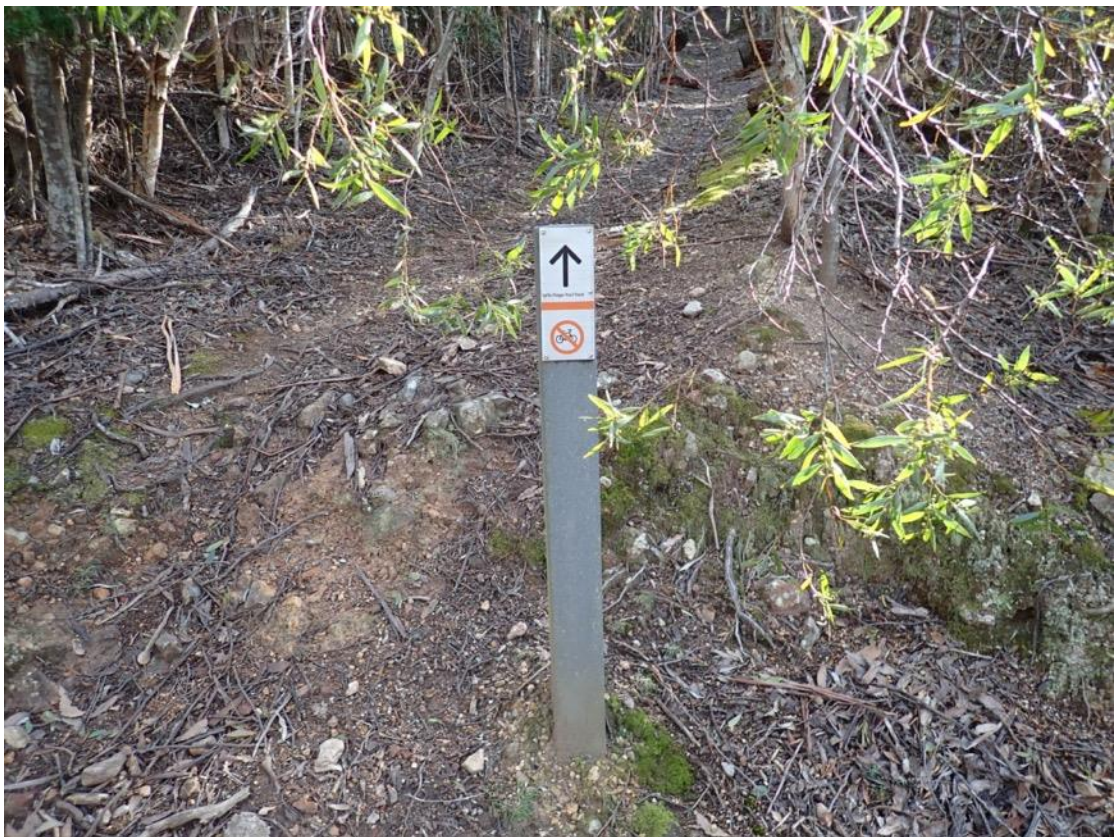
Figure 5.2.8 Looking south along the former part of Fingerpost Track near its intersection with O'Grady's Falls Fire Trail.

Figure B.1.8 Looking south along the former part of Fingerpost Track near its intersection with O'Grady's Falls Fire Trail.

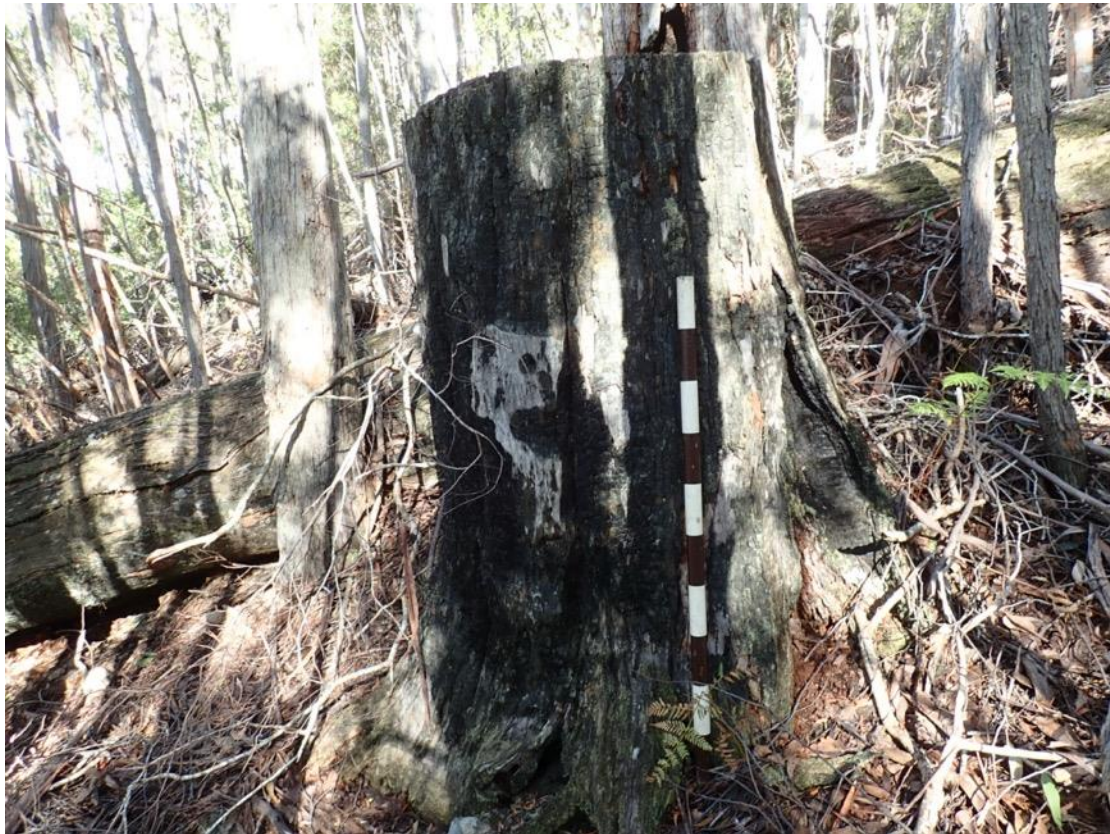
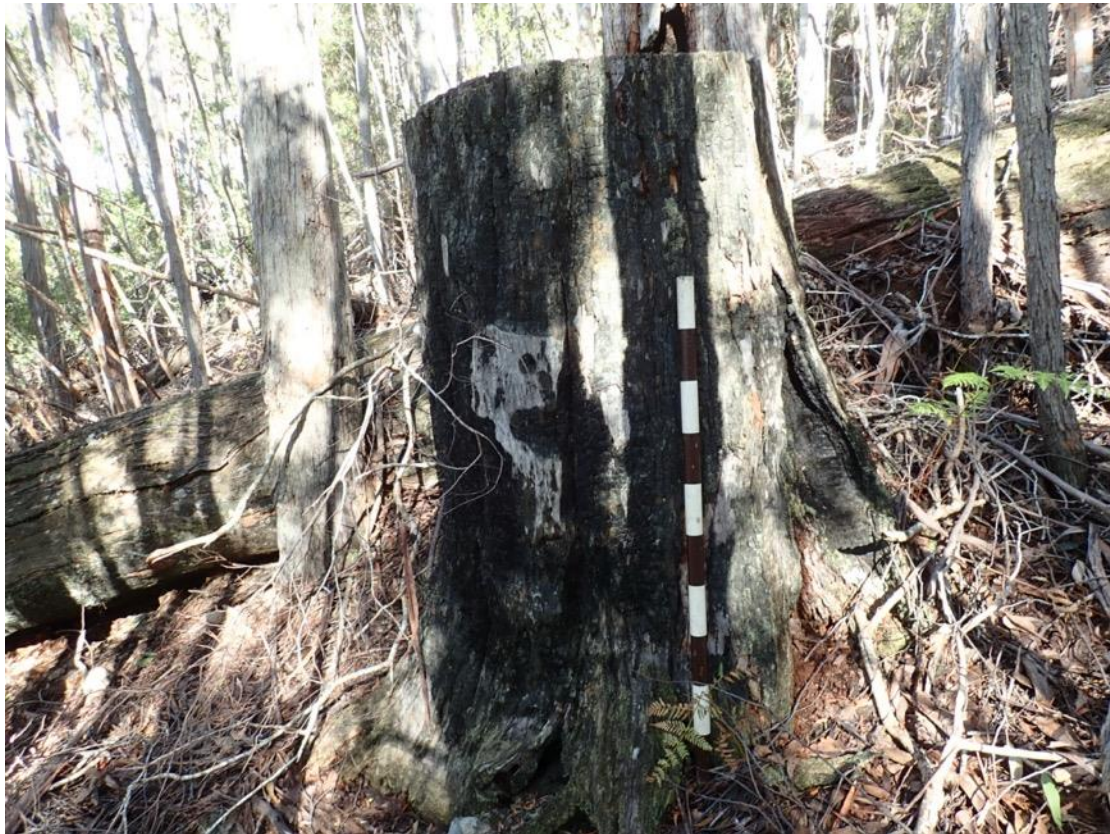
A single sawn tree stump, offset ~10m from the proposed Track 1a was also present within the survey area. However, due to its age and state of decay no specific manner of sawing could be observed on the surface of this stump.

Figure 5.2.9 Looking east at the sawn stump. The scale has 100mm marks.

Figure B.1.9 Looking east at the sawn stump. The scale has 100mm marks.

6. The presence of the sawn stump in Study Area One should be noted in works specifications and avoided if consideration of alterations to the proposed track take place. All staff and contractors should be given heritage inductions regarding historical archaeological features and deposits with specific reference to cultural traces left by timber-getting.

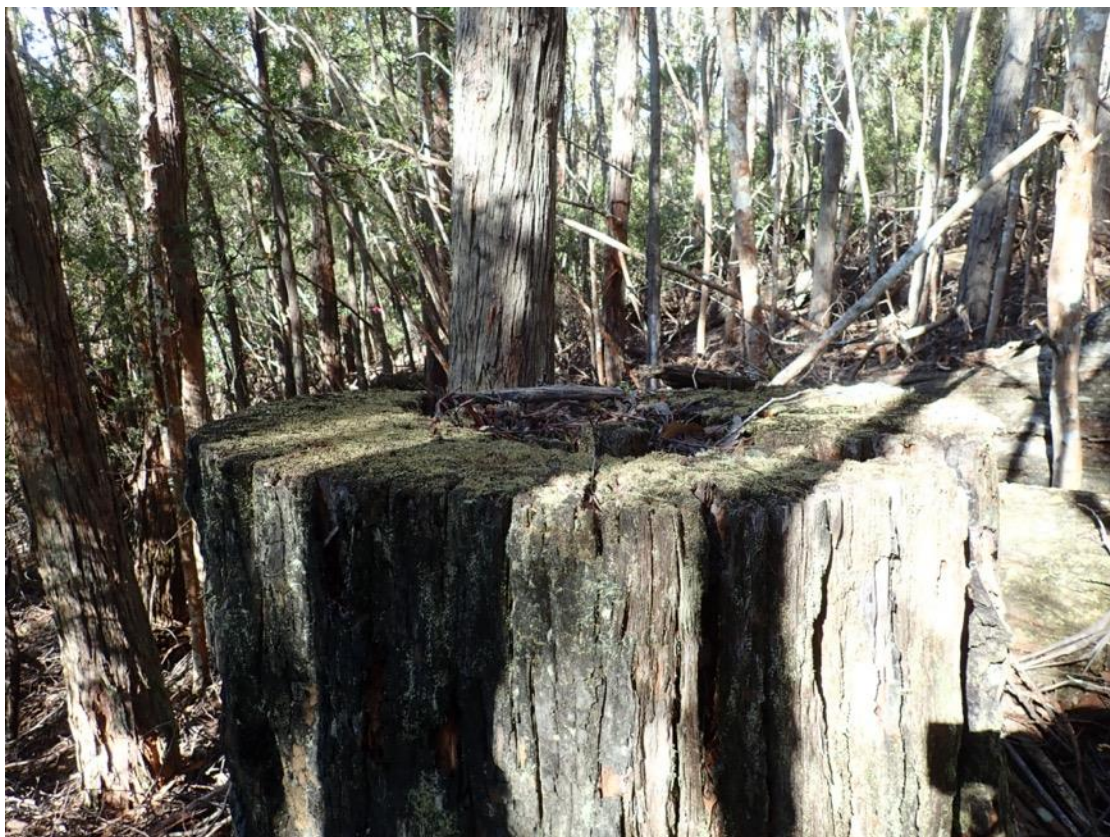
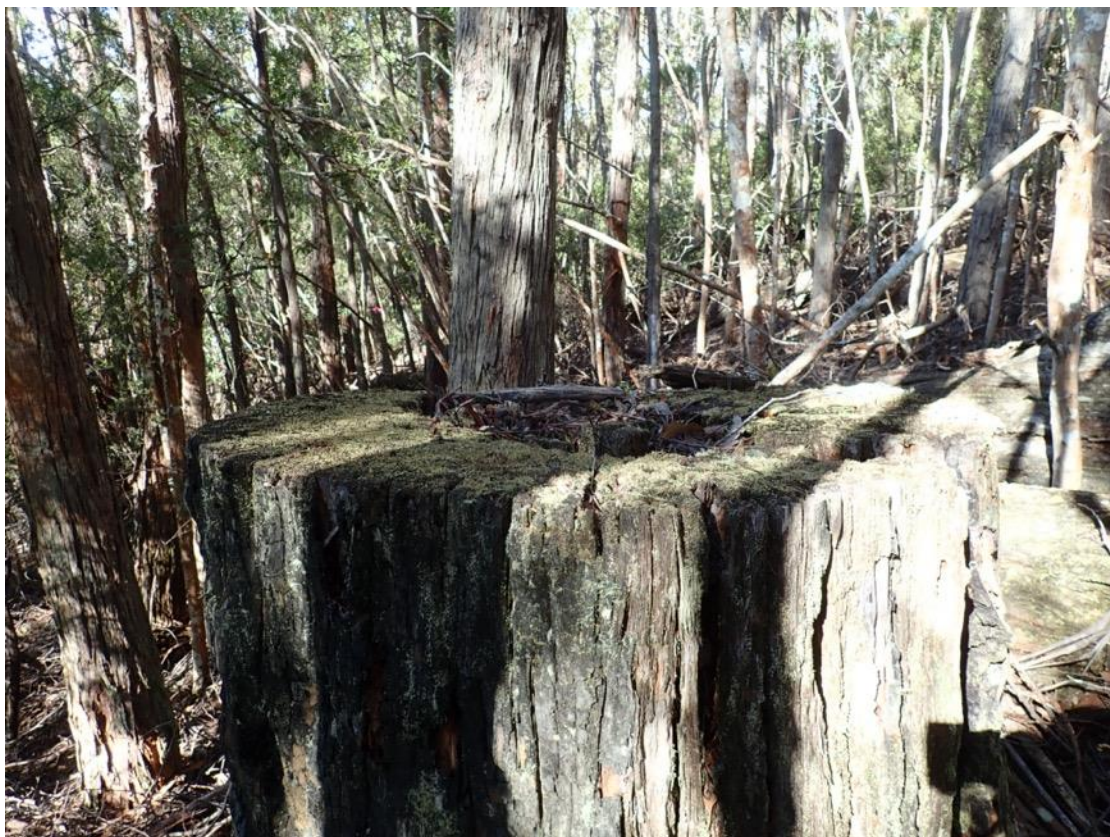
Figure 5.2.10 Detail view of the surface of the sawn stump showing that its degradation precludes accurate identification of its method of sawing.

Figure B.1.10 Detail view of the surface of the sawn stump showing that its degradation precludes accurate identification of its method of sawing.

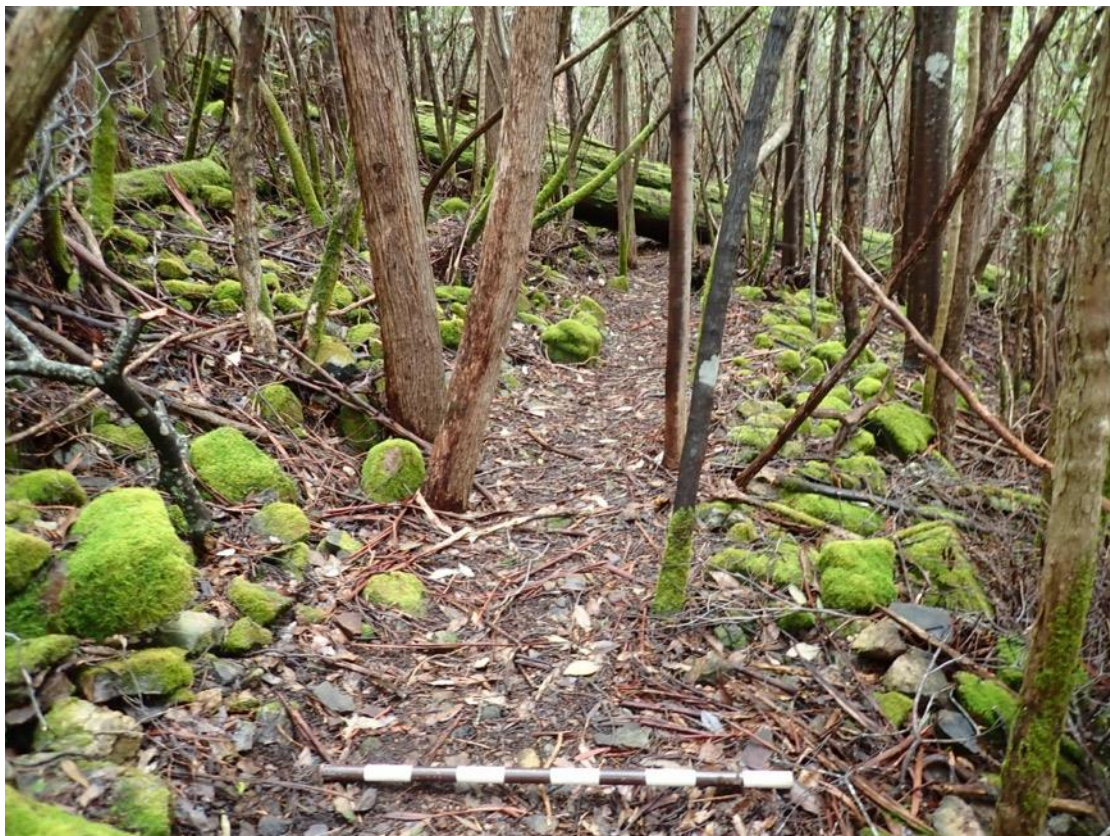
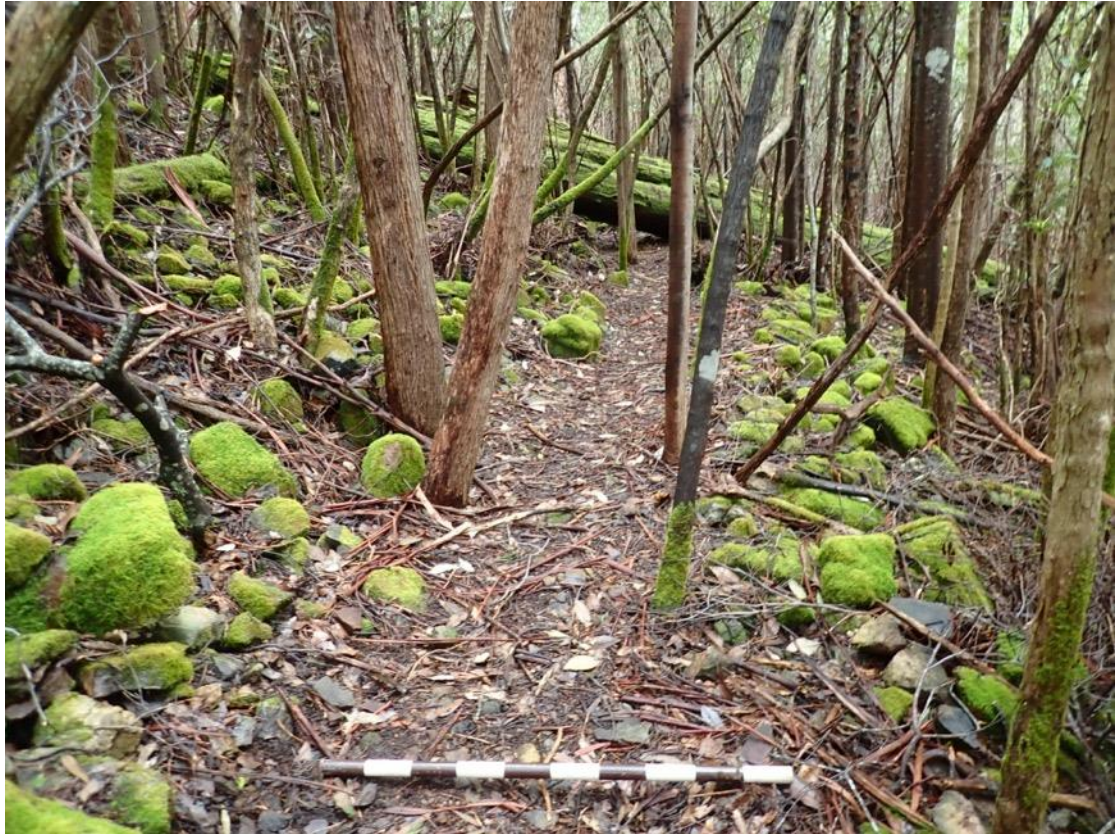
Figure 5.2.11 Looking north northwest along Featherstones Cascade Track. The scale has 100mm marks.

Figure B.1.11 Looking north northwest along Featherstones Cascade Track. The scale has 100mm marks.
