kunanyi / Mount Wellington Mountain Bike Tracks 1a, 1b, 12 and Upper Luge Historic Heritage Assessment

Final Report for the City of Hobart

20 November 2020

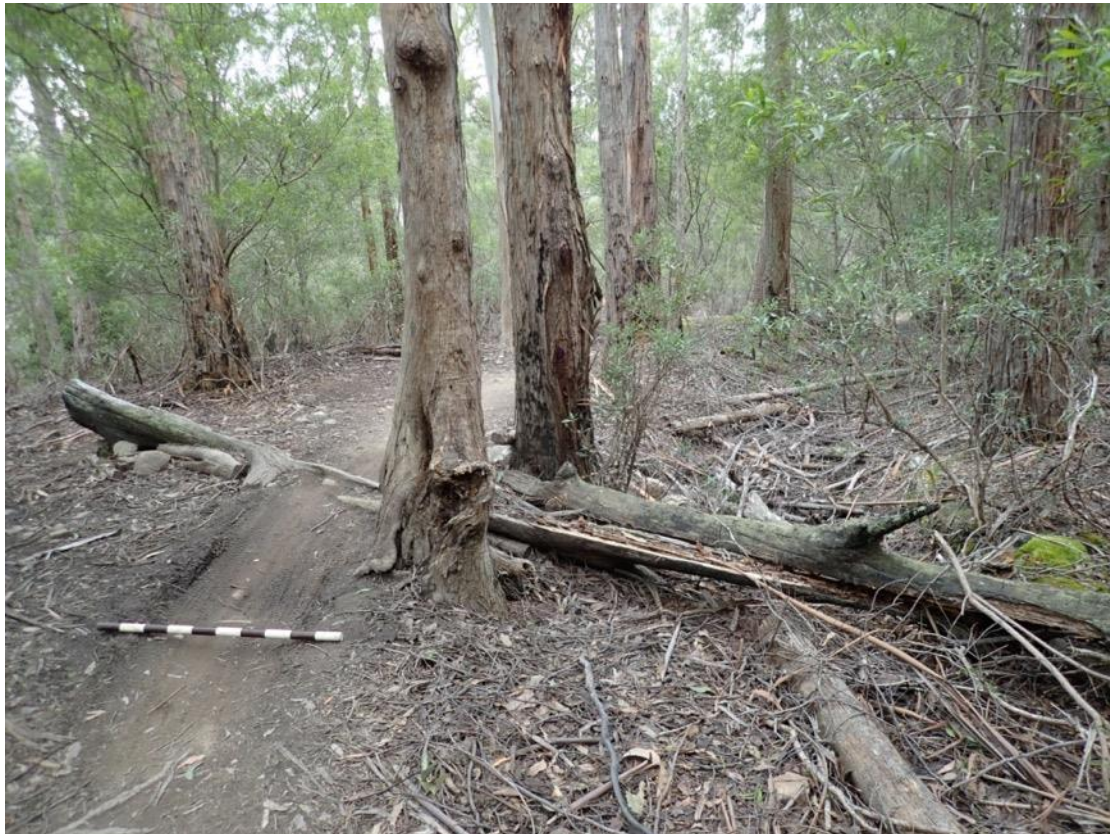
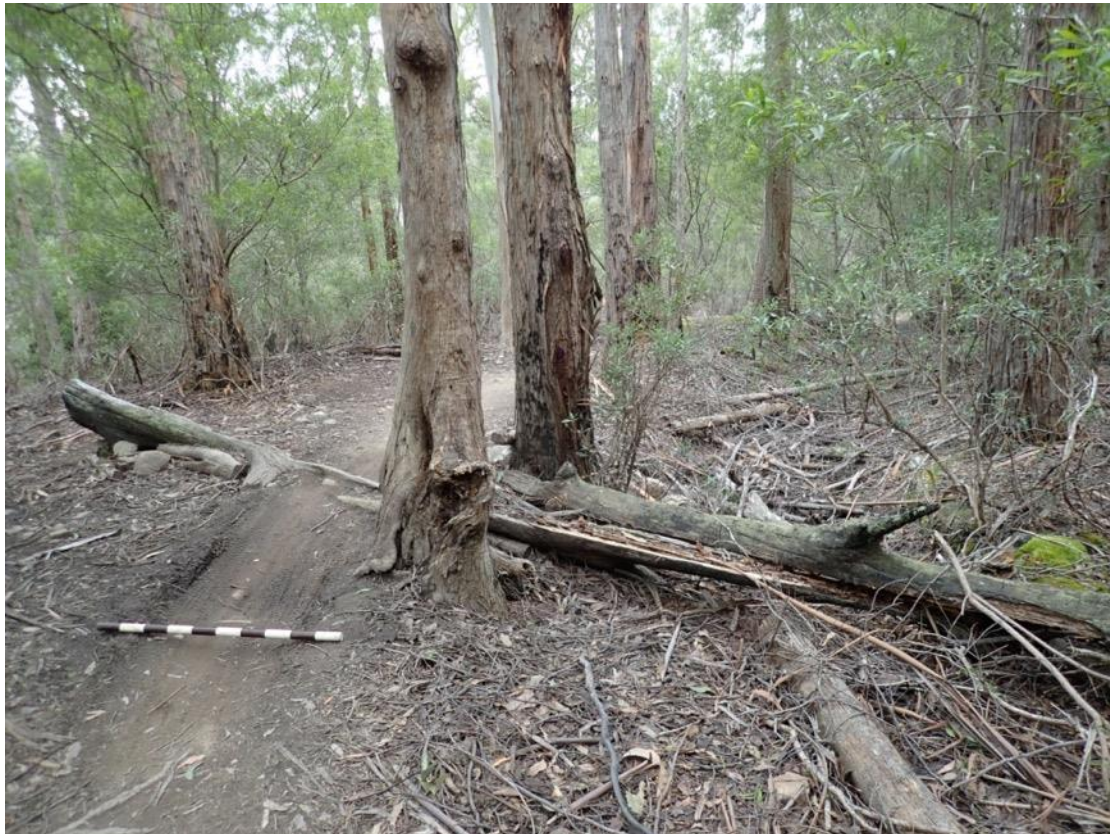
Figure 5.3.1 Looking east along the Upper Luge Track, left of photograph, and a snig track, right of photograph. The snig track is partially obscured by a large amount of deadfall and leaf litter. The scale has 100mm marks.

Figure B.2.1 Looking east along the Upper Luge Track, left of photograph, and a snig track, right of photograph. The snig track is partially obscured by a large amount of deadfall and leaf litter. The scale has 100mm marks.

and historical archaeological features identified during the survey. It is recommended that the Upper Luge Track remain where it is and be formalised as shifting its course is likely to cause more harm to nearby historic features that can otherwise be avoided.

likelier it is to cause damage to additional historic heritage features. Given the richness of the historic heritage in the surrounding landscape the long term use of the Upper Luge Track in its current location should be considered to be the minimal impact approach. In making fit the Upper Luge Track for its current purpose within the context of safety a minimum of modification should take place. However, whatever measures are necessary should be used to maintain the alignment of this track without additional braiding (e.g. track hardening or water bars). Where possible run off should be channelled away from the adjacent sections of snig track and fanned out on the surrounding terrain to avoid accidental erosion and the creation of rills. Once again, given the difficulty of closing this track and the sensitivity of the surrounding terrain, the Upper Luge Track should be formalised and maintained as much as necessary as a sacrificial track to avoid the widening of already existing impact.

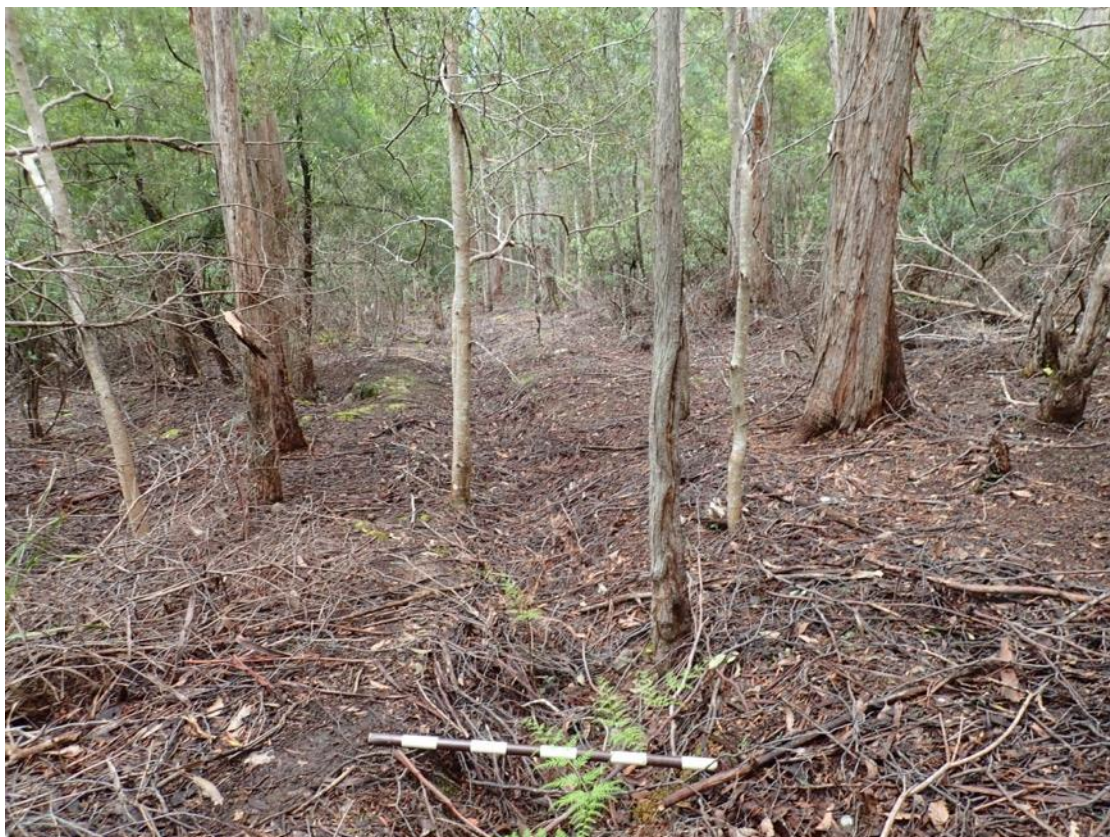
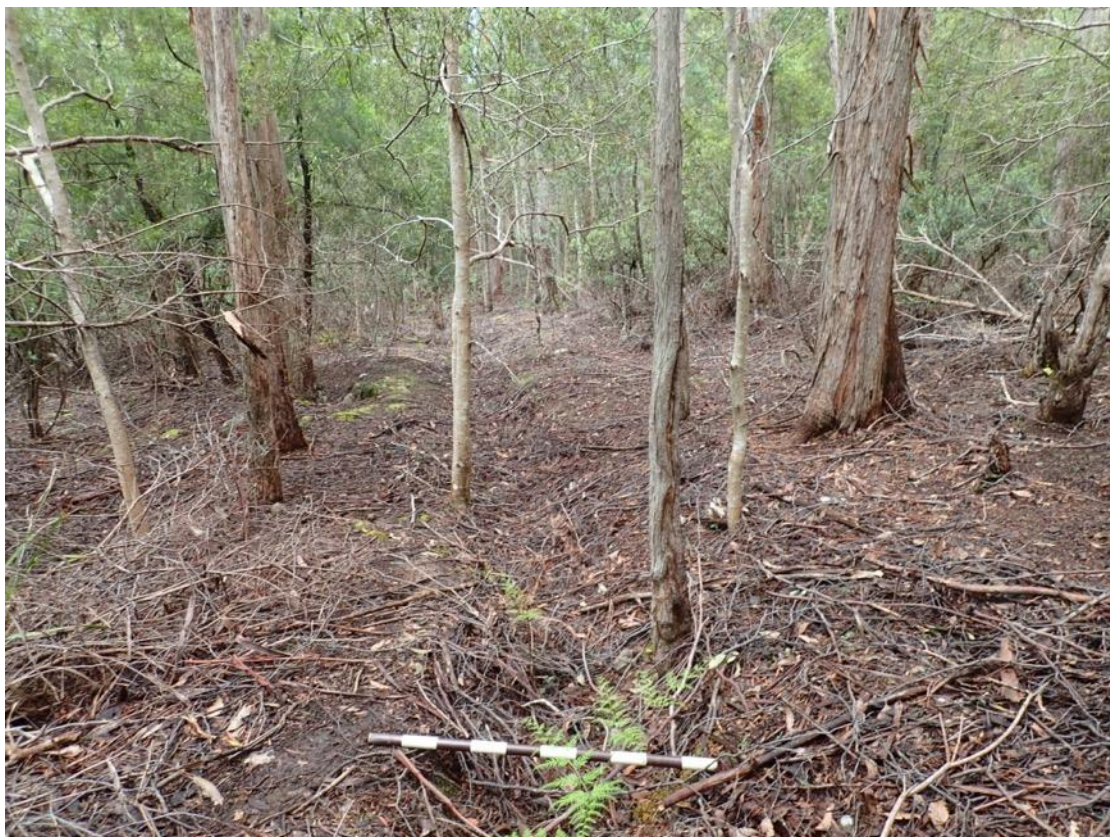
Figure 5.3.2 Looking southeast along the line of Snig Track 1.

Figure B.2.2 Looking southeast along the line of Snig Track 1.

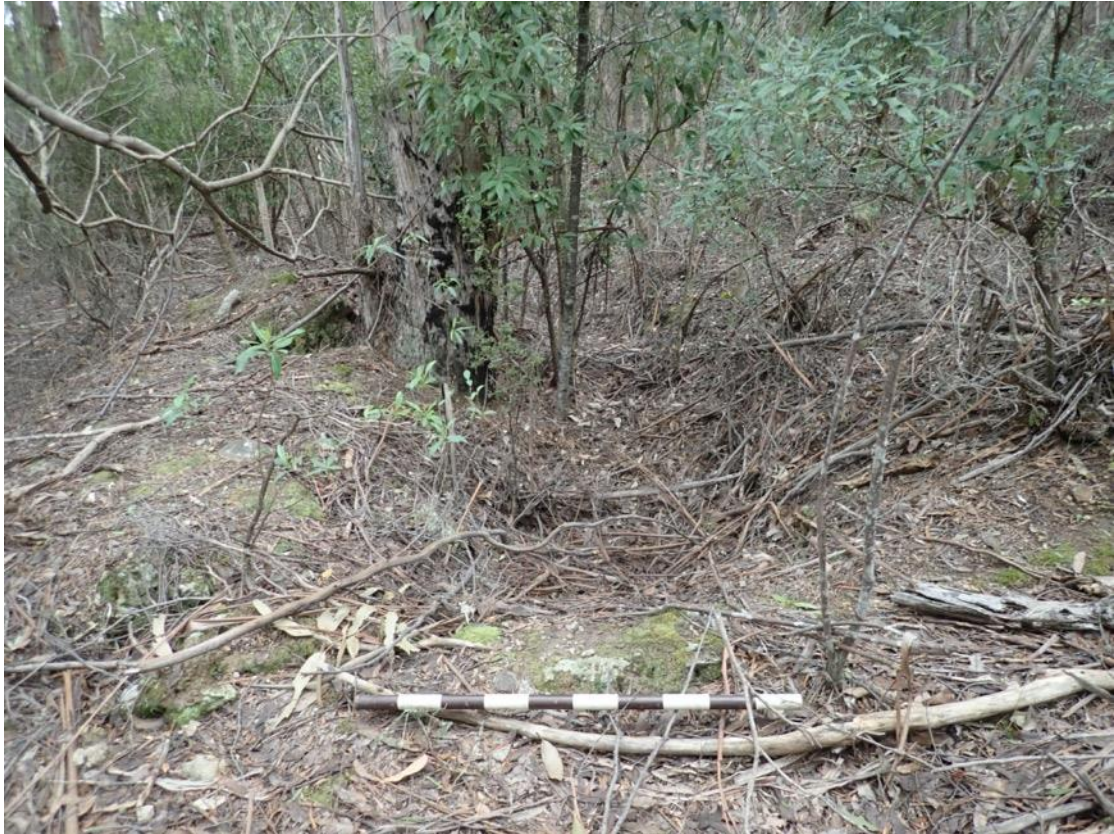
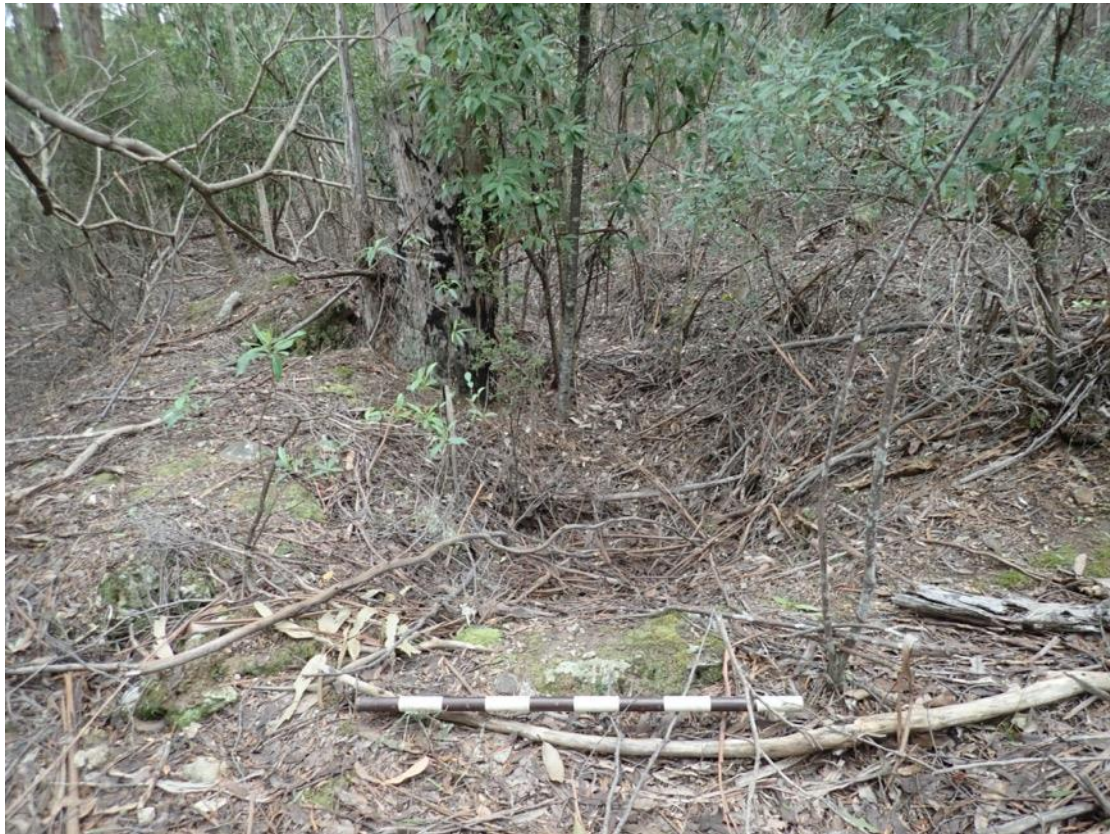
Figure 5.3.3 View to the southwest along Sawpit 1, note the distinct hard clay soil in the bottom of the photograph indicating that this was a pit and not a snig track. The scale has 100mm marks.

Figure B.2.3 View to the southwest along Sawpit 1, note the distinct hard clay soil in the bottom of the photograph indicating that this was a pit and not a snig track. The scale has 100mm marks.

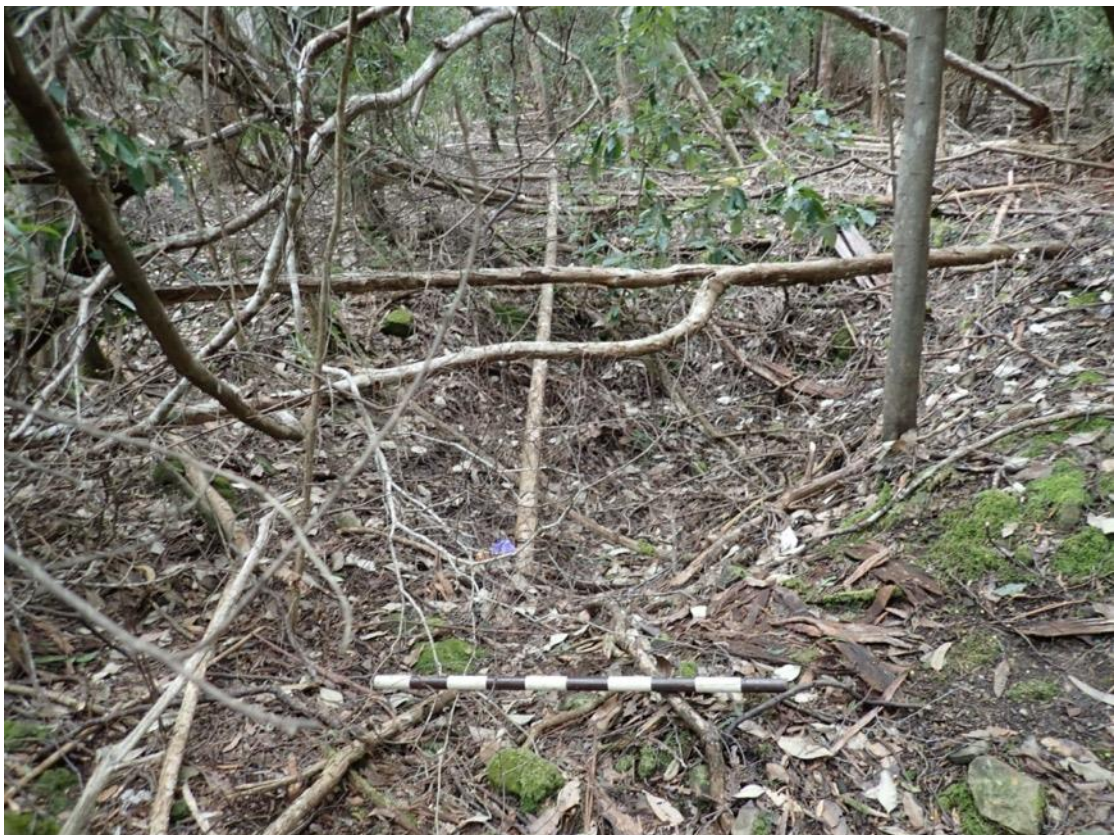
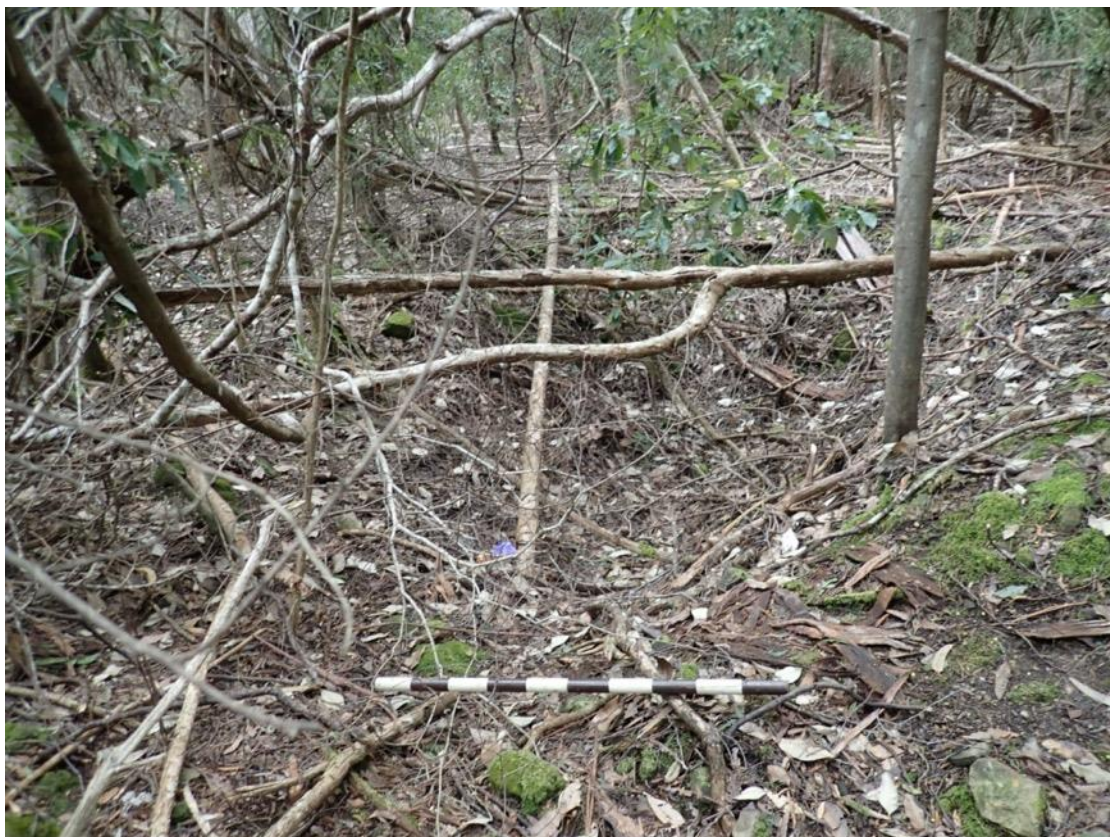
Figure 5.3.4 Looking to the south over potential Sawpit 4, although this feature is obscured by leaf litter and deadfall it is neither a snig track nor natural soil disturbance arising from an uprooted tree. The scale has 100mm marks.

Figure B.2.4 Looking to the south over potential Sawpit 4, although this feature is obscured by leaf litter and deadfall it is neither a snig track or natural soil disturbance arising from an uprooted tree. The scale has 100mm marks.

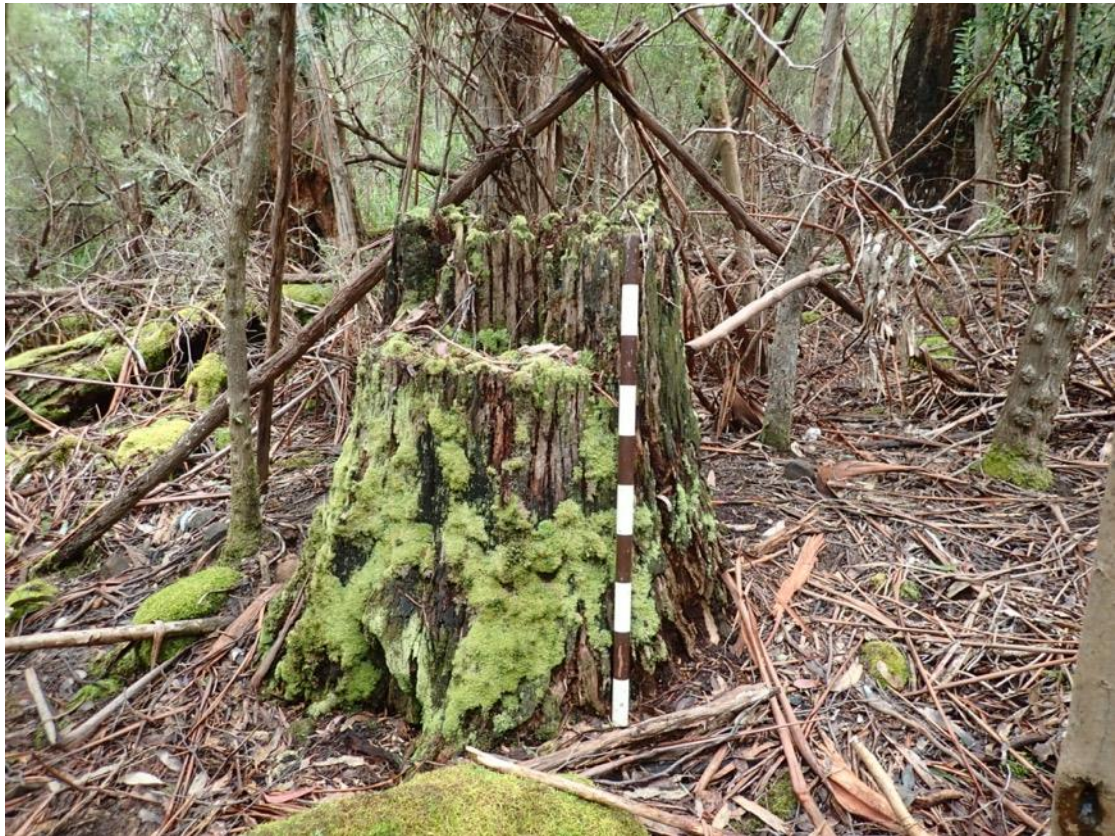
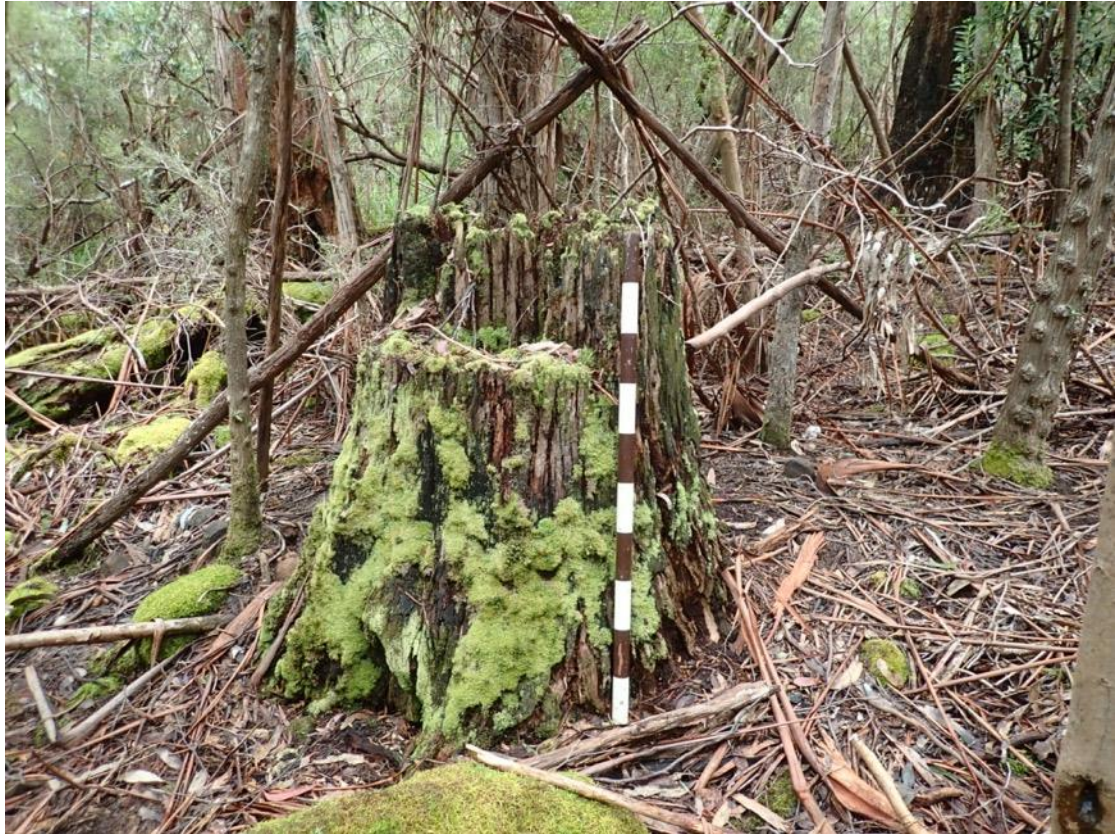
Figure 5.3.5 Detail view of Stump 7, the notch cut is clearly visible facing towards the viewer. The scale has 100mm marks.

Figure B.2.5 Detail view of Stump 7, the notch cut is clearly visible facing towards the viewer. The scale has 100mm marks.

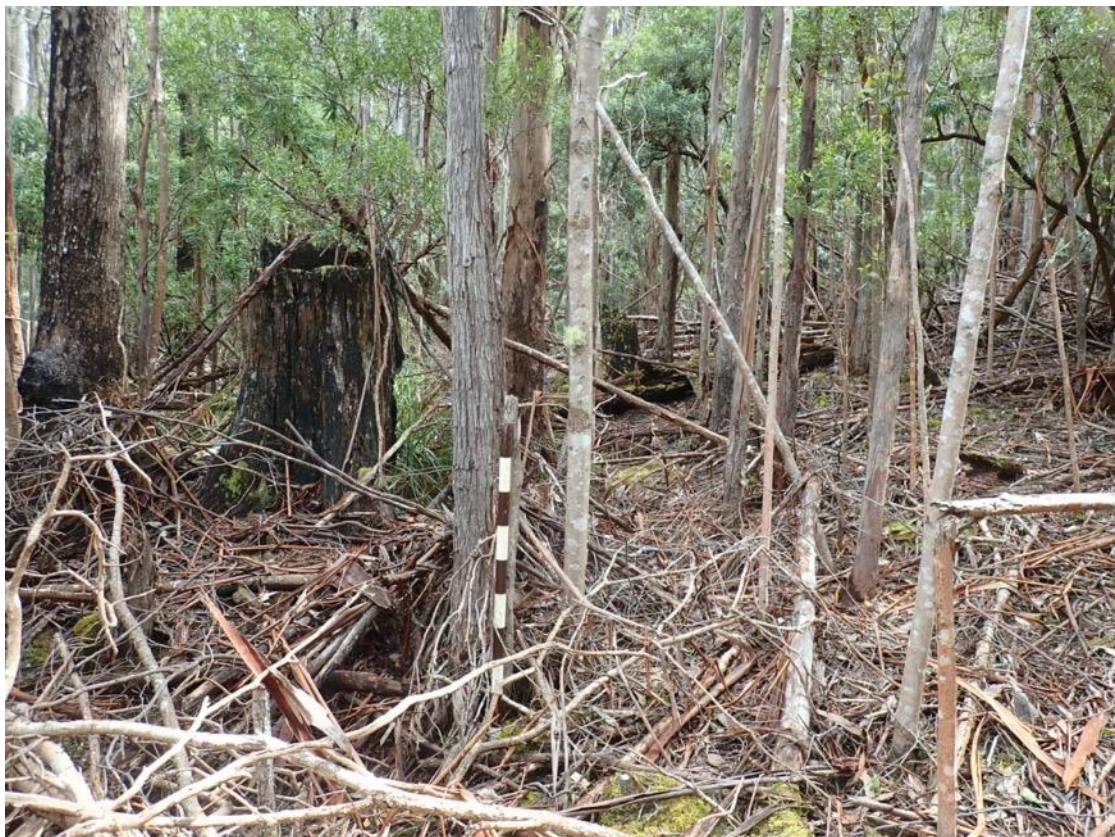
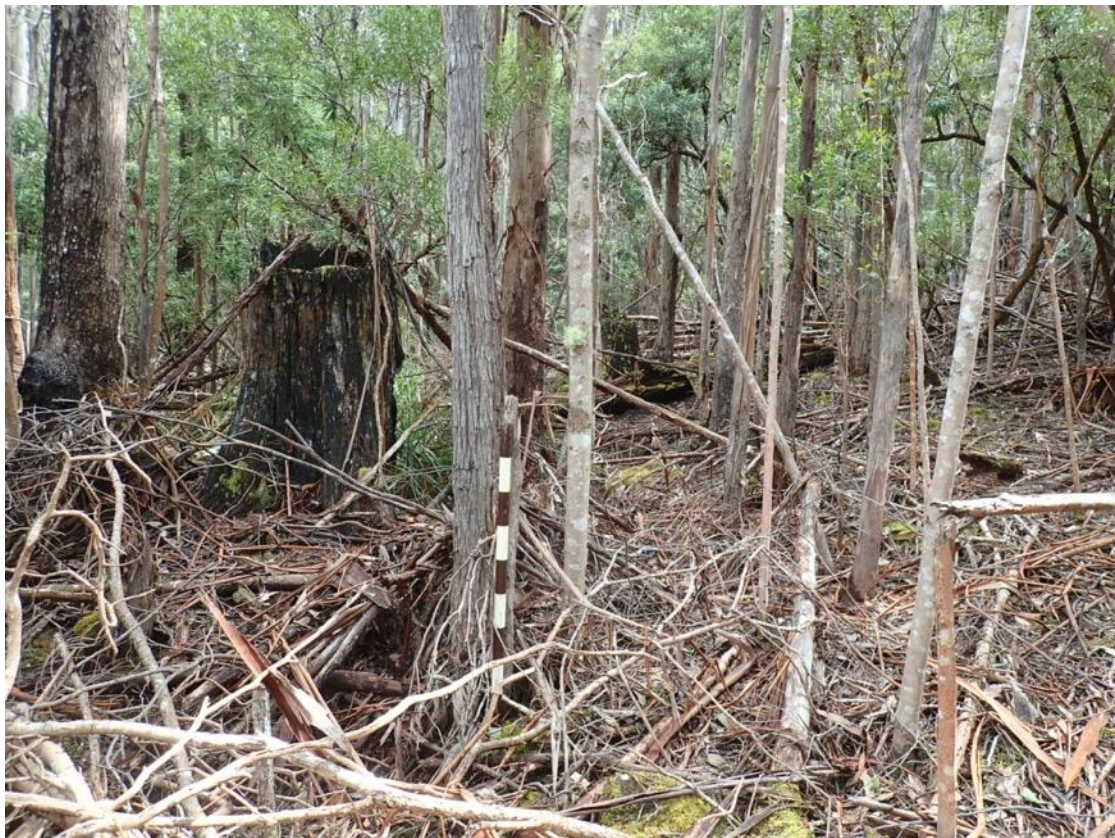
Figure 5.3.6 Looking to the west and showing two of the three closely spaced stumps (Sawn Stump 4 to 6) in the centre of the study area. A notch cut is visible on the stump in the left of the photograph. The scale has 100mm marks.

Figure B.2.6 Looking to the west and showing two of the three closely spaced stumps (Sawn Stump 4 to 6) in the centre of the study area. A notch cut is visible on the stump in the left of the photograph. The scale has 100mm marks.

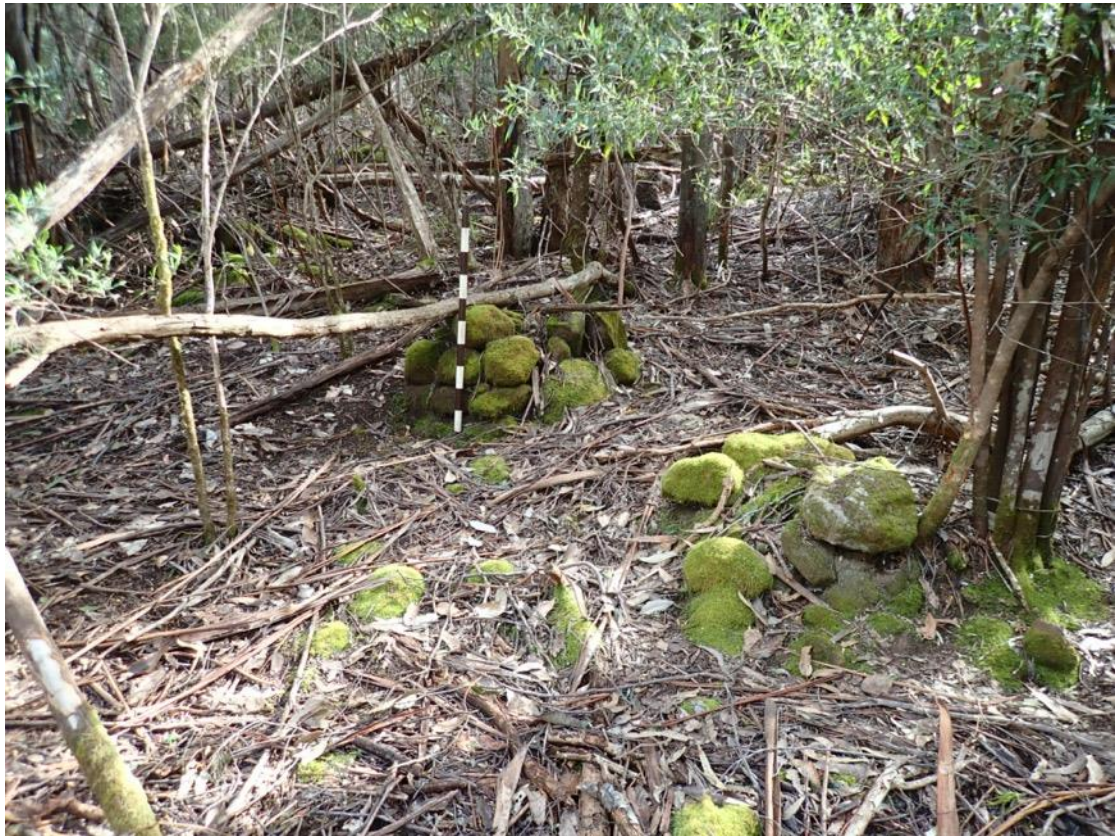
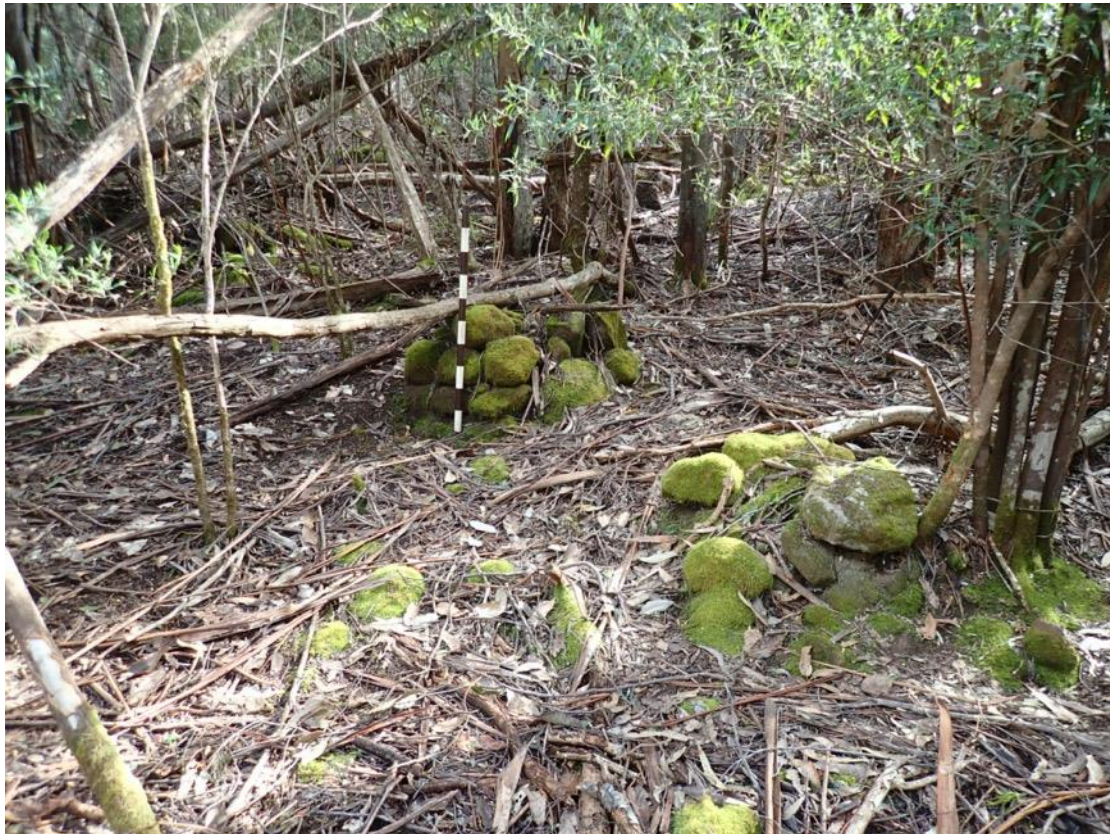
Figure 5.3.7 Looking north to the partly coursed random rubble features in the area of possible stone footings. The scale has 100mm marks.

Figure B.2.7 Looking north to the partly coursed random rubble features in the area of possible stone footings. The scale has 100mm marks.

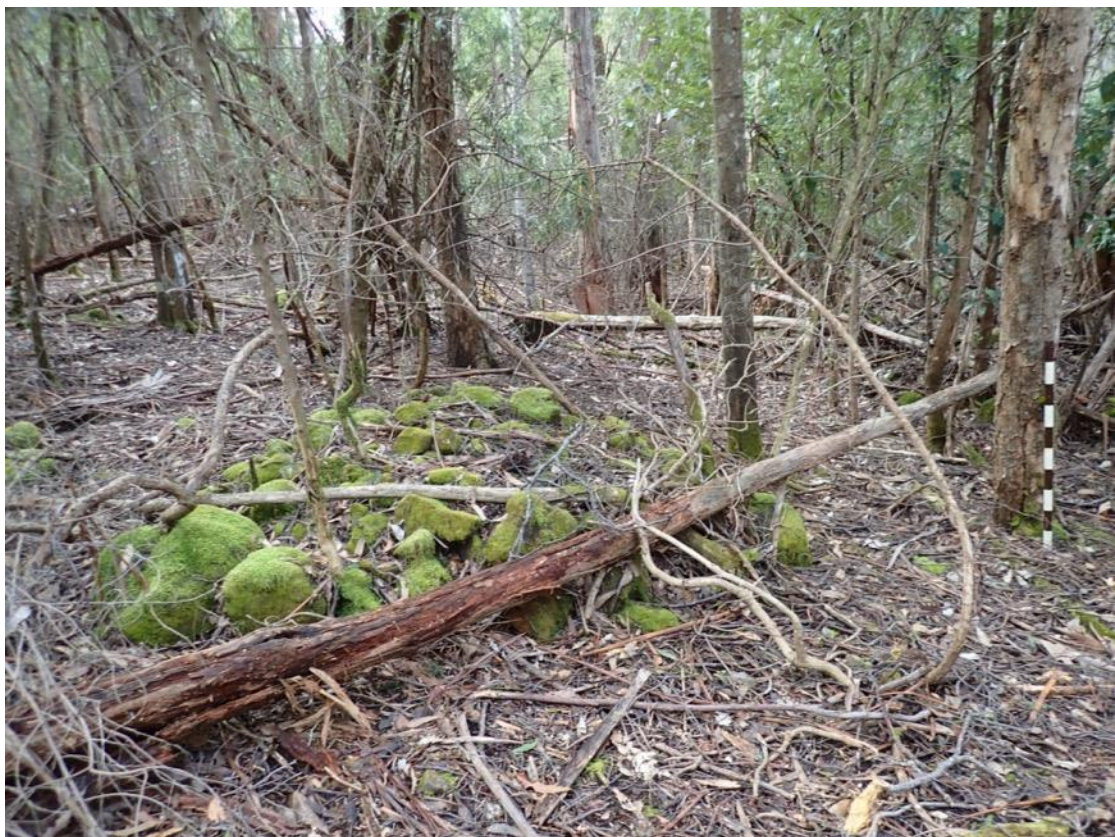
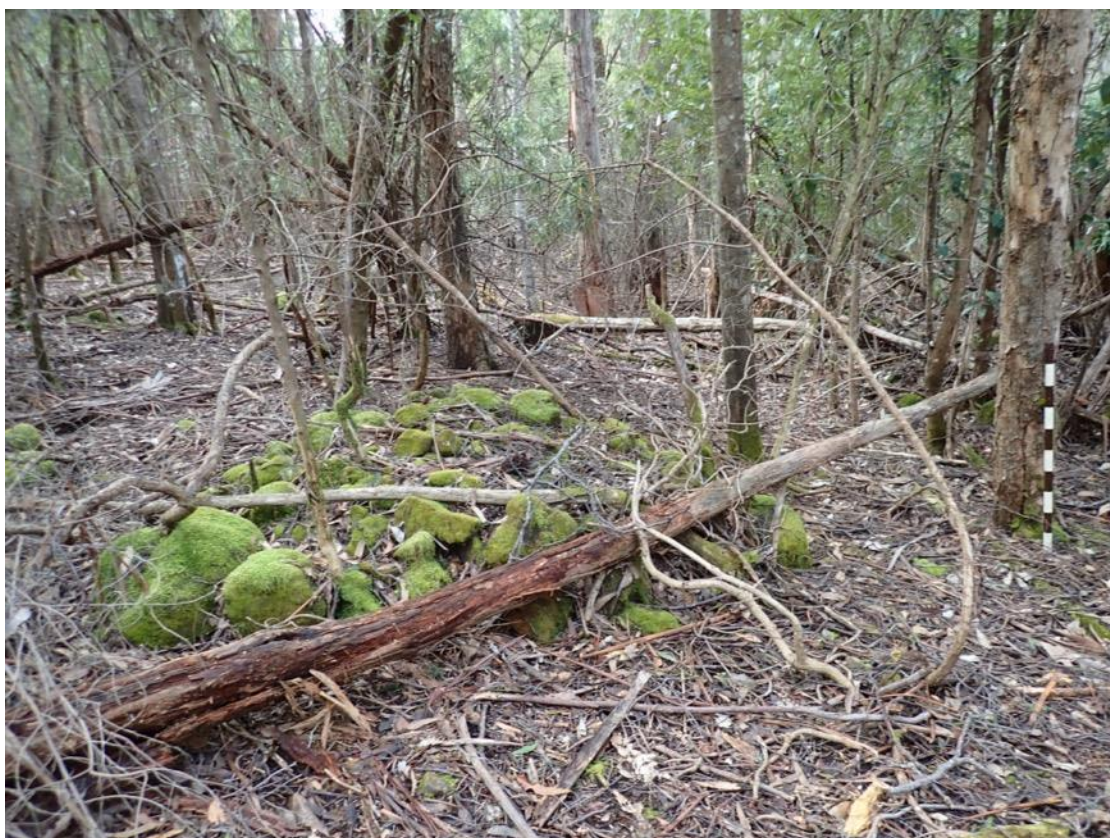
Figure 5.3.8 A rectilinear feature in the area of stone footings. Looking east at the sawn stump. The scale has 100mm marks.

Figure B.2.8 A rectilinear feature in the area of stone footings. Looking east at the sawn stump. The scale has 100mm marks.

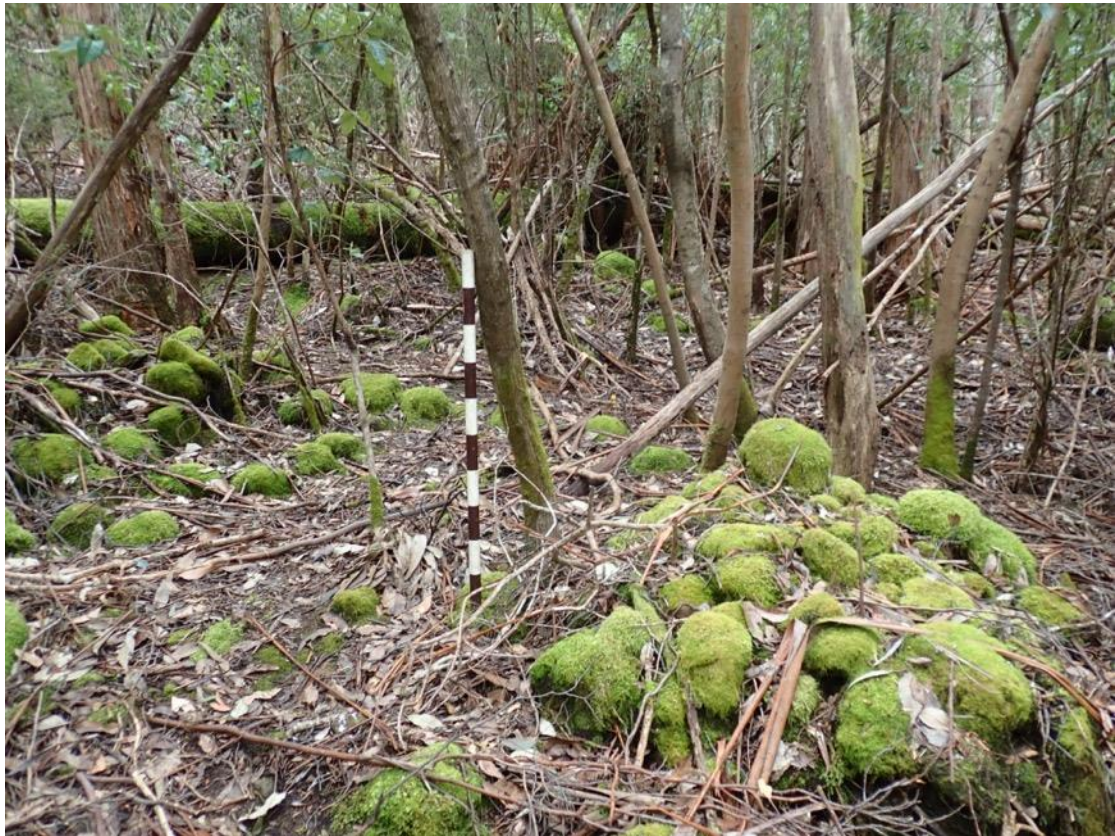
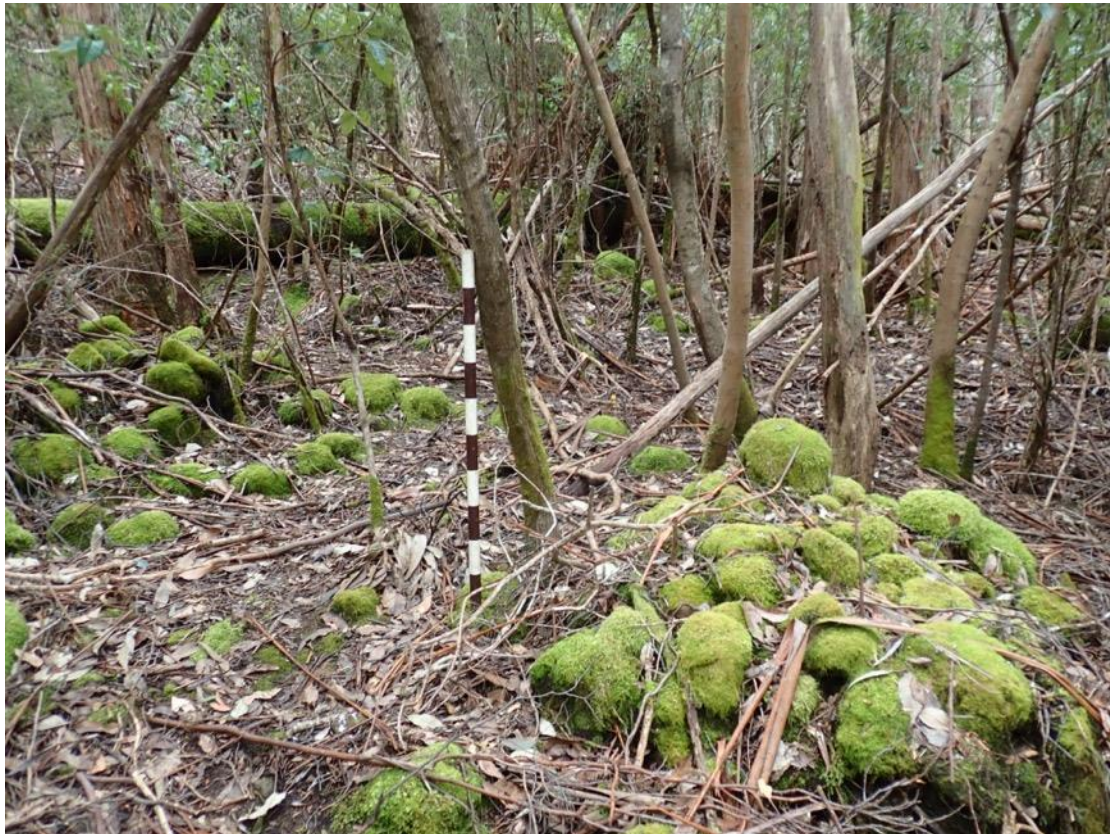
Figure 5.3.9 Looking to the northwest over the stone features in the foreground and the snig track, heavily overgrown, immediately behind them in the centre of the photograph. A corresponding set of stone features are just visible to the northwest of the snig track. The scales have 100mm marks.

Figure B.2.9 Looking to the northwest over the stone features in the foreground and the snig track, heavily overgrown, immediately behind them in the centre of the photograph. A corresponding set of stone features are just visible to the northwest of the snig track. The scales have 100mm marks.

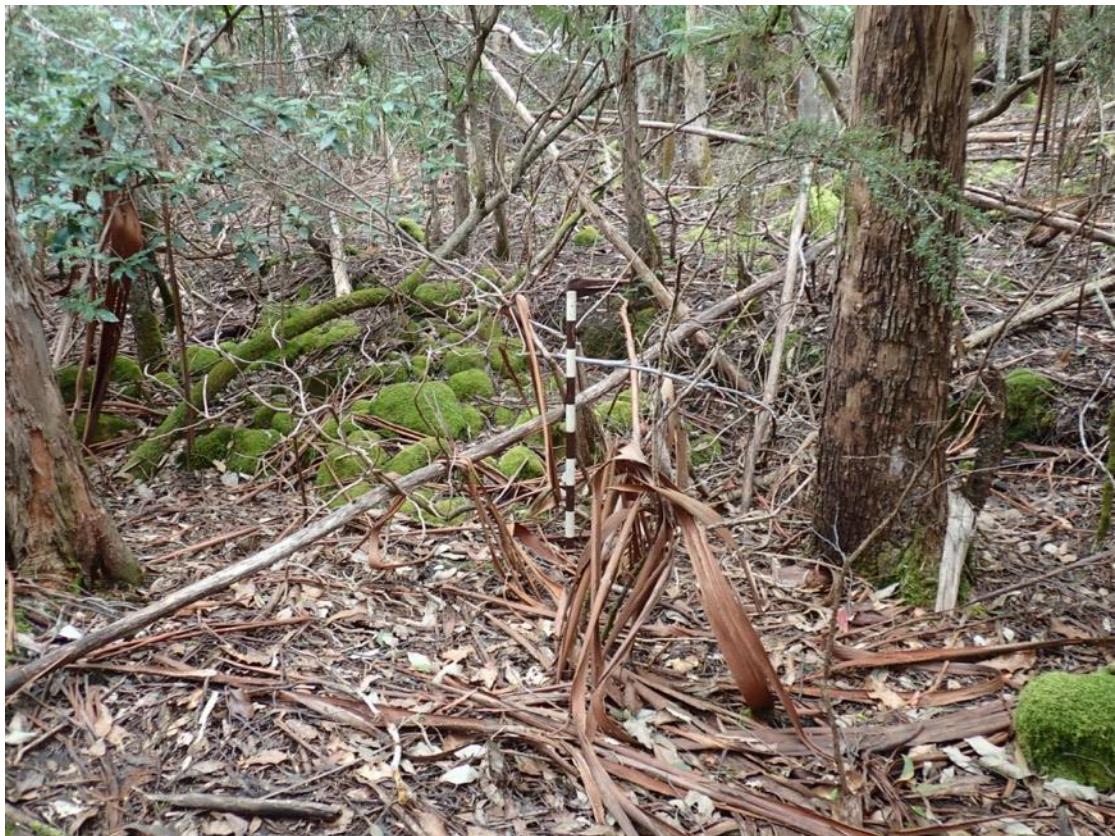
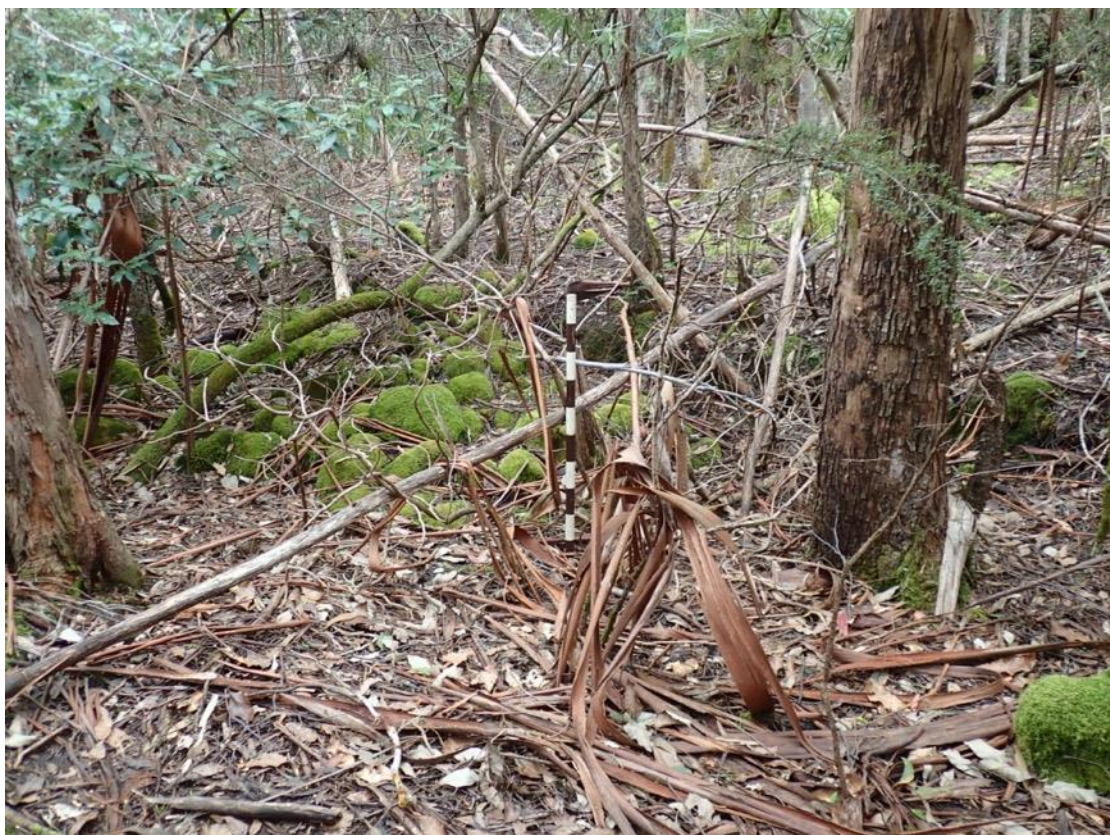
Figure 5.3.10 Looking to the west over the stone feature and benched area in 'Bart's Cut.' The scale has 100mm marks.

Figure B.2.10 Looking to the west over the stone feature and benched area in 'Bart's Cut.' The scale has 100mm marks.

The three previously distinct sites Bart's Cut (WPHH0453) Golden Gully North Sawpit (WPHH0461) and Golden Gully North Stone Mounds (WPHH0462) should be reregistered as a single site along with the "Timber Getting Complex" identified in this area. A more apt name than any of the above listed should be selected by the WPMT to identify this area. The site formerly registered as Kings Pits within the database should also be reviewed in the light of the new historical information presented in this report.

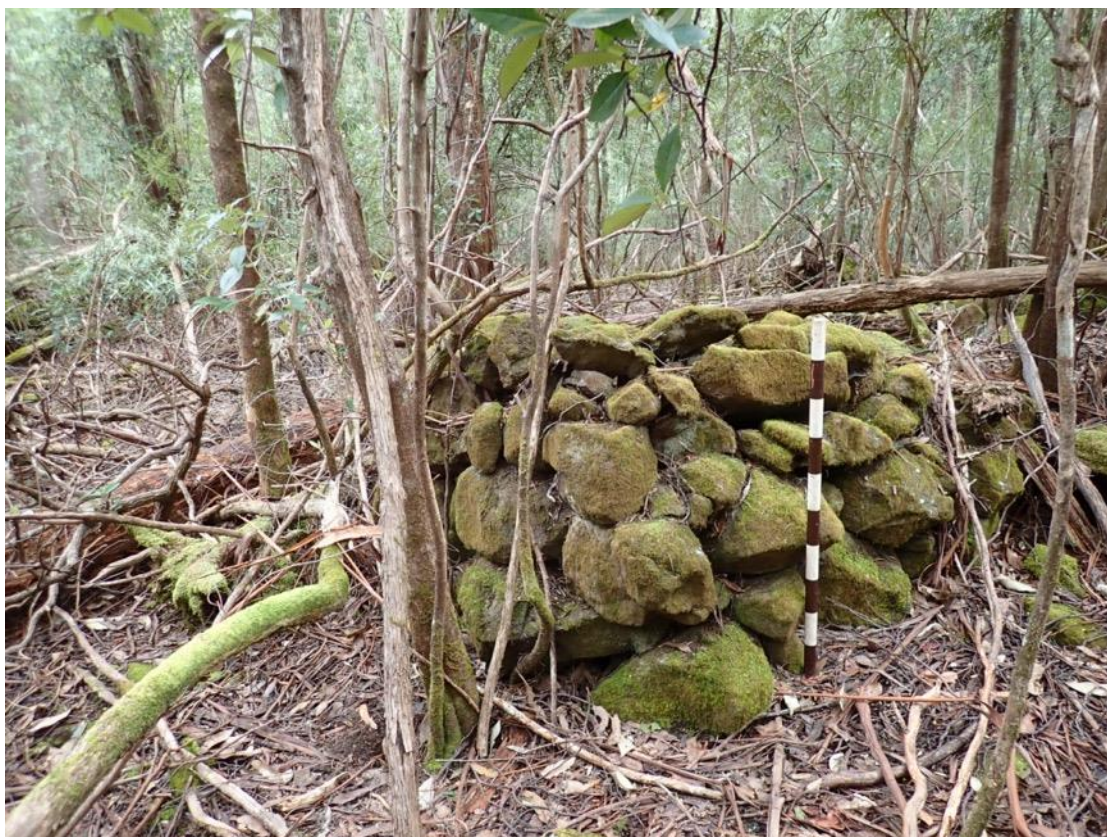
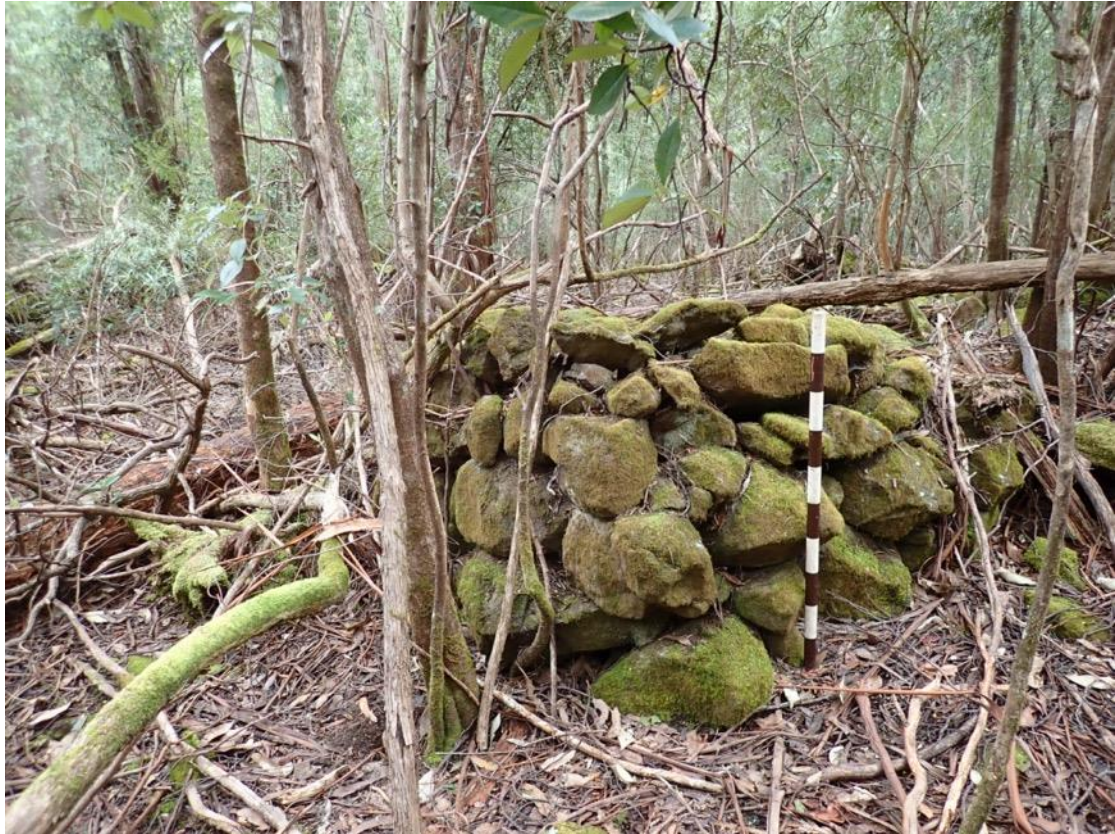
Figure 5.3.11 Looking to the south at a clearly constructed stone feature, nearly a metre above the current ground surface; note that there is no additional evidence of bonding or other structural elements. The scale has 100mm marks.

Figure B.2.11 Looking to the south at a clearly constructed stone feature, nearly a metre above the current ground surface; there is no additional evidence of bonding or other structural elements. The scale has 100mm marks.

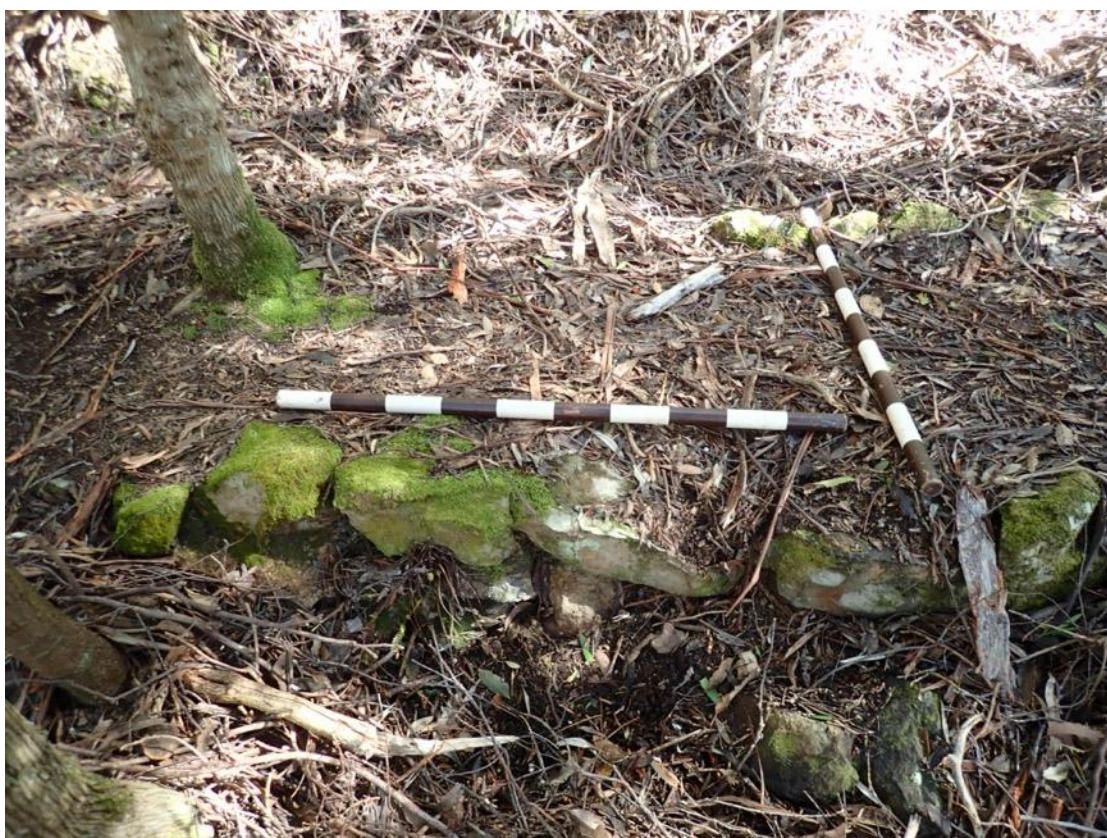
Figure B.1.6 Detail view of the uncoursed stone rubble forming the base of the Boundary Track. The scale has 100mm marks.
