kunanyi / Mount Wellington Mountain Bike Tracks 1a, 1b, 12 and Upper Luge Historic Heritage Assessment

Final Report for the City of Hobart

20 November 2020

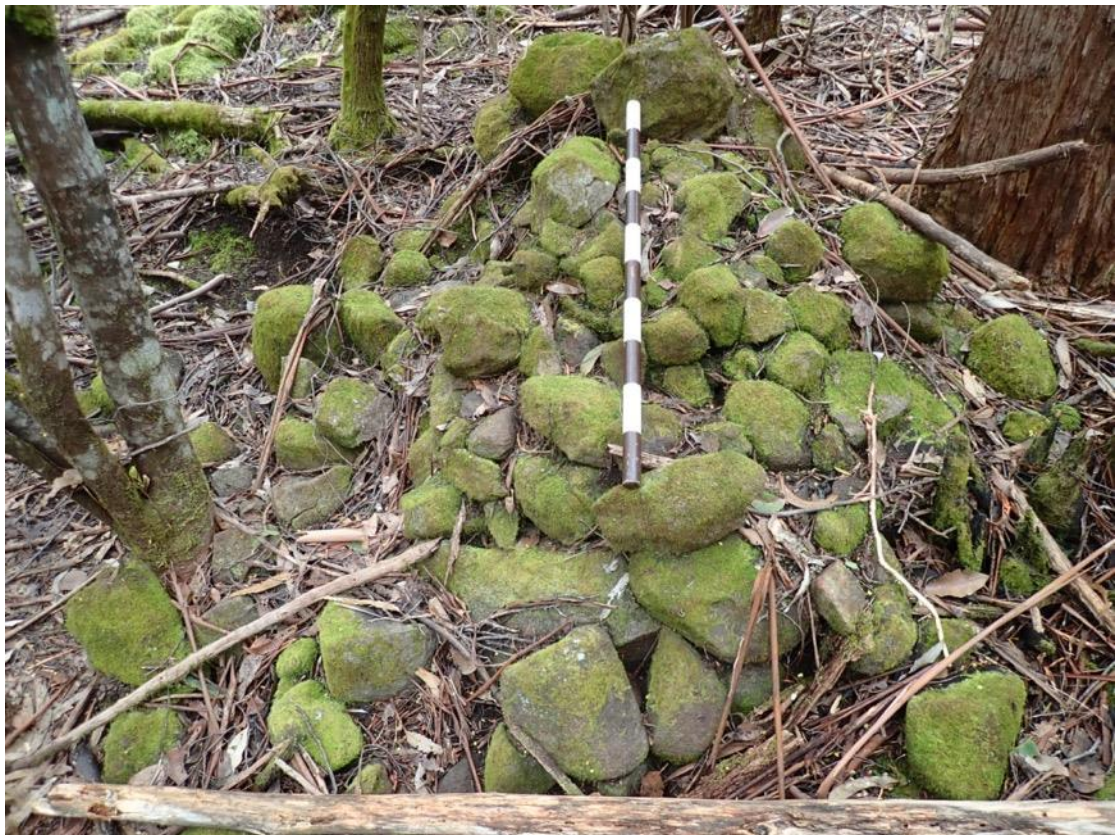
Figure B.2.12 Detail view of the surface of a stone feature. The scale has 100mm marks.
