Prepared for Hobart City Council

March 2012 (Final Report)

Hobart Mountain Water Supply System Conservation Management Plan

Conservation and management policies designed to assist in the conservation of the historically important Hobart Mountain Water Supply System, from Mount Wellington to Hobart City. This document reviews and builds upon the 1994 Pipeline Track Conservation and Management Plan.

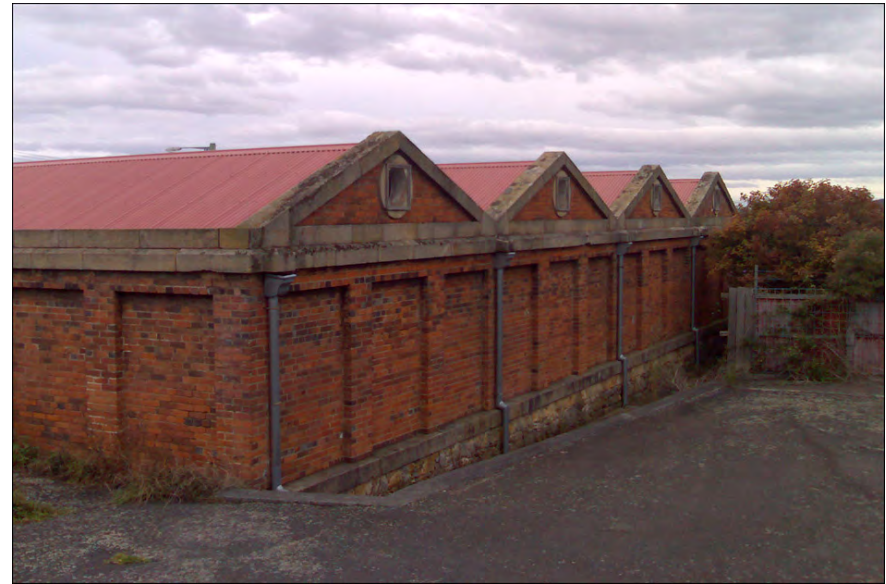
Water was drawn from the dam via a decorative sandstone valve tower, which was truncated in the 20th century. Water drawn from the dam entered a reticulation system running into Hobart Town and in 1862 a service reservoir was constructed within the town at Hill Street. Much of this system survives in service albeit in a modified form. The intake of the System was extended to Long Creek between 1867 and 1869 to augment supply. This extension was undertaken using cast iron pipes rather than wooden troughing.

Figure 9–The Hill St service reservoir, modified but still in use. (North 2007)

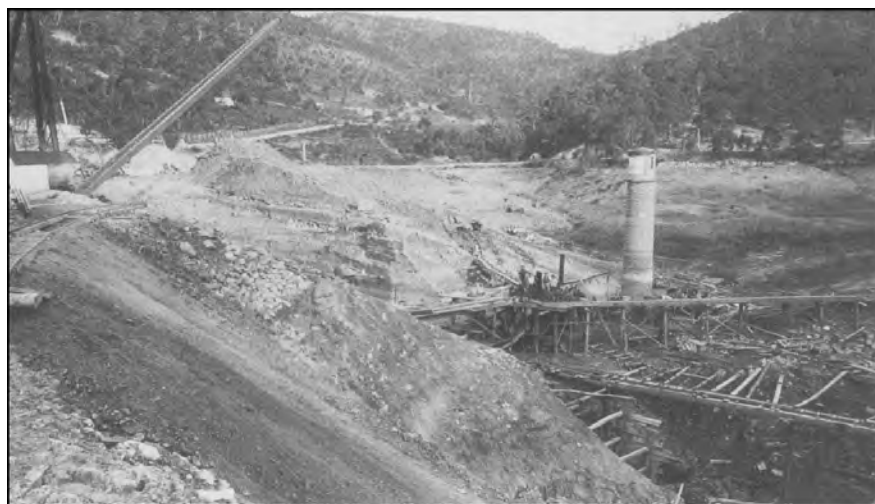
Figure 11– Reservoir No 1 under construction (Crawford and Ryan 1988: 44). Note the valve tower, which gives some impression of the depth of the reservoir.

The commissioning of Reservoir No 2 provided the opportunity to correct the faults with Reservoir No 1. Between 1891 and 1895, Reservoir No 1 was substantially rebuilt to a similar shape as the original however most of the essential components were replaced, including the outlet pipe, which was the site of one of the major dam failures. This outlet was again replaced in 1975 to increase its capacity. Both Reservoirs continue to service the city with little change from their 1890s configuration; however increased demand saw the System augmented again in the early 20th century.

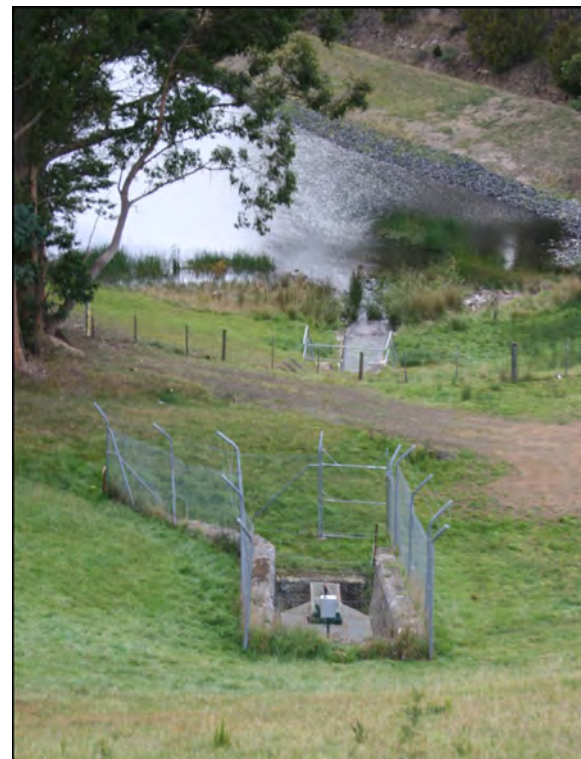
Figure 16– View of Reservoir No 1, looking down slope from Reservoir No 2 (North 2007)

Reservoir No 1 is highly significant as the first major reservoir built in Tasmania in 1861 to service the City of Hobart. The reservoir is an earthen dam with a puddled clay core and a cast iron outlet leading to the town reticulation system. A drainage channel runs along the southern side of the reservoir, with the side of the reservoir faced in cut sandstone and the other side of the channel in natural stone. This channel was widened in recent years, leading to some loss of the original rough quarried stone

face of the channel. While the reservoir was reconstructed in the 1890s due to the partial failure of the dam wall, it remains largely unmodified since that time and is recognisable as a 19th century engineering work. It is one of the earliest reservoirs in Australia, preceded by Yan Yean Reservoir in Victoria (1857) and Crown Street Reservoir in New South Wales (1859), both of which are still in service.

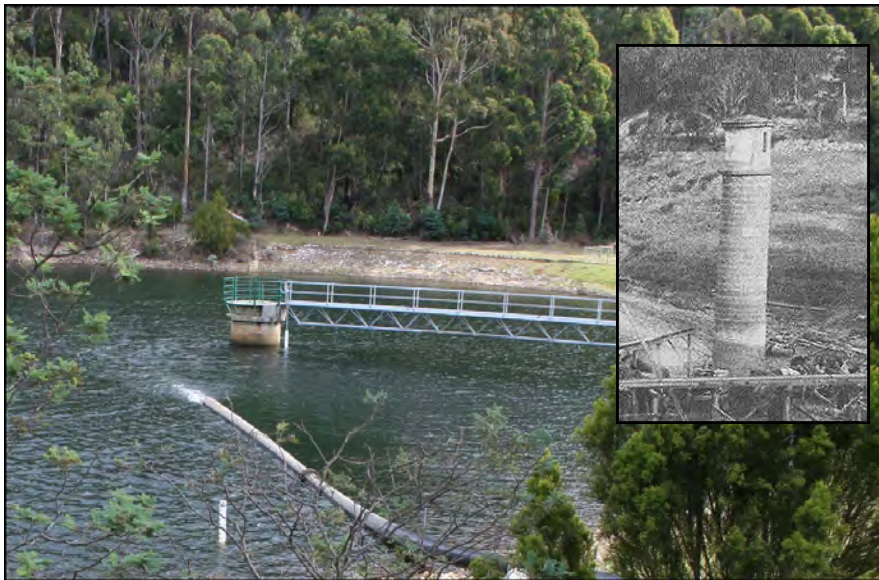
Figure 17– Reservoir No 1 Valve House.

from the top of the dam wall out to the Valve House. The top of the Valve House has been removed, possibly to accommodate the installation of the bridge. The inset image shows the 19th century configuration of the Valve House. While the exact date of removal is unknown, it had occurred by 1961.⁵⁴ The original plans of the Valve House still exist and the top could be reconstructed. The condition of the Valve House below the level of the waterline is unknown.

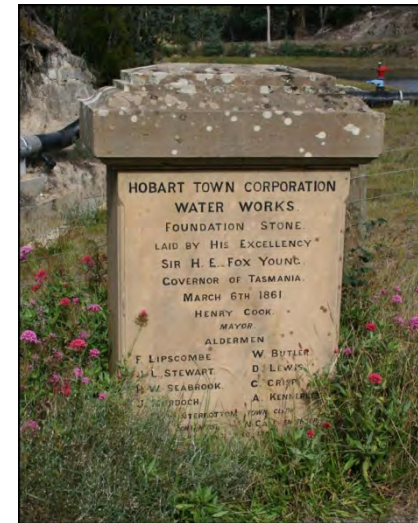
Figure 18–Date stone associated with the opening of Reservoir No 1 in 1861. (North 2007)

The sandstone date stone for Reservoir No 1 is located at the bridge over the stormwater channel which runs along the southern side of the Reservoir and is generally in good condition.

The bridge over the channel has been replaced with a modern concrete deck and the stormwater channel has been widened, which required removal of some remnant sandstone.

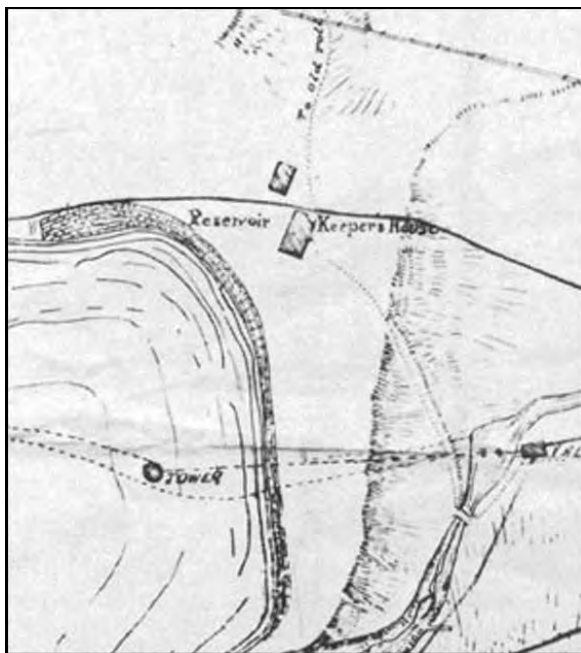
Figure 19–Detail from the circa 1875 plan of Reservoir 1, showing the location of the Keeper’s Cottage just north of the valve tower.

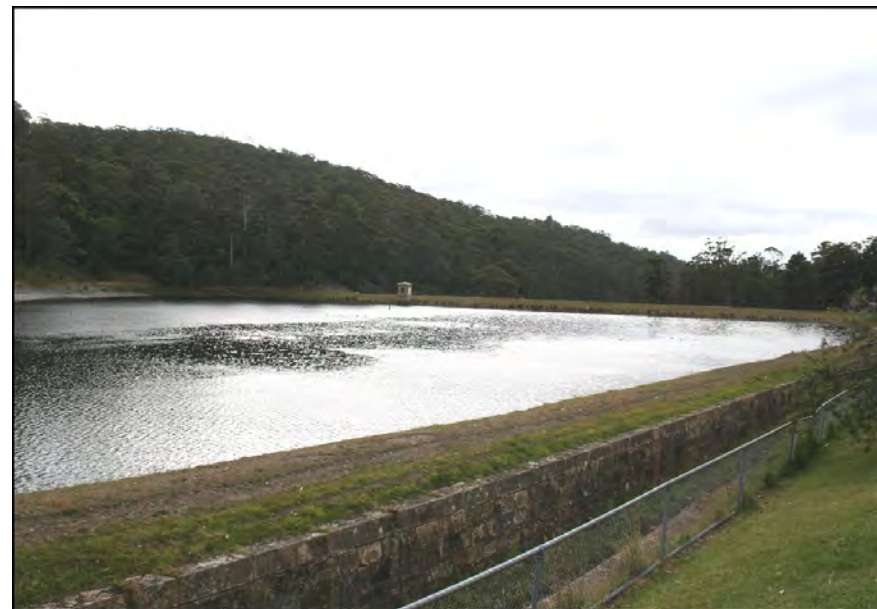
Figure 20– Reservoir No 2, with the Hard Water Channel visible alongside (North 2007)

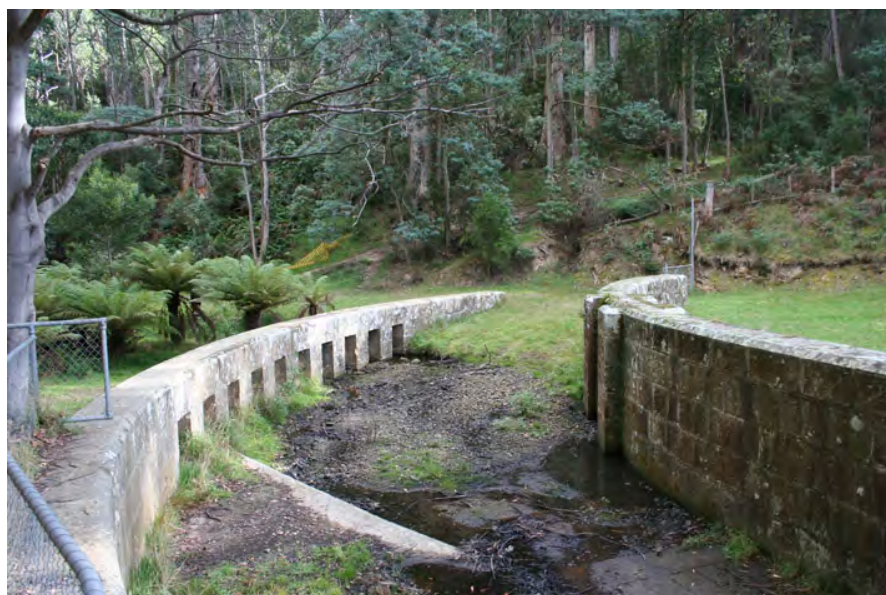
Running alongside both Reservoirs 1 and 2 is the Hard Water Channel, which serves to divert stormwater and runoff around, rather than into, the reservoirs. This Channel is a mix of stone blockwork and rock-cut sections. A portion of the Channel, near the Lower Reservoir, has been widened in recent years to increase capacity.

Figure 21 - The top end of the Hard Water Channel, running alongside the Upper Reservoir

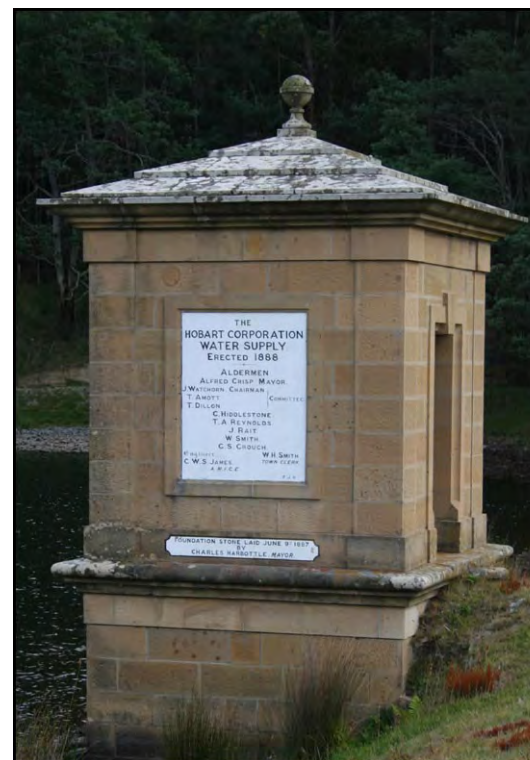
Figure 22— The Valve House for Reservoir No 2, containing the commemorative plaque for its opening in 1888. (North 2007)

The Valve House for Reservoir No 2 is a decorative sandstone structure with commemorative information in an inset plaque, built adjacent to the dam wall at the eastern end of the reservoir. Like the Lower Valve House, it is used to control the flow of water from Reservoir No 2, into Reservoir No 1 below. It is in good condition and serves as a logical interpretive node for the Waterworks Reserve, due to its central location between Reservoirs 1 and 2.

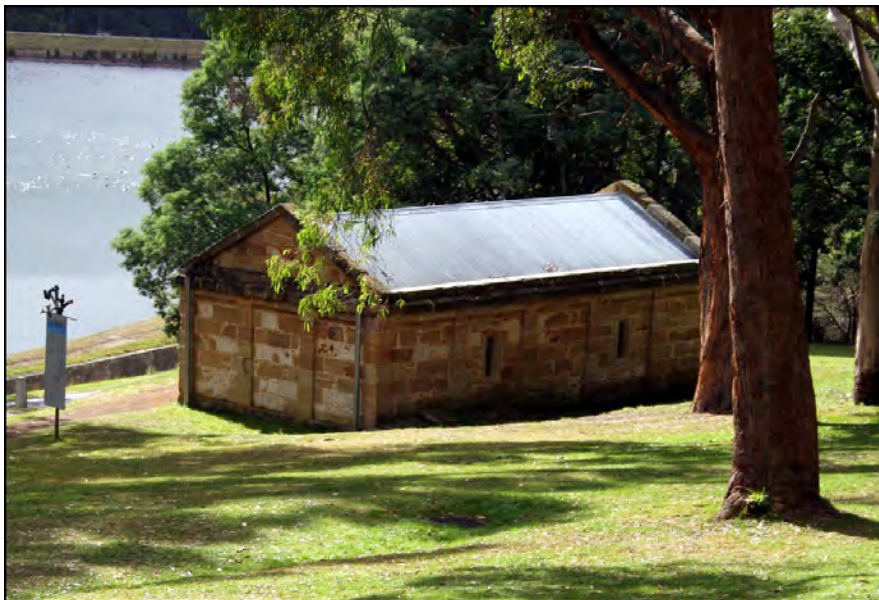
Figure 23–The Receiving House (North 2007)

The Receiving House dates from 1861 and was the location where water from the pipelines was originally screened for debris and mixed from different outlets before entering Reservoir No 1. It became redundant in 1908.⁵⁵ The structure has been heavily modified on a number of occasions, including for use as a picnic shelter with internal barbeque in the mid- to late-20th century. A concrete slab floor was installed at that time, concealing the screening chambers originally located in the base of the building. In the 1990s interpretive material regarding the Mountain

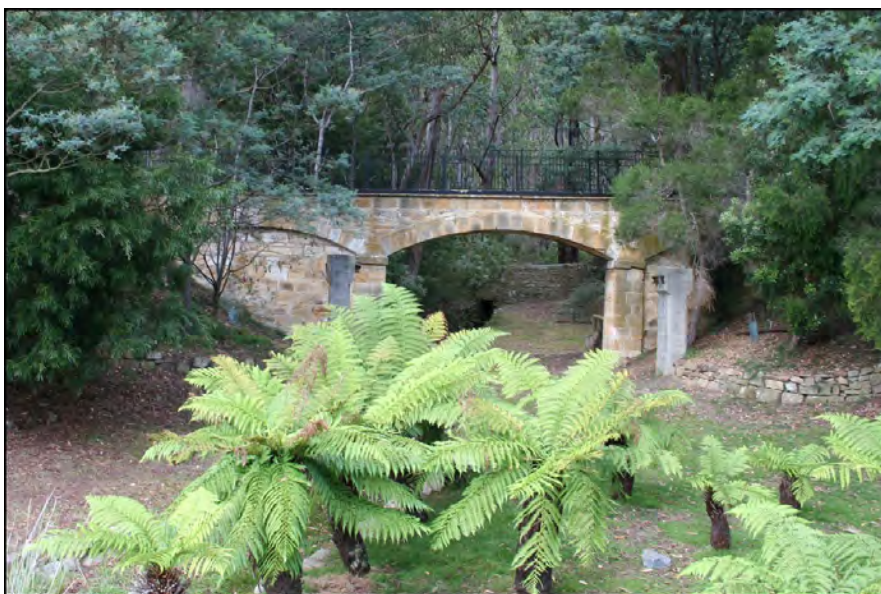
Figure 24—Regans Gully Bridge (North 2007)

Regans Gully Bridge was constructed initially in the 1860s to carry water from the Receiving House to Reservoir No 1. It now serves a dual purpose as both a footbridge and aqueduct for pipes. The bridge was subject to a structural assessment in the early 1990s, when several areas of failure were identified. Small portions of the aqueduct appear to have been rebuilt and the structure appears generally sound. Large trees growing near the abutment at one end still present a potential risk to the structure and should be investigated to determine if they are impacting upon the fabric of the Bridge.

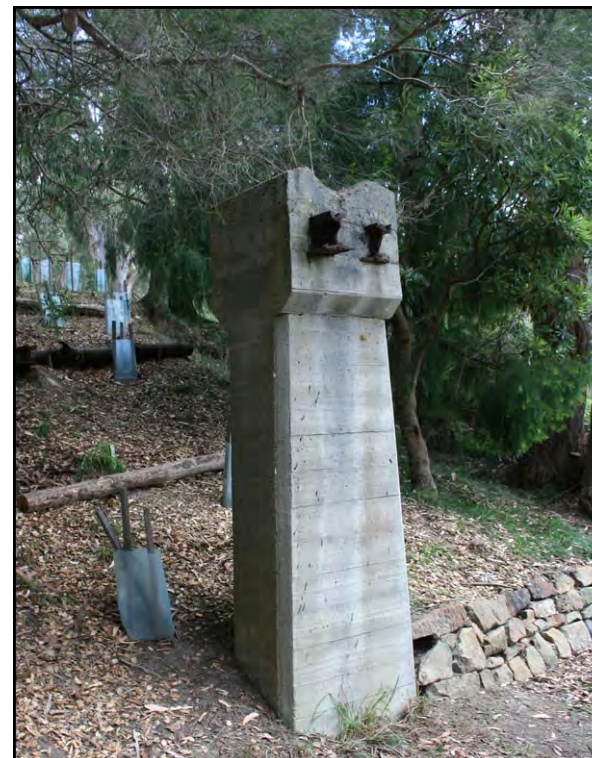
Figure 25—Concrete pipe stands

The concrete pipe stands date from the early 20th century and represent a short-lived augmentation to the System. The stands remain as remnant structures within the Reserve and have some limited interpretive potential. They appear to be generally in good condition.

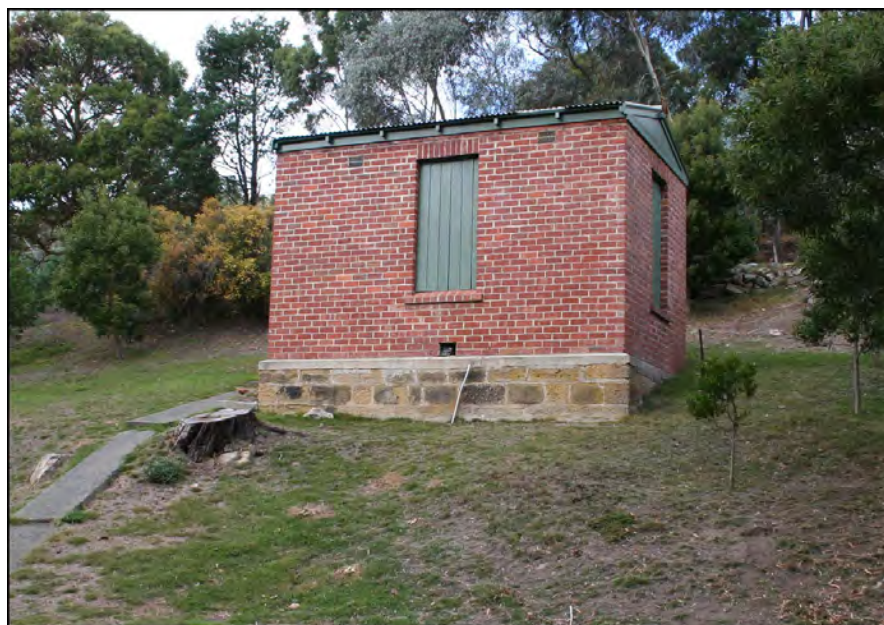
Figure 26–Pump House

The Pump House is a late addition to the Reserve, having been constructed in the 1950s to augment the transfer of water into reservoir

No 1. While not particularly rare or notable in its own right, it is a highly visible structure on the way into the reserve and assists in understanding the System as a continuously modified and functioning entity across three centuries.

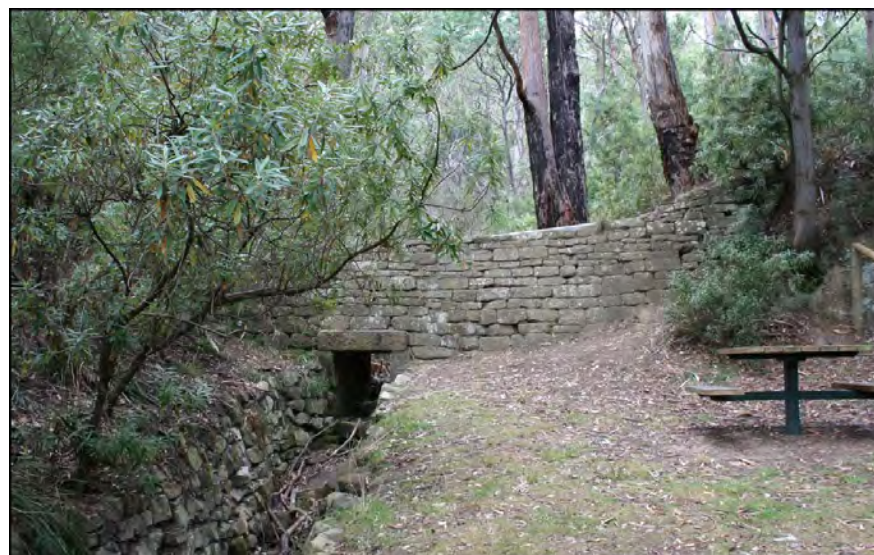
Dry stone walling is used in various locations throughout the park and contributes to the character of the Reserve. The stonework, while well executed, is rustic and functional rather than ornamental or gardenesque in character. The stone walling should be used as an example to guide future wall construction in the Reserve or along the System.

Figure 27–Dry stone walls located at the back of Regans Gully. Similar walls can be found in other locations in the Reserve.

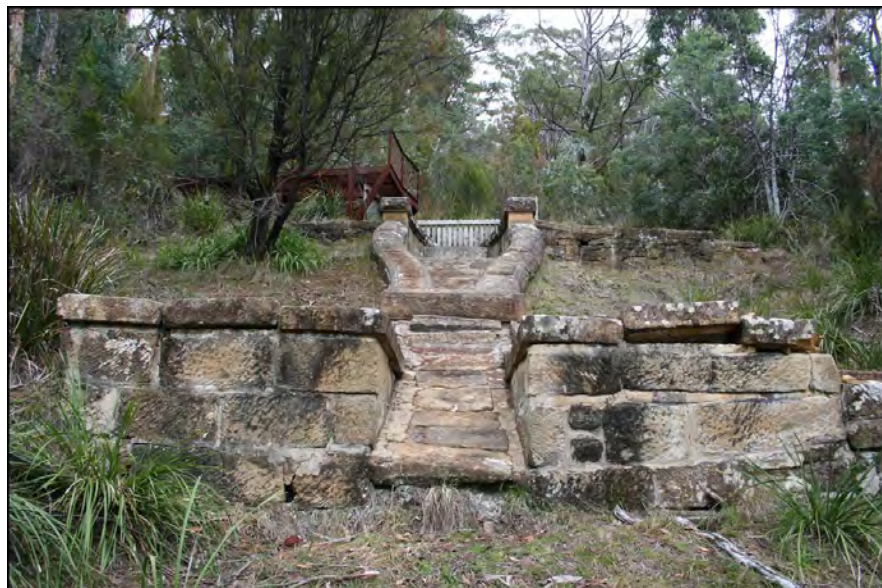
Figure 29–The Pipe-Head Well

In addition to requiring conservation works, the Pipe-Head Well is a key element of the early system which needs to be reintegrated into the Pipeline Track and interpreted. The viewing platform and picket fence should be removed and a track and interpretive node reinstated which direct visitors to the location.

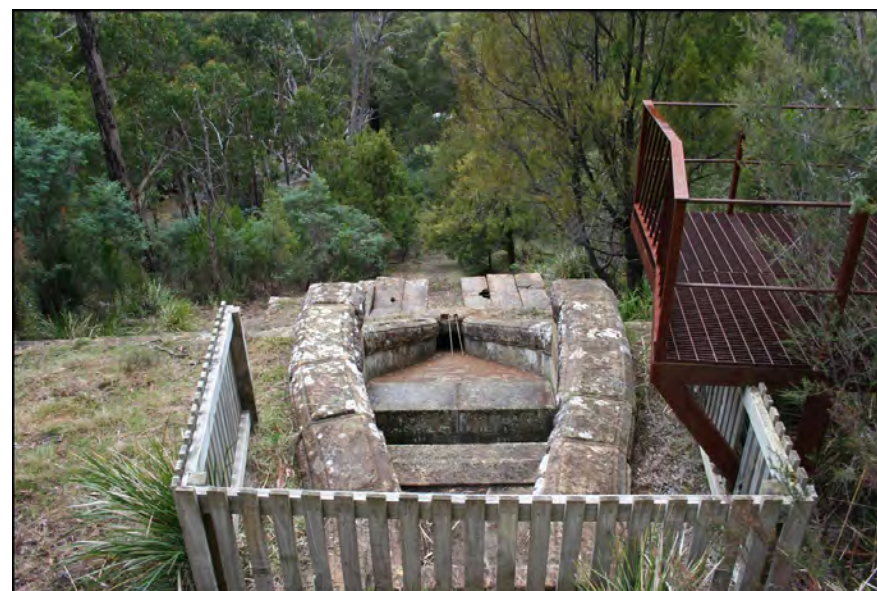
gentler grade. The Pipe-Head Well has suffered some damage due to a tree fall circa 2006 which has cracked several sandstone panels covering one of the mixing chambers. The place also has several unsympathetic accretions, including a steel viewing platform installed in the 1980s and a domestic picket fence installed for safety reasons around the structure.

Figure 30–The Pipe-Head Well, looking down slope. Note the intrusive viewing platform at the right.

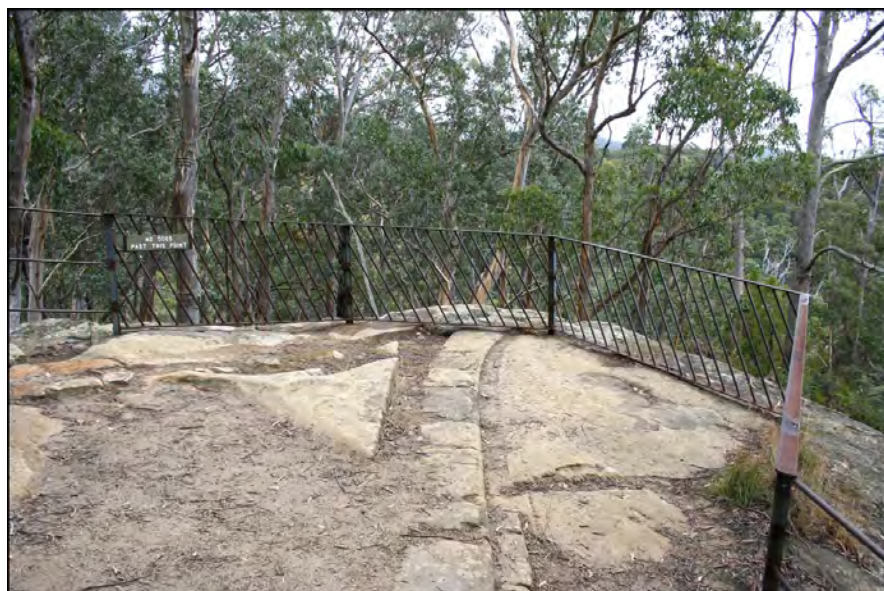
Gentle Annie Falls occurs in relatively rugged terrain. The Falls were man-made and comprise a cut channel in the sandstone bedrock, where water was directed from the sandstone troughing over a cliff and into a small receiving basin. From the basin, water was conducted downhill in pipes to the Pipe-Head Well. Gentle Annie Falls provides a scenic overlook of parts of the Waterworks Reserve below and allows an appreciation of the ruggedness of the terrain in which the Pipeline was originally constructed. The rock cut channel and associated stairs cut into the sandstone cliff, attest to the amount of sheer physical effort which was put into the construction of the water supply system. Sandstone quarries, where stone was cut for use along the Pipeline, are located in the bush nearby.

Figure 31–The top of Gentle Annie Falls. Note the sandstone water channel which leads to the edge of the cliff.

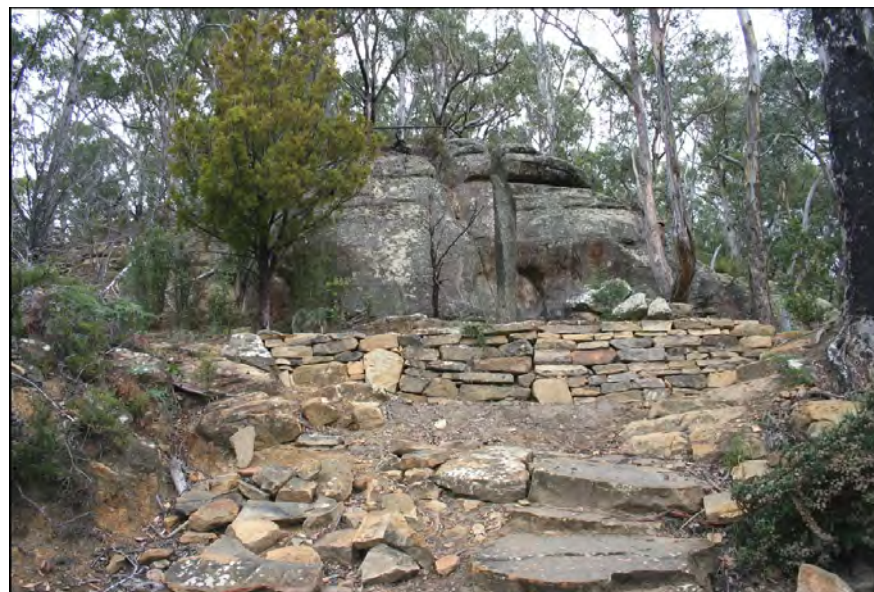
Figure 32–View up slope to Gentle Annie Falls. The stone walling is recent (c 2006) and overly formal for what is otherwise a very rough section of track.

The Falls are an important scenic and interpretive location. Current safety fencing, while robust, now looks dated and is somewhat intrusive. A different style of fencing or alternate method of providing safety barriers which is less visually intrusive to the rock platform of the upper Falls is desirable. The areas above and below the cliff should also serve as interpretive nodes for the System.

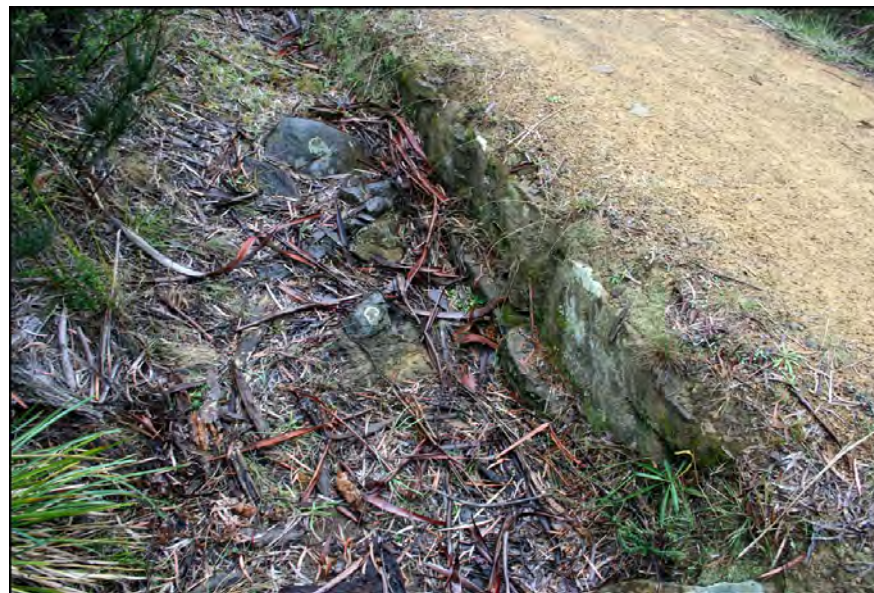
Figure 33 - The side wall of the troughing, visible in an area where the ground has been built up to form the track on top of the sandstone troughing.

Careful monitoring of the condition of the troughing in different locations will be a key element in determining the appropriate conservation treatment for a particular section. Due to the variable conditions along the route, there is not necessarily any one technique which will be universally applicable along the entire route.

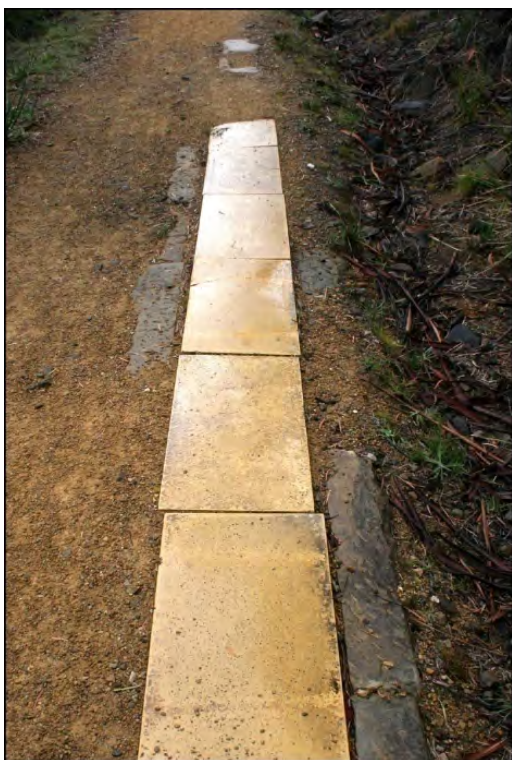
Figure 34–Inappropriate replacement covers on sandstone troughing

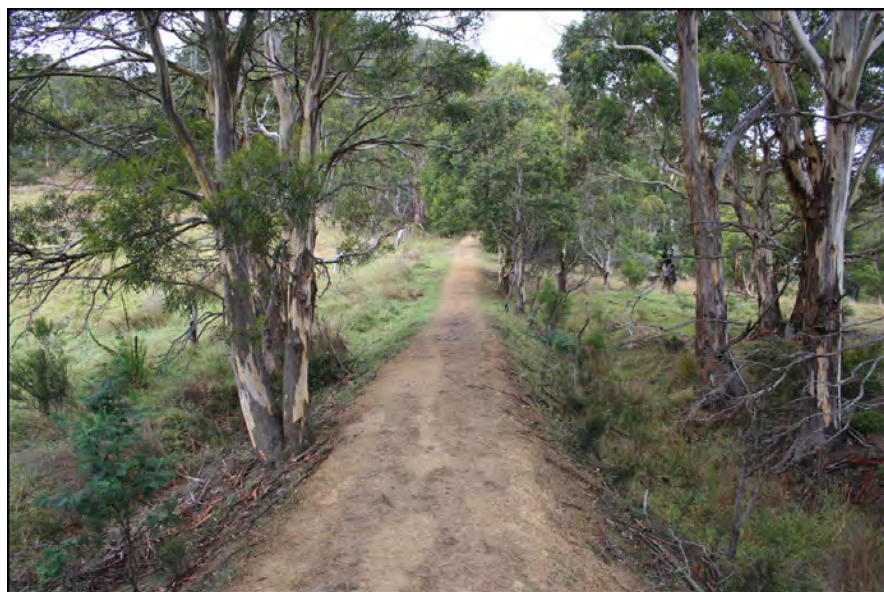
Above is a schematic representation of a typical cross-section of sandstone troughing – note the capstone is generally raised slightly above the side walls rather than flush as suggested by the diagram. The trough is constructed of a stone bottom and two stone side slabs with a soft mortar between the sides and the base. The capstone sits loosely on top of the sides and much of the capstone material shows signs of wear from foot traffic and other use over 150 years. Damage has also been caused to capstones through vehicle traffic along pipeline, mainly for routine and emergency maintenance works.

Figure 36 – The sandstone troughing near McDermott’s Saddle, facing east. In this location, the troughing is contained within a built-up earth embankment, which also serves as the pedestrian Pipeline Track route.

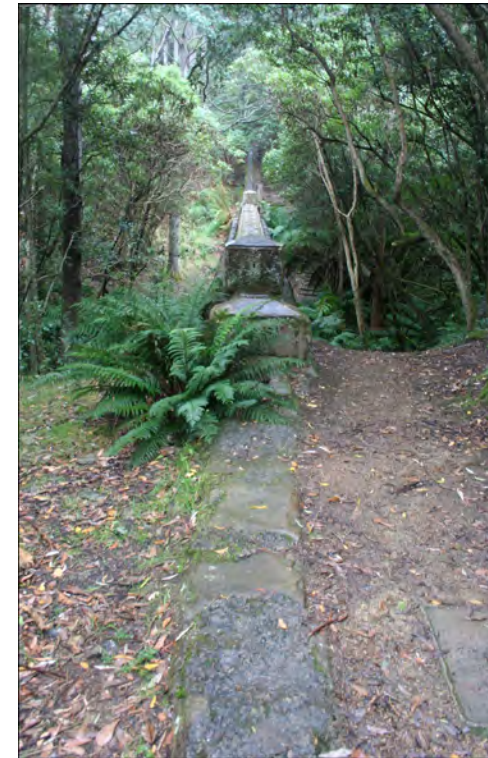
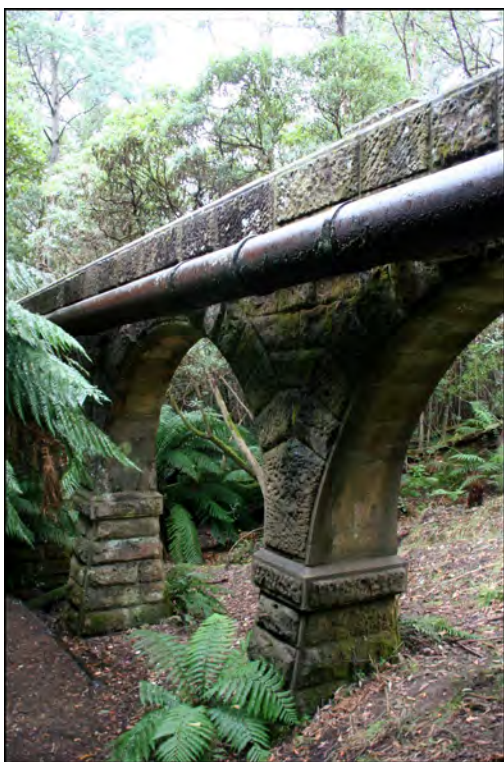
Two sandstone aqueducts span branches of Longhill Creek and Sassafras Creek and were built in 1881 to replace the earlier timber bridge which carried the water in troughs across the Creek. These aqueducts date from the second phase of the water supply and are still in service. While generally in good condition, the structures have a range of accretions including cast iron pipes added to the sides which now carry the water, as well as telecommunications cables and evidence of old metal bracing and strapping. The aqueducts are largely enclosed by the forest canopy and are prone to vegetation and moss growth, which obscures them and, in the longer term, may damage the stonework. In early 2007, the aqueducts were cleaned by hand to remove vegetation and other debris. While successful, the works did however highlight the difficulties of maintaining the aqueducts in light of modern safety standards, due to height issues.

Figure 38–Aqueduct over Longhill Creek

Figure 39—Aqueduct over Sassafras Creek

The aqueducts are some of the most evocative structures within the System and are relatively accessible to visitors. Ideally the accretions to the aqueducts should be removed and no new items should be attached to the structures.

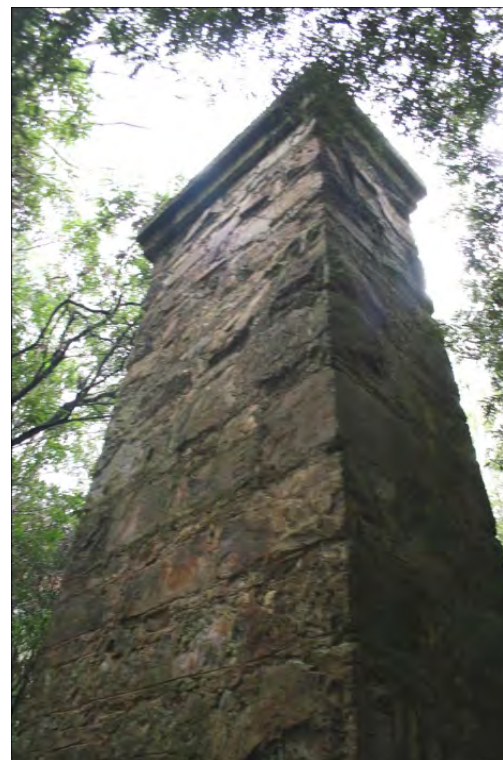
the 1880s pipeline route) and is rather degraded, but is still accessible by determined walkers. The pillars have been the subject of some limited conservation works but a structural assessment would be prudent.

Figure 40—Remnant pillar, from 1861

As this is an important remnant feature of the early water supply system, it is desirable to re-establish a good walking trail past the pillars with appropriate interpretive media.

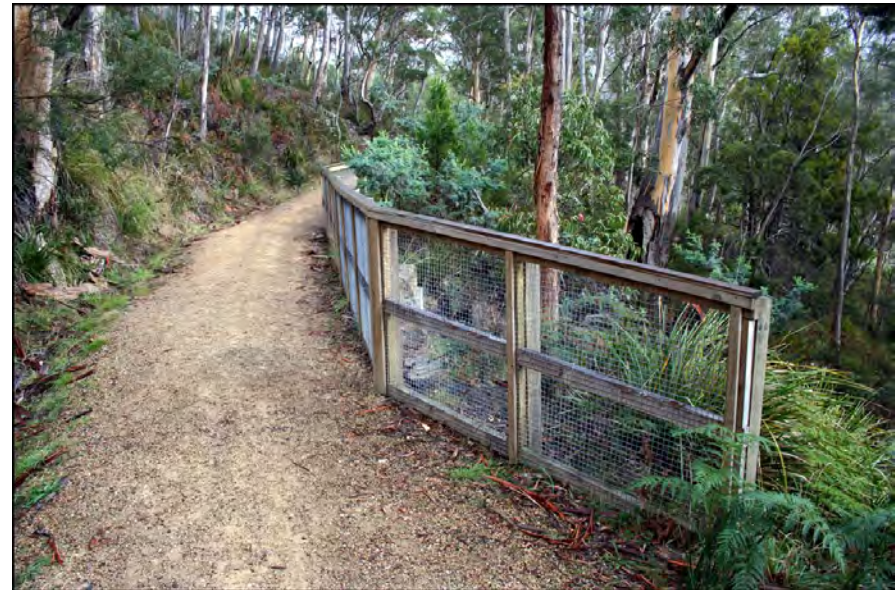
Figure 43—An example of inappropriate fencing along the pipeline. This fencing uses modern dressed timber, which is a jarring contrast to the natural and rural character of this section of the pipeline.

The approach to the general presentation of the System in this section also requires further consideration. At present, there are a wide range of types of fencing, barriers and access control devices that range in materials from modern dressed timber to old unpainted metal to contemporary colourbonded steel. Better consistency in the selection of materials and the use of materials which reflect the character of the System will enhance the experience of visitors. Efforts should also be made to provide visitors opportunities to access “lost” aspects of this section of the System such as the Pipe-Head Well and the pillars from the original timber Longhill Creek aqueduct, which are presently bypassed.

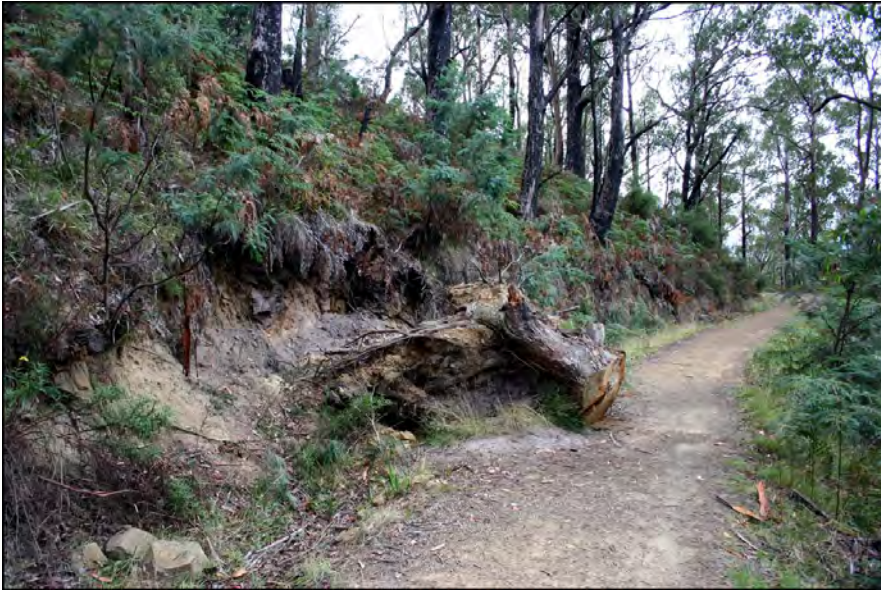
Figure 44—A tree fall across the pipeline and associated track.

Here the sandstone troughing has been concealed beneath the Pipeline Track but tree falls have the potential to damage the stonework. The earthen embankments constructed to support the troughing in this location are also not suited to support large trees. Tree growth will need to be managed on an ongoing basis to ensure trees do not threaten the historic pipeline (ie, sandstone troughing) and associated infrastructure or the stability of the embankments and the Pipeline Track.

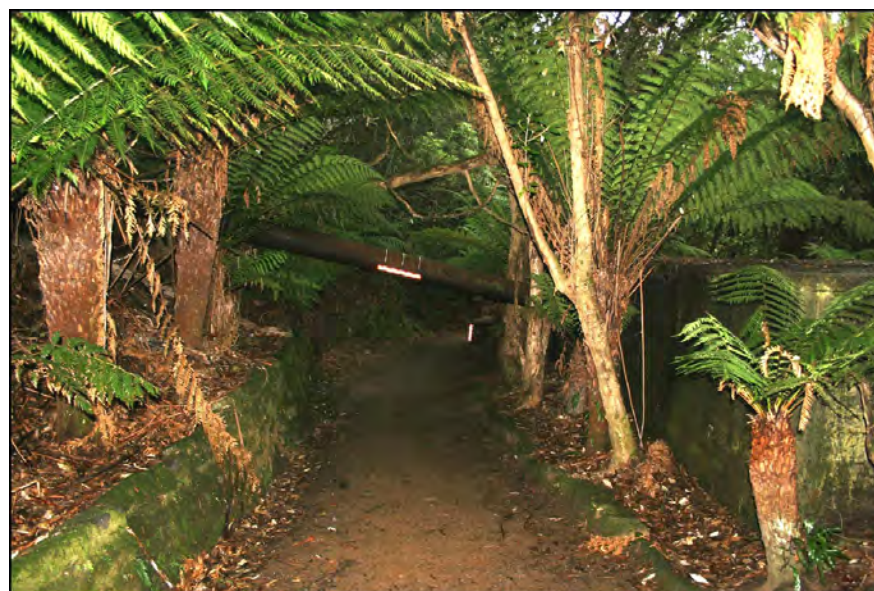
Figure 47–Fern Tree Bower in 2007

The Fern Tree Bower was an important local recreational destination until the major damage of the 1960 floods. The Bower as it currently stands bears little resemblance to its pre-1960 configuration. At present, the Bower feels overgrown and enclosed, providing little in the way of areas for recreation or picnicking use. All that survives of the original Bower construction is the date stone which was relocated following the floods.

The original Bower was both part of the water supply and a destination for recreational visitors, with a mix of formal plantings and bush surrounding the site. Since the damage caused in the 1960 flood, the area

is now dominated by regrowth vegetation and bears no resemblance to its earlier, park-like configuration. Reinstatement of the Bower to its earlier configuration would be possible but would require considerable effort and conjectural reconstruction. The impact on the regrowth bush may also be considered undesirable. As Hobart and Fern Tree are well furnished with recreational destinations, the reinstatement of the Bower as a major recreational spot may not be considered a priority, although it may be warranted if Silver Falls continues as an important recreational destination .

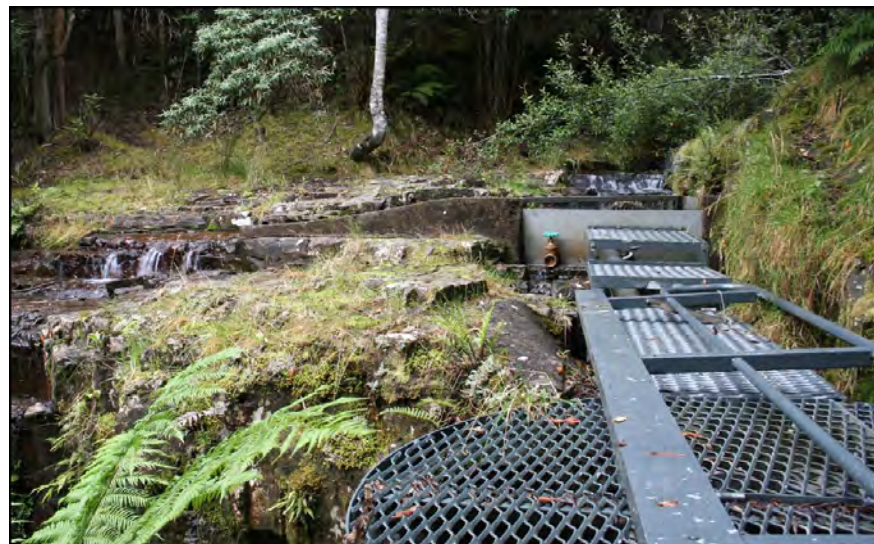
Presently, the Weir consists of a small concrete structure which channels water into an open trough before the water enters the sandstone (originally timber) troughing at the Bower proper, a few hundred metres away. The weir and its surrounds have been substantially altered since their original construction. Much of the ground surface at the weir has been concreted and unsympathetic safety fencing has been installed. The weir has been modified in recent years with the installation of safety and access equipment by Southern Water, which is visually intrusive. Ideally this equipment should be modified to be concealed or otherwise better integrated into the weir and its surrounds.

Figure 49–Intrusive equipment at Silver Falls Weir

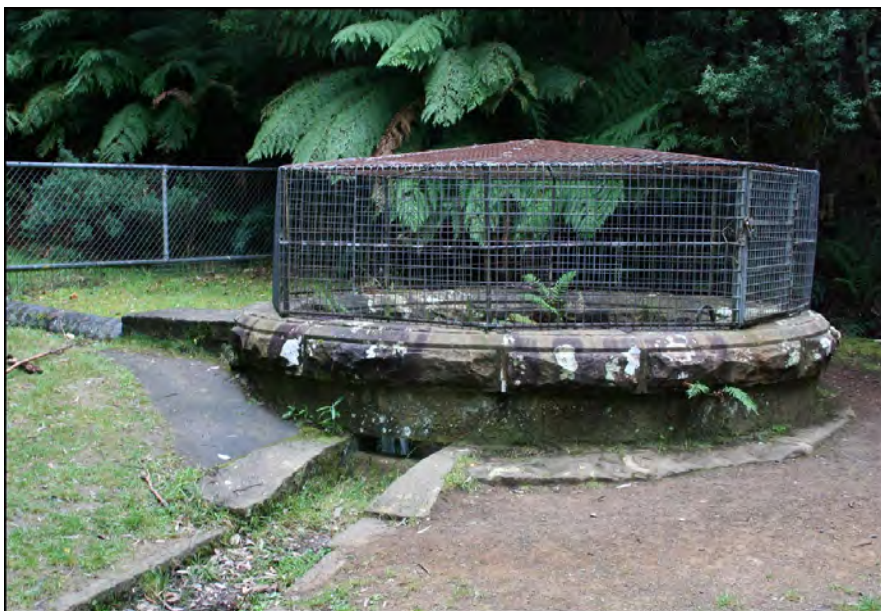
Figure 50–The Wishing Well

Creek. By the late 1860s, with the extension of the scheme to Long Creek, two additional sandstone intakes had been added on Long Creek. The Wishing Well essentially acts as a mixing chamber for these four intakes and directs the water downhill towards the Bower.

There is a small clearing at the Wishing Well which serves as a logical stopping point for people using the Pipeline Track recreationally. The Wishing Well itself is in good condition with the only significant modification being the installation of a mesh cage above in the mid 20th century. Modern chain mesh fencing has been installed in some areas to prevent access to the Fork Creek intake. The Wishing Well is an important interpretive node for the System and has some interpretive signage at the moment.

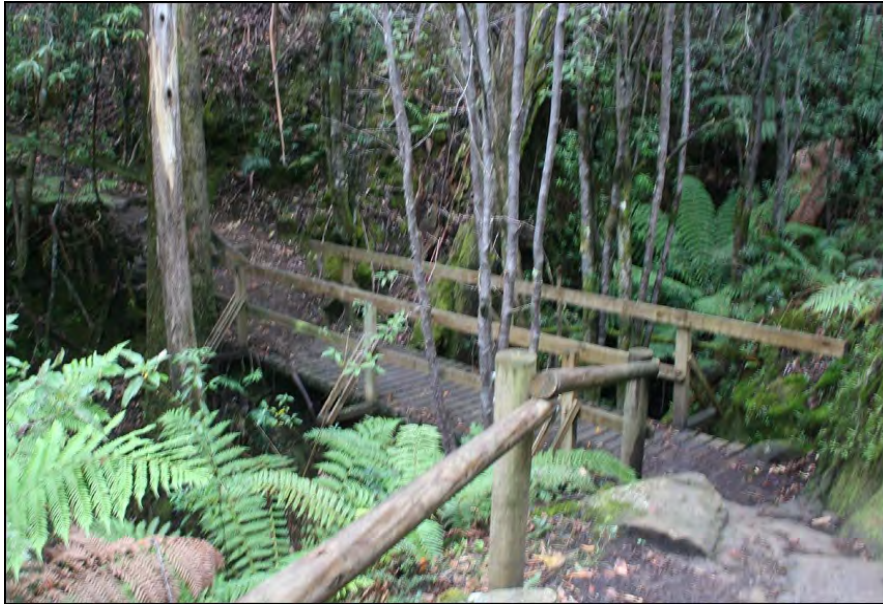
Figure 51–Twin Bridge 1

The Twin Bridges are two narrow bridges over Long Creek. Neither of these bridges is original but bridges are known to have been in this location from the late 1860s, as the Pipeline was extended to include new intakes. Hartzell noted that there have been at least three different bridges in this location at different times.⁶¹ One bridge is of recent timber construction while the other is modern steel decking and wire mesh. The steel deck bridge carries water pipelines beneath it. The bridges act as a bit of a bottleneck for foot and cycle traffic on the Pipeline Track in this location due to their narrowness. This could be overcome through widening or duplication of the bridges if visitor use figures warranted such action.

The different construction materials of the two bridges is jarring in the forest setting and when the bridges are replaced in future it is desirable if they could be constructed in similar materials which are more sympathetic to the surroundings. As the Bridges also serve as significant crossings for operational water pipes, any reconfiguration of the Bridges should take into account the need for easy access for both routine inspection and emergency access to the pipes. This could be achieved through the use of decking panels which are easily removable.

Ideally, existing modern additions along this section of the pipeline should be progressively replaced with more appropriate structures, particularly the safety equipment at Silver Falls Weir, and the Twin Bridges. As these structures themselves have minimal heritage significance, there is considerable flexibility to design sensitive replacement. At a minimum, this should be considered when the present structures reach the end of their operational life, if not before, if not before. There is also an opportunity to improve the appearance of the safety structures at the Wishing Well.

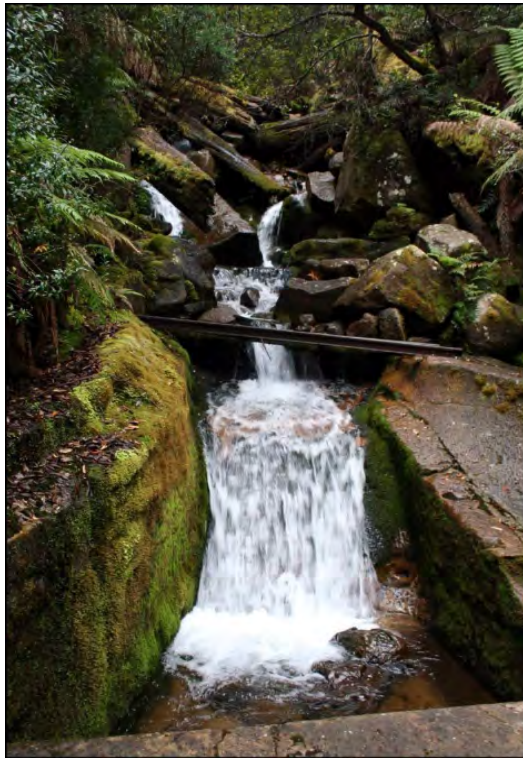
Figure 55–St Crispins Well

There are a number of small intakes along the 1881 section of pipeline, most dating from the late 19th century, although some were rebuilt or replaced in the early 1900s.⁶² The best known of these is St Crispins Well, which was the upper reach of the 1881 system and is roughly halfway along this section of the Pipeline Track. At the base of the path leading to St Crispins Well is a small timber and corrugated metal hut close to the former tramway route which is used as a temporary shelter by walkers. This hut was constructed in the 1970s however a range of different huts are believed to have been in this location from circa 1881.⁶³ Each of the intakes consists of a small weir formed from a mix of local stone and brick which creates a small chamber from which water is diverted into a cast

All of the intakes are relatively simple structures consisting of a small weir constructed of local rock, sometimes with a small basin cut into the bedrock. In some instances, offcuts from iron tram rails have been reused as support structures for the weirs. The weirs direct water into a cast iron pipe and there is generally a small scour valve allowing the basin to be fully drained. Southern Water monitors the water quality of these intakes regularly using taps installed along the track below and regularly scrubs the intakes.

The intakes are generally in good condition and have had minimal modification over their lifetime, although there has clearly been a phase of repair and in one case, building of a replacement weir. This occurred in the 1910s augmentation of the MWSS, generally recognisable by the use of concrete and dolerite, as opposed to the sandstone and mortar used in the earlier work.⁶⁶ Restricting public access to the intakes themselves is justified given water quality concerns however it may be possible to interpret the intakes along the Pipeline Track to inform visitors about their construction and function.

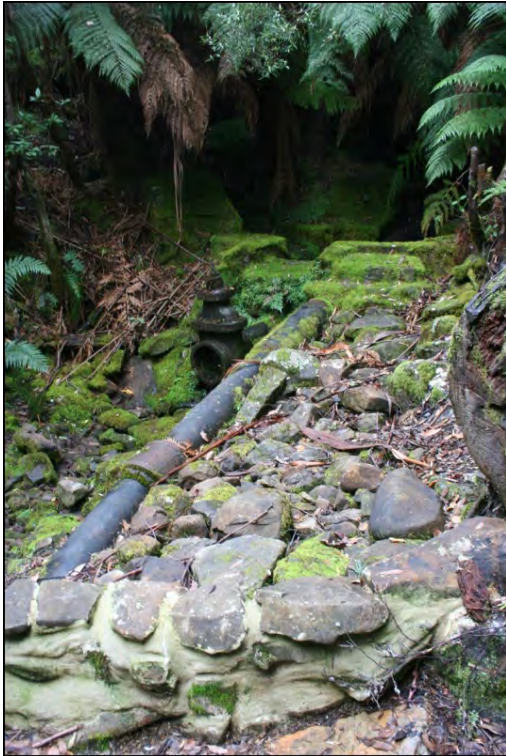
Figure 56—Intake with 20th century supplementary stone and concrete works.

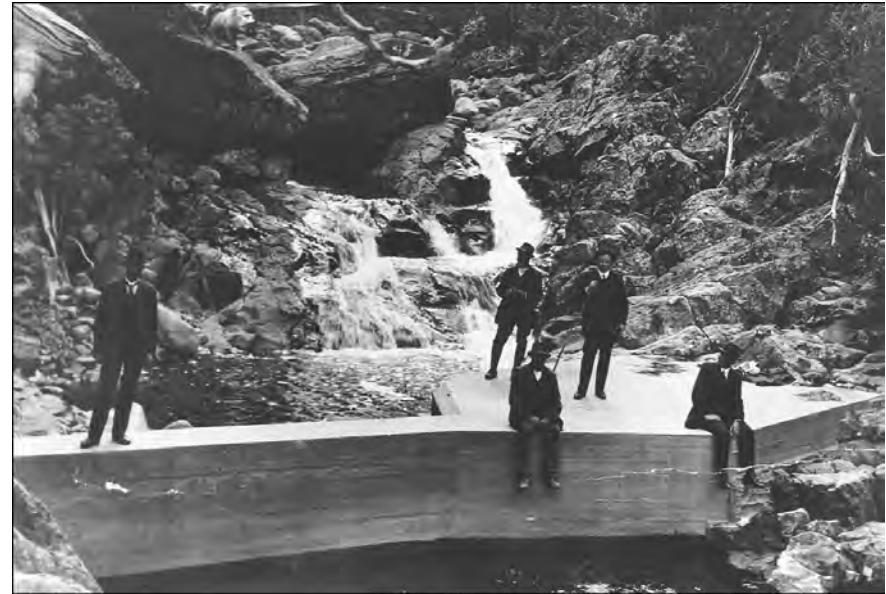
Figure 57—Historic view of North West Bay River Weir

The North West Bay River Weir marks the final extent of the Mountain Water Supply System, in the final phase of its expansion in the early 20th century. The Weir itself is a simple mass concrete structure, which diverts water into large diameter metal pipes and then to the Siphon, which carries the water across steep valley terrain before linking in with the main pipeline between St Crispins and Neika.

The Weir is a robust concrete structure that appears to have had little in the way of modification since its construction, as these two photos, showing the weir circa 1920 and in 2007, demonstrate.

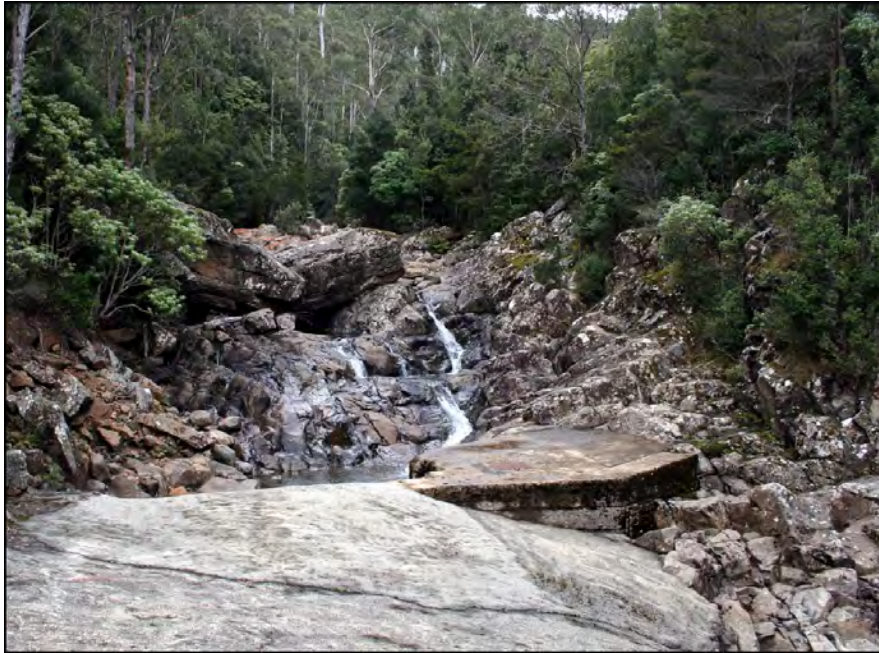
Figure 58—Contemporary view of North West Bay River Weir

Access to the weir is largely restricted to operational personnel due to a large landslide in the 1990s which has left a section of unstable hillside above a portion of the Track.
