Prepared for Hobart City Council

March 2012 (Final Report)

Hobart Mountain Water Supply System Conservation Management Plan

Conservation and management policies designed to assist in the conservation of the historically important Hobart Mountain Water Supply System, from Mount Wellington to Hobart City. This document reviews and builds upon the 1994 Pipeline Track Conservation and Management Plan.

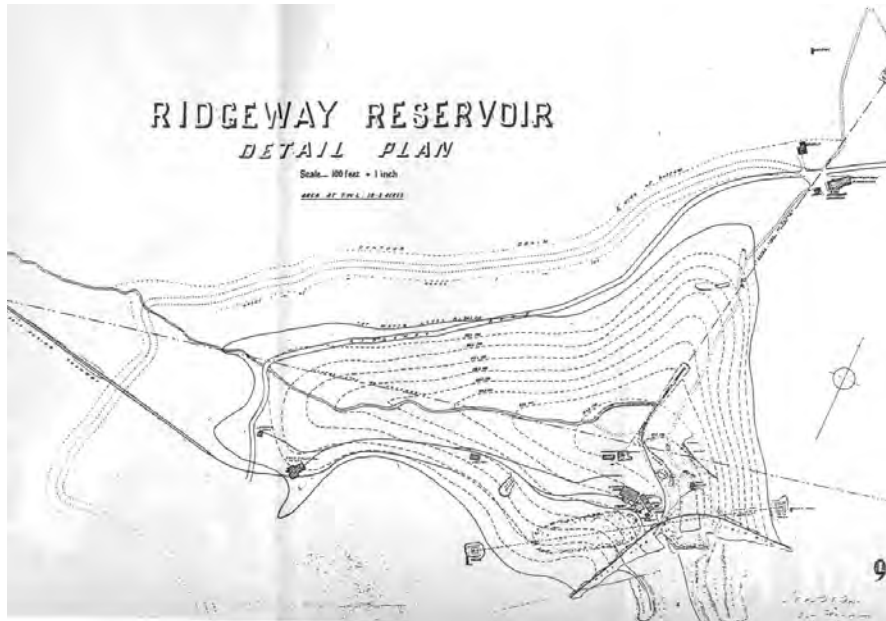
Figure 60—Plan for Ridgeway Reservoir, c 1905

The dam remains in service and is believed to be in generally good condition.
