STATE OF OUR RIVULETS

A REPORT INTO THE ENVIRONMENTAL
HEALTH OF HOBART'S WATERWAYS

City of **HOBART**

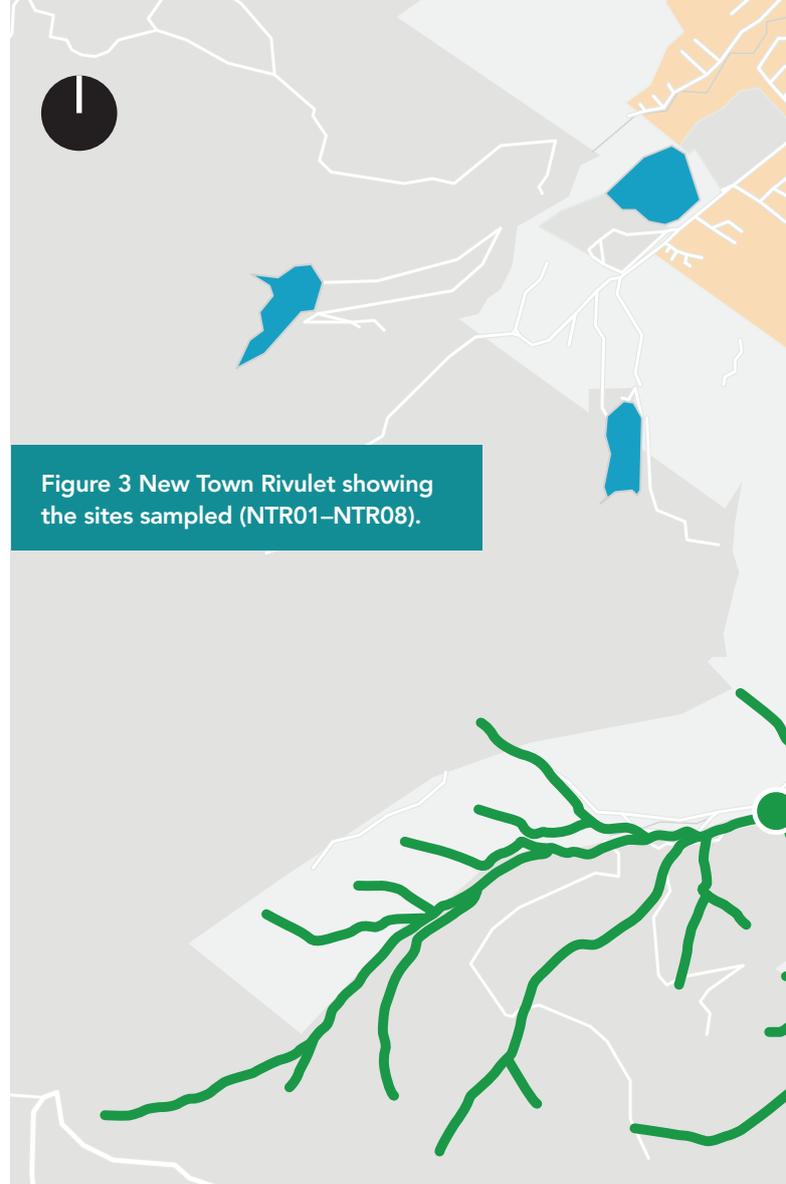
Figure 3 New Town Rivulet showing the sites sampled (NTR01–NTR08).

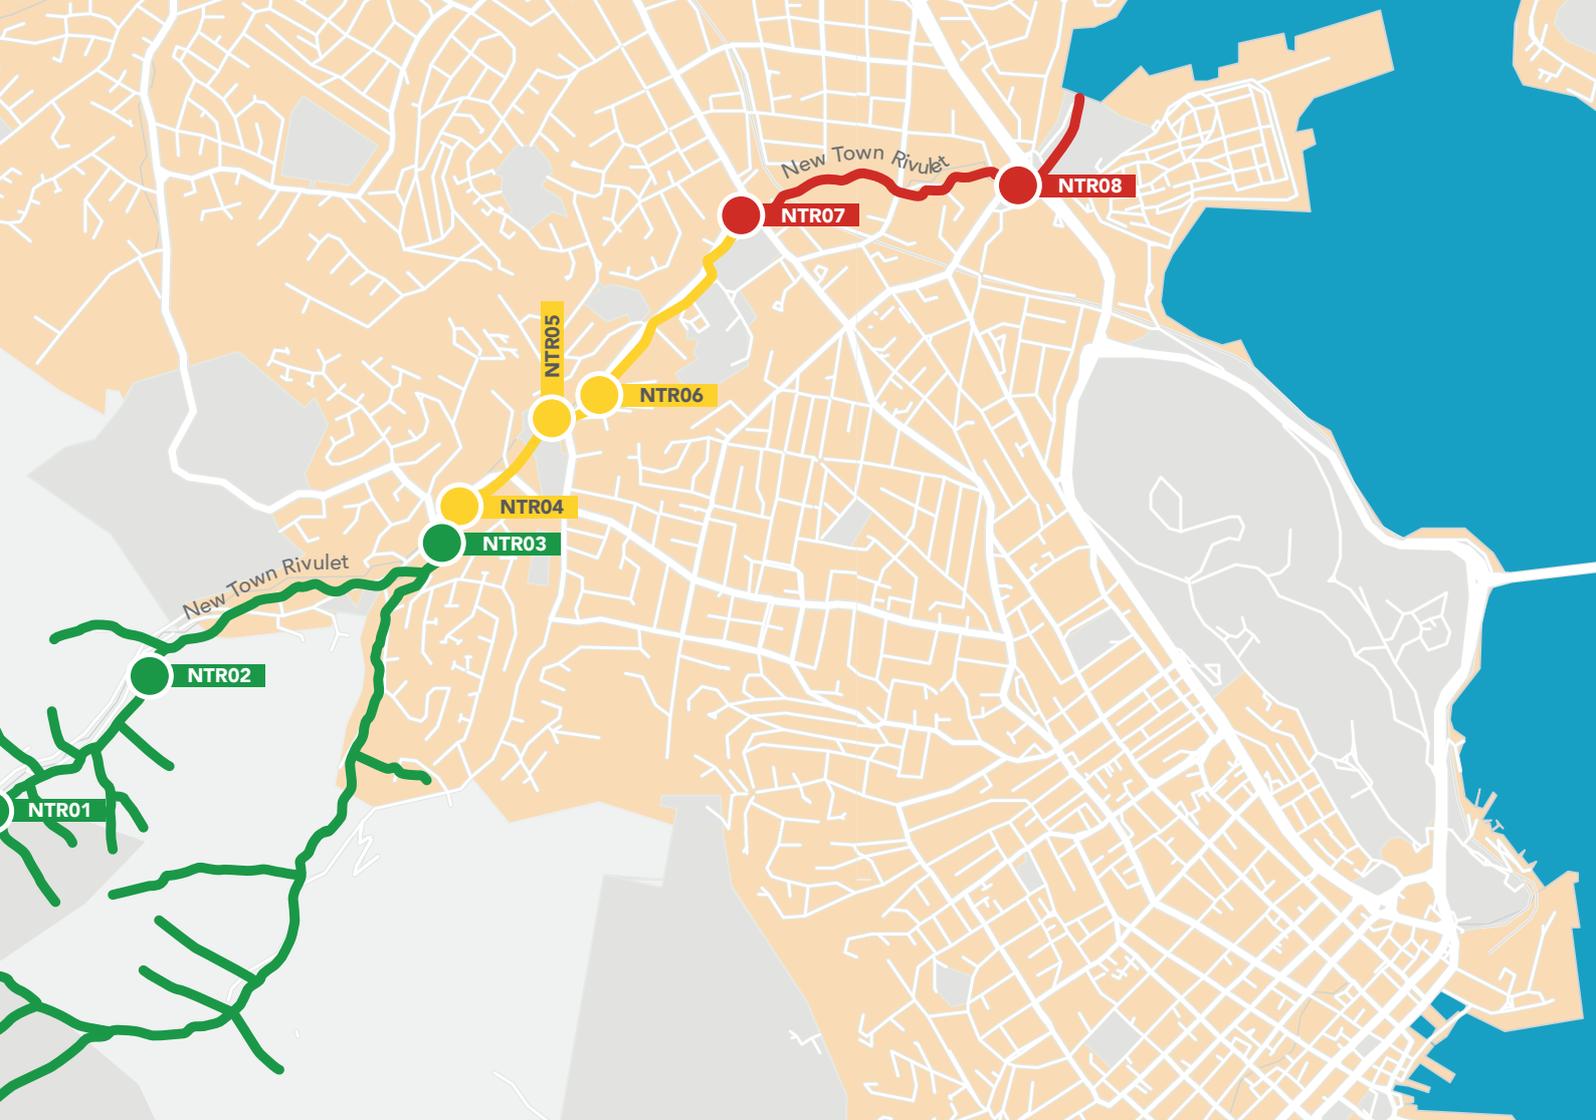
Figure 4 SIGNALT scores for sites in the New Town Rivulet. NTR01 is an upstream healthy site, site numbers increase downstream. Circles are for weighted SIGNALT scores, crosses show unweighted scores. The background colours approximate the level of impact at each site, red being heavily impacted, and green relatively natural/healthy.

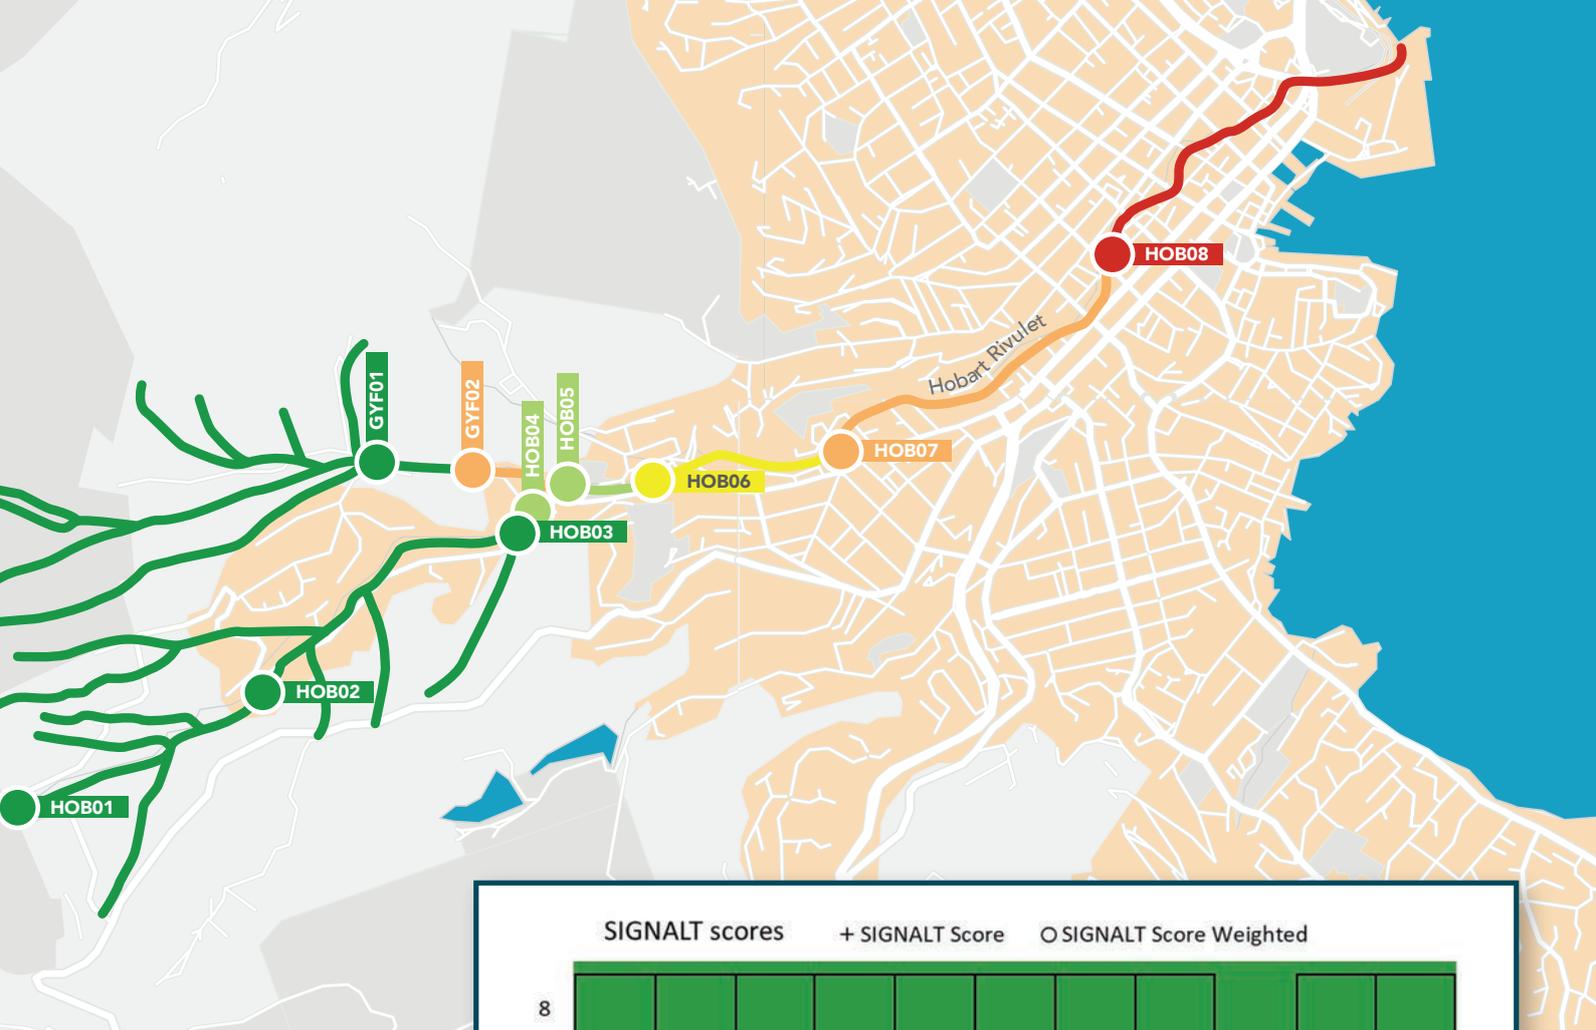
GYF02 is noticeably different to the upstream reference site GYF01 (Figure 9). This site placement was intended to see if the willow infestation at the lower site would result in a drop in ecological health. These sites are ideal for this comparison – both sites share very similar and low levels of urbanisation and are upstream of most stormwater pollution. The only possible impact other than willows at GYF02 could be leaky septic upstream, but this scenario is just as likely for GYF01 upstream.

Figure 9 SIGNALT scores for sites on the Hobart Rivulet. HOB01 is an upstream, healthy site, site numbers increase downstream. Circles are for weighted SIGNALT scores, crosses show unweighted scores. The background colours approximate the level of impact at each site, red being heavily impacted, and green relatively natural/healthy. Guy Fawkes Rivulet (a tributary of the Hobart Rivulet) sites have the code GYF01 and GYF02.

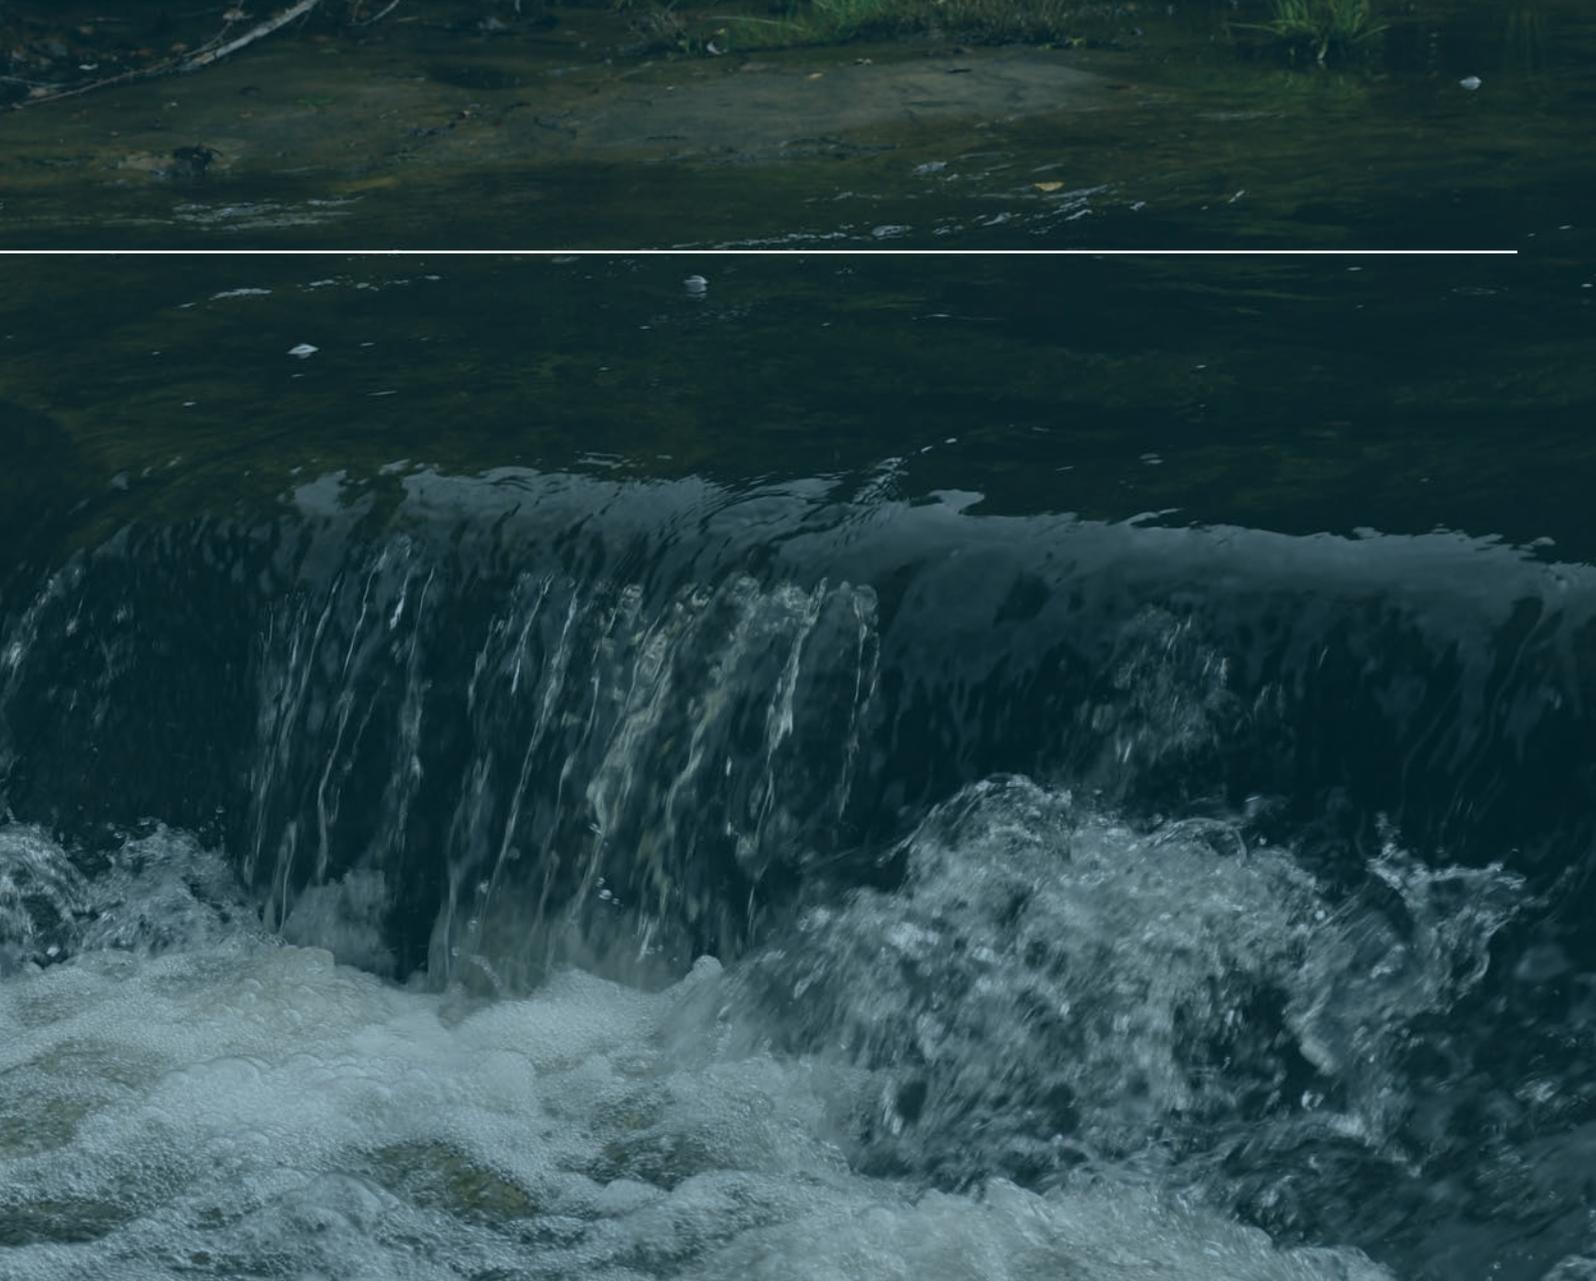
Electrical conductivity increases downstream (Figure 11), but remains relatively constant between HOB03

and HOB06. This is possibly a reflection of how geographically close these sites are.

Figure 11 Two water quality measures, Electrical Conductivity (EC), left, and Temperature (Temp), right. Sites are arranged with down-stream to the right of the figure.

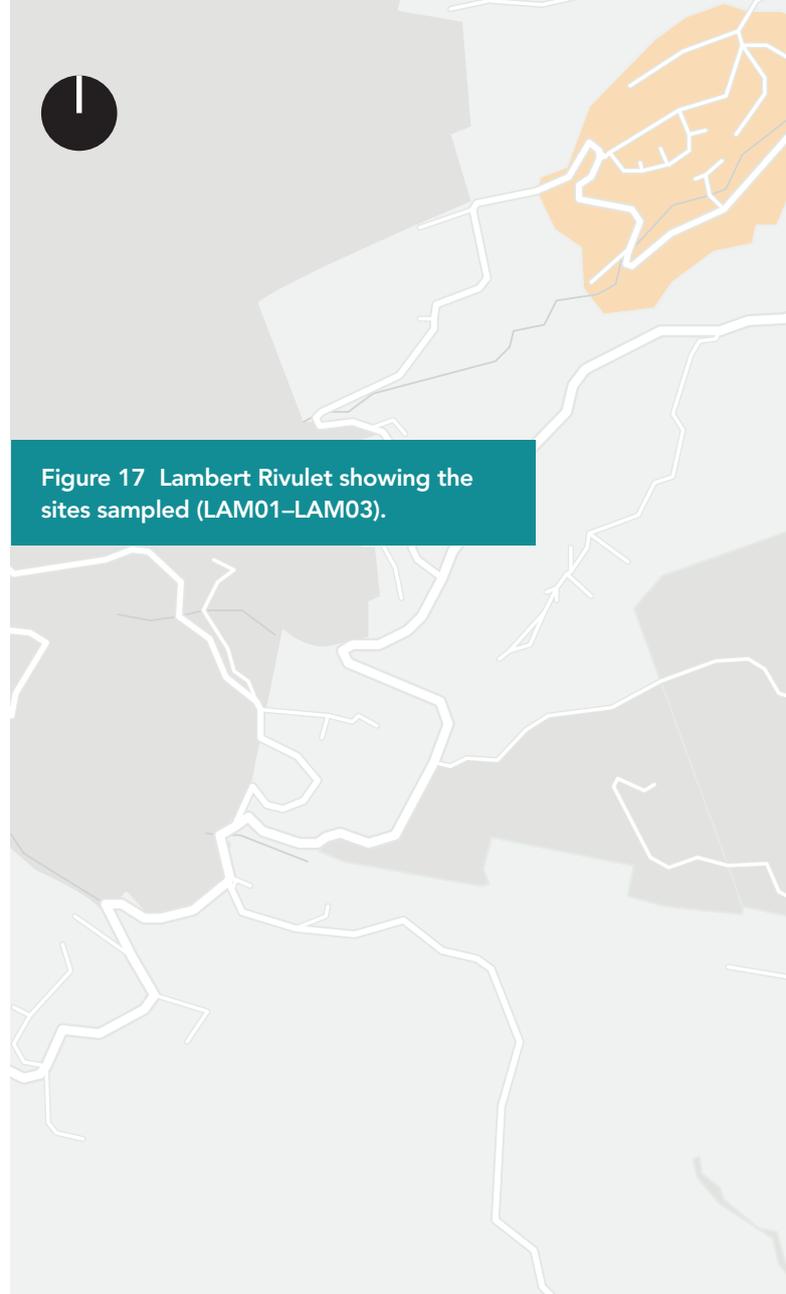
Lambert Rivulet is the smallest of the rivulets sampled. It differs from the other three in having some urbanisation along the entirety of its length (Figure 17). The other three rivulets all contain upstream catchments that are predominantly native bushland. The upstream site in this rivulet (LAM01) starts as impacted, and the two sites downstream are worse but similar to one another (Figure 18).

Figure 17 Lambert Rivulet showing the sites sampled (LAM01–LAM03).

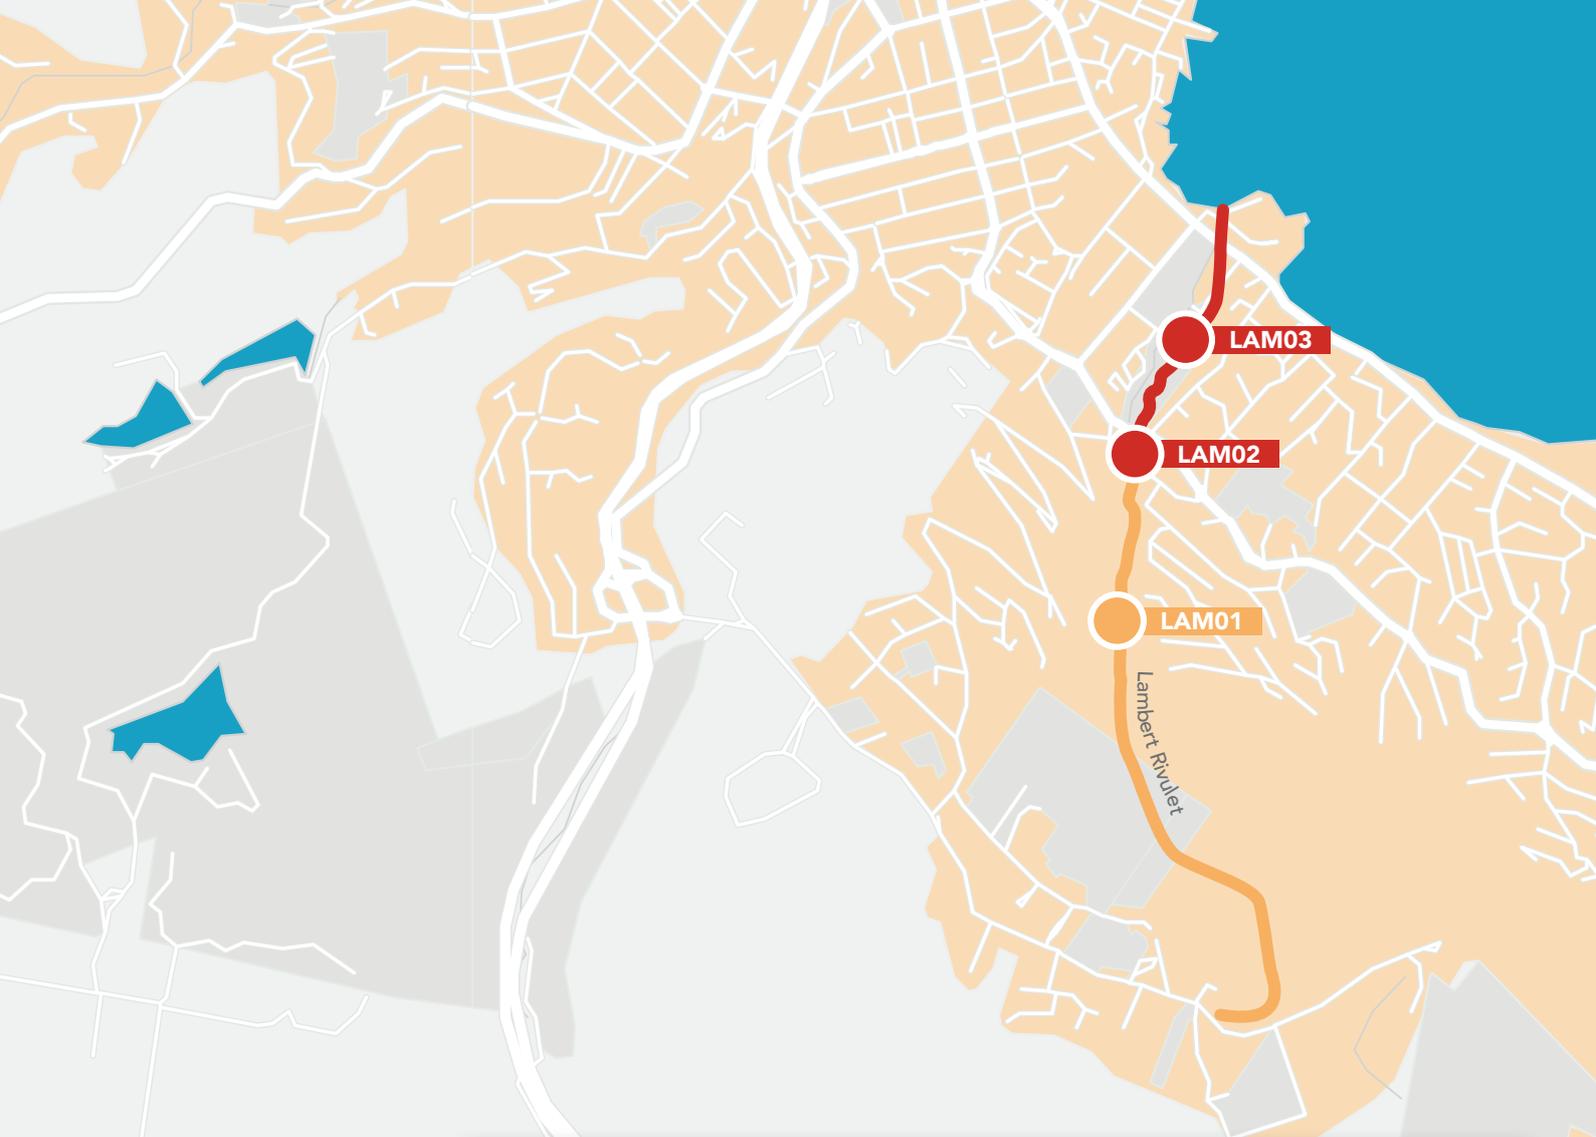
Figure 18 SIGNALT scores for sites in Lambert Rivulet. Site numbers increase downstream. Circles are for weighted SIGNALT scores, crosses show unweighted scores. The background colours approximate the level of impact at each site, red being heavily impacted, orange moderately impacted and green relatively natural/healthy.

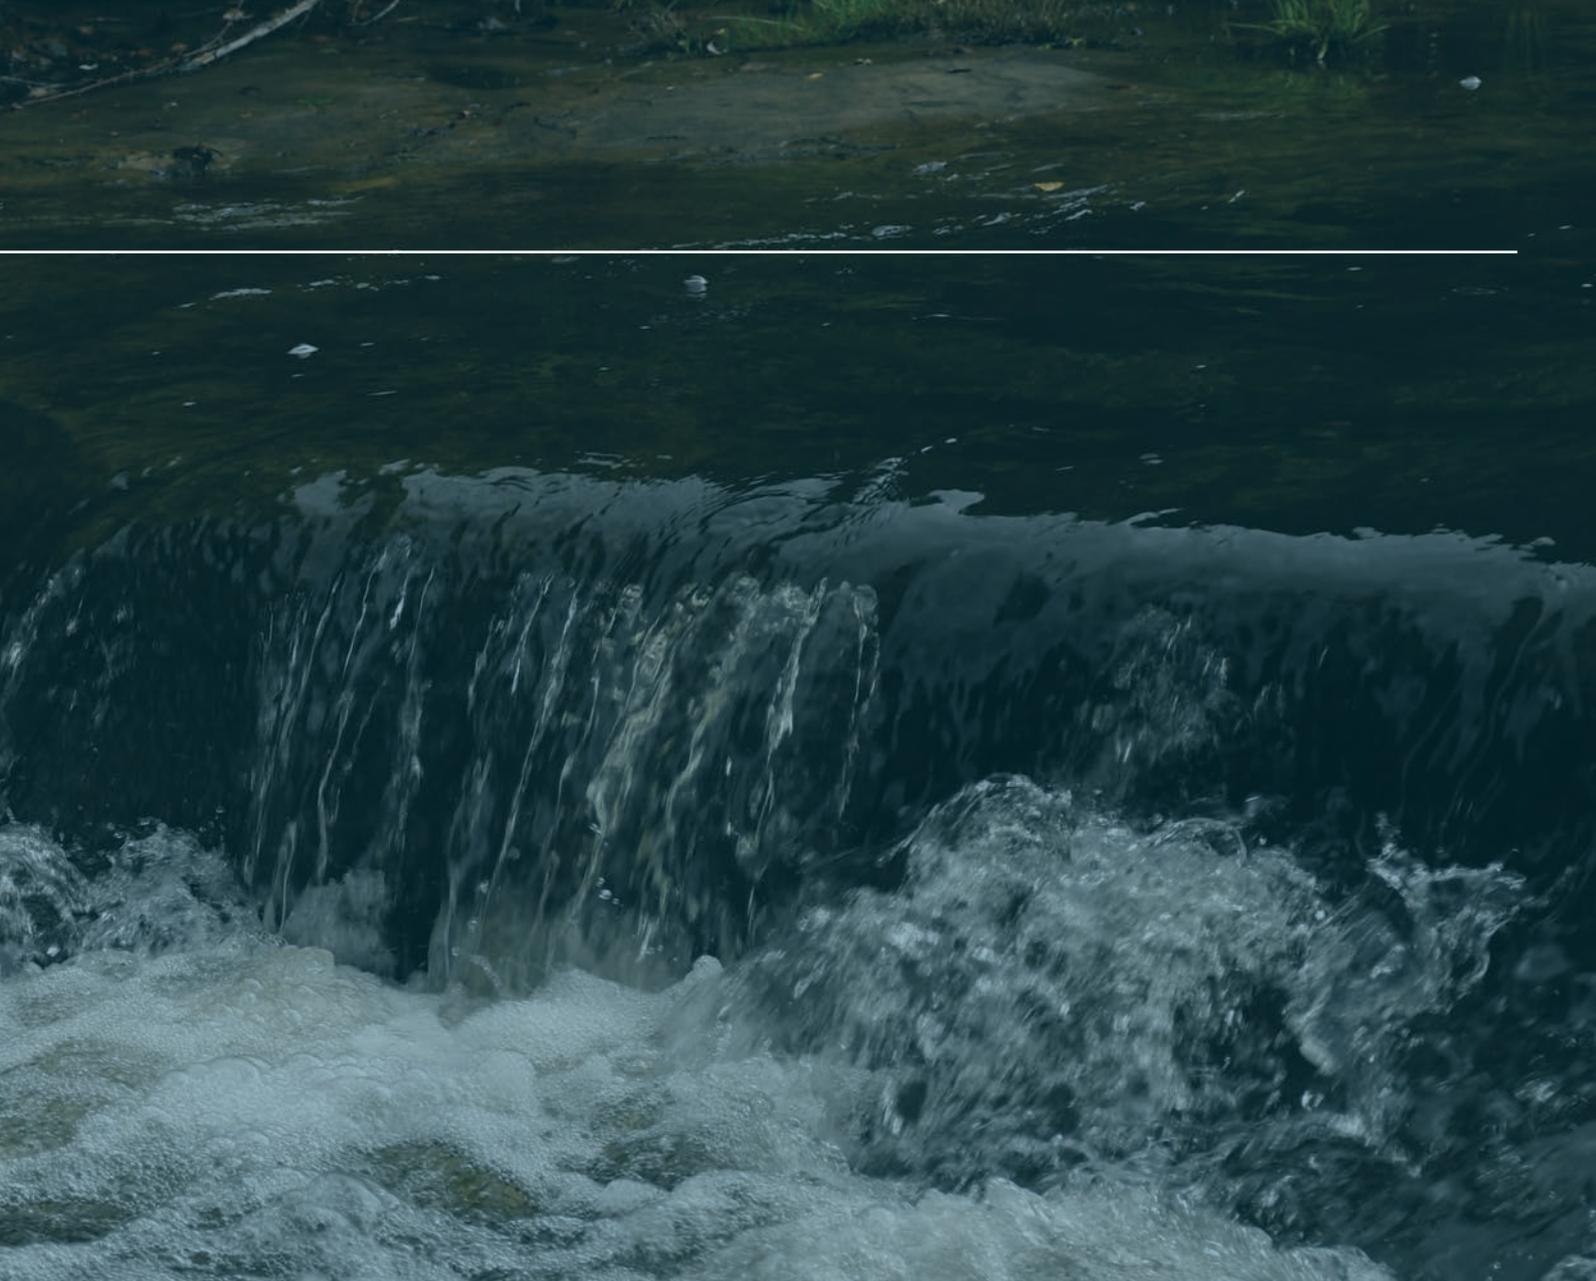
Figure 20 Two water quality measures, Electrical Conductivity (EC) figured left and Temperature (Temp) figured right. Sites are arranged with downstream to the right of the figure. Note the y axis on the temperature plot has been truncated.
