# CITY HALL, HOBART CONSERVATION PLAN

Prepared by Ian Terry  
in association with  
Paul Davies Pty Ltd  
for:

March 2002

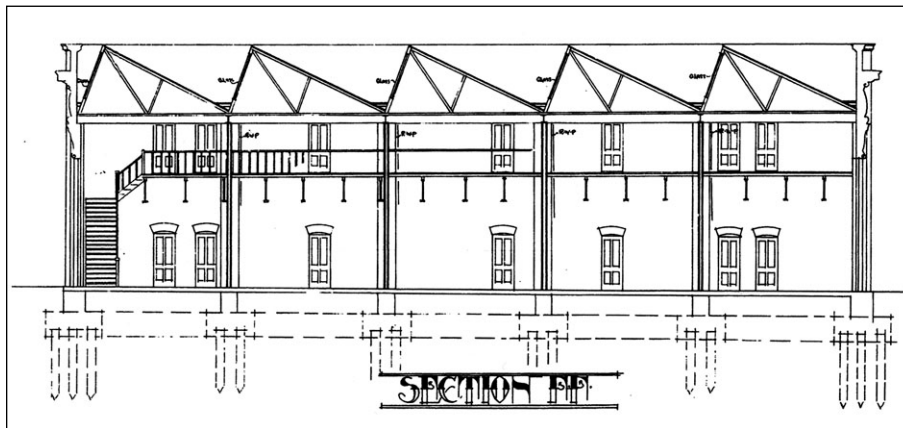
Figure 20. 1914 section showing market entrances to shops and stairs, balcony and doors to storage rooms above the shops. Note also the sawtooth roof and piles below the foundations (HCC Drawing A7<sup>5</sup>).

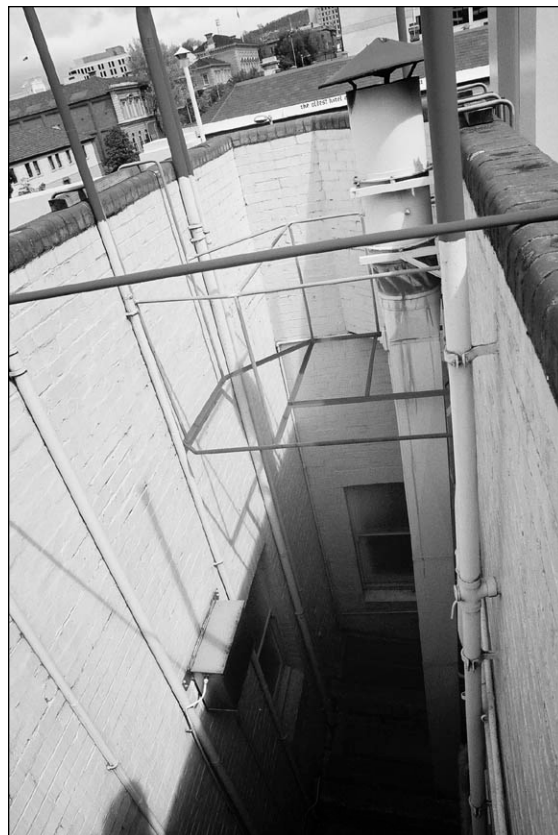
Figure 52. Lightwell above foyer showing structure to support 63 Macquarie Street exhaust fan.

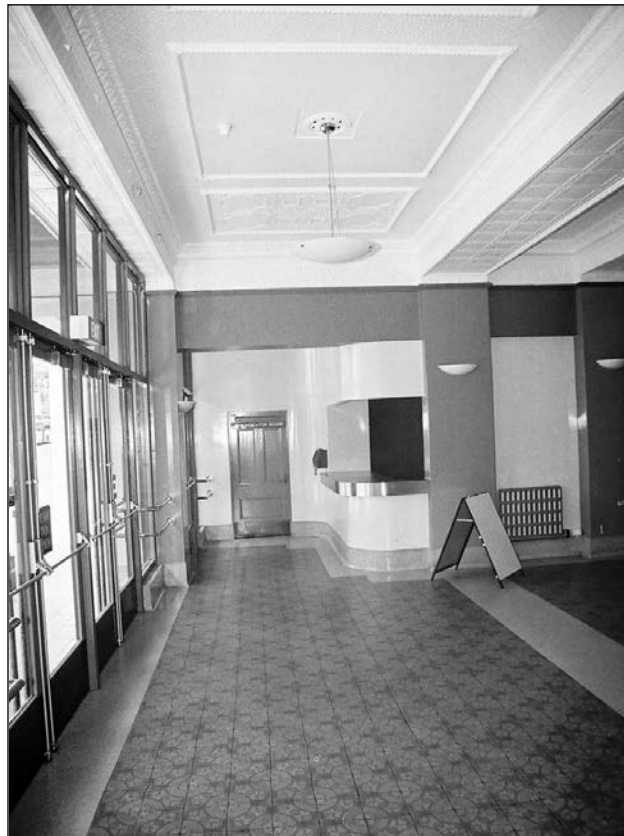
Figure 55. View of foyer showing counter. Note the missing panel of pressed metal in the ceiling around the light.
