*City of* **HOBART**

**McRobies Gully Waste Management Centre**  
**Annual Environmental Review 2025/2026**

September 2026

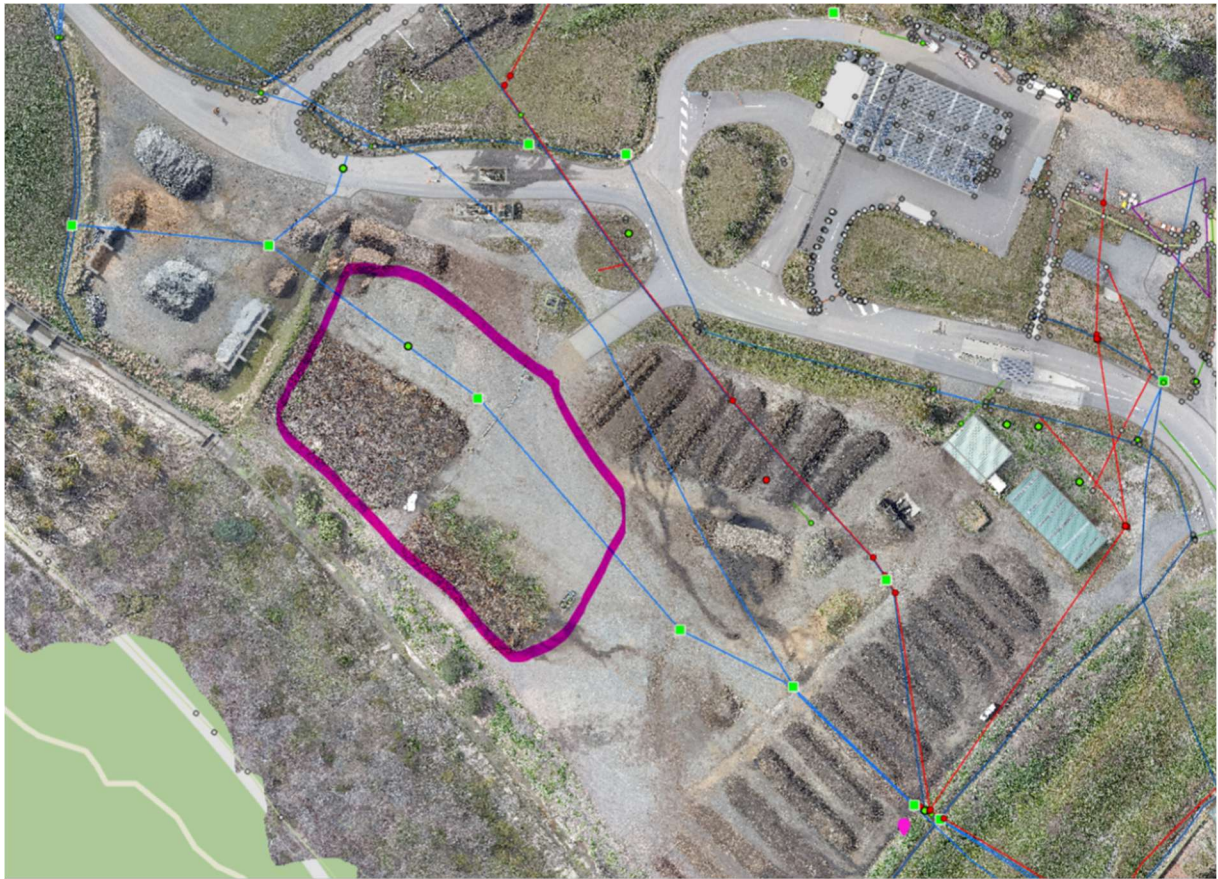
**Figure 1. Indicative geofabric repair area within the organics processing area**

Separately, an area of geofabric within the organics processing area was identified as requiring replacement following green-waste shredding activities. The affected area has been mapped, and replacement works are planned for summer.

The indicative repair area, outlined in purple in the figure below, shows the section of geofabric identified for replacement.
